# Wind Mitigation Inspection Report

| <b>Name:</b> | Sun Ketch 2 Condo Assoc Inc Bldg 1 | | | | | | | | | |
| <b>Address:</b> | 207-213 Sun Vista Ct S | | | | | | | | | |

# Uniform Mitigation Verification Inspection Form

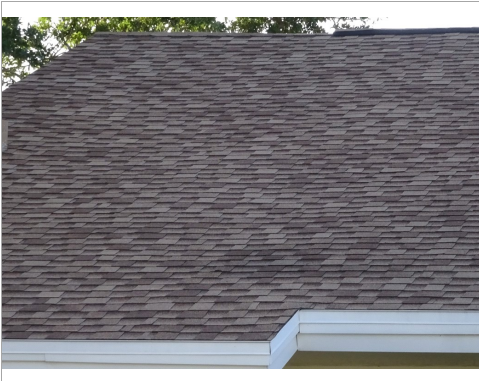
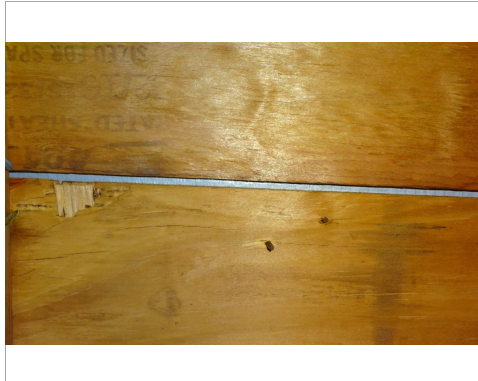
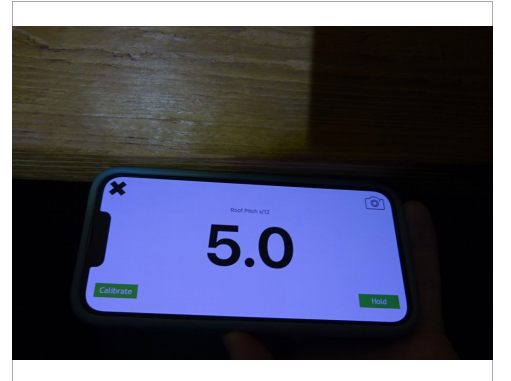
## Roof Covering Types, Roof Slope and Secondary Water Resistance

Permit Date: Nov 9, 2020

| Description: | RE-ROOF 21 BUILDINGS AND (1) POOL HOUSE. ALL BUILDINGS 5/12 PITCH. TEAR OFF DOWN TO WOOD DECK. FELT BUSTER UNDERLAYMENT.FL#18686-R2 GAF SHINGLES FL#10124-R27 | | | | |

Main Material Type: Shingle

Date Replaced: Nov 9, 2020

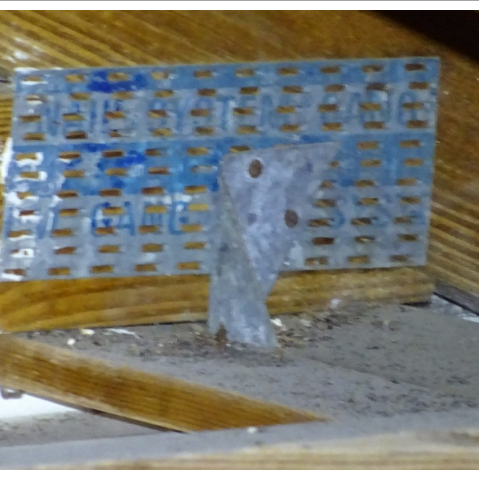
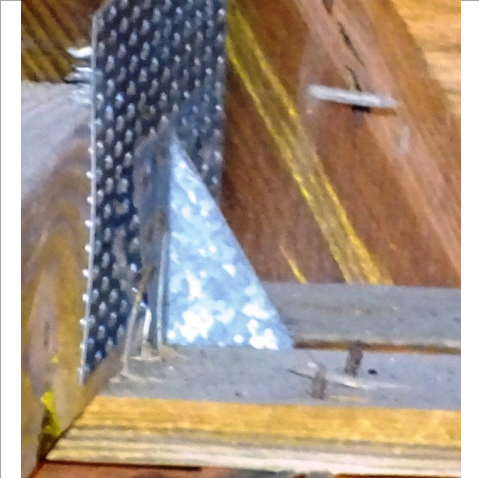
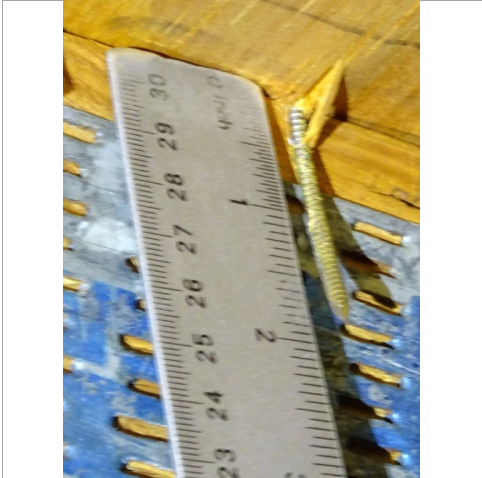
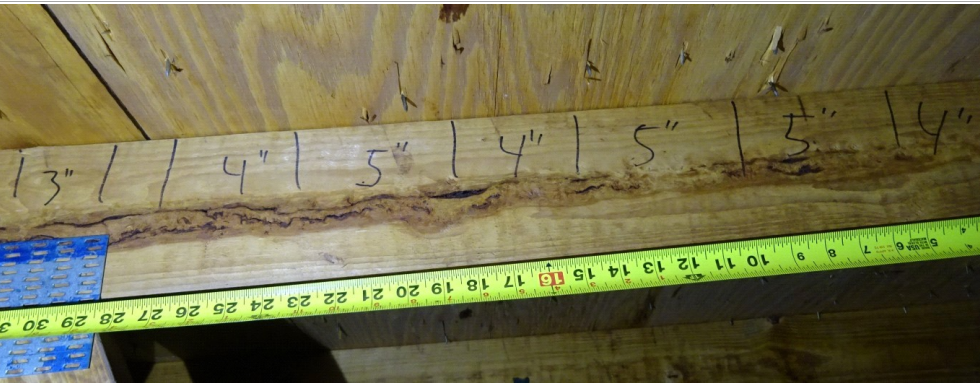
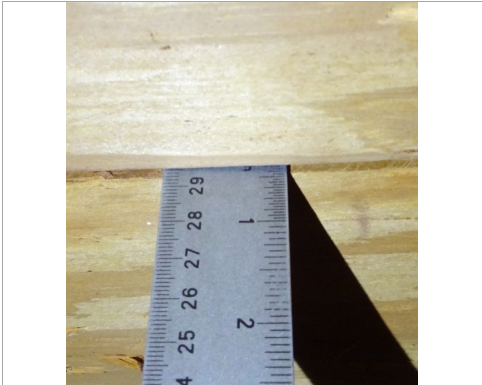
Roof Deck Attachment and Roof to Wall Attachment

- ☒ C. Plywood/OSB roof sheathing with a minimum thickness of 7/16" attached to the roof truss/rafter (spaced a maximum of 24" o.c.) by 8d common nails spaced a maximum of 6" in the field. OR Dimensional lumber/Tongue Groove decking with a minimum of 2 nails per board (or 1 nail per board if each board is equal to or less than 6" in width). OR Any system of screws, nails, adhesives, other deck fastening system or truss/rafter spacing that is shown to have an equivalent or greater resistance than 8d common nails spaced a maximum of 6" in the field (max 24" truss/rafter spacing) or has a mean ultimate uplift resistance of at least 182 psf.

☒ B. Clips

- ☒ Metal connectors that do not wrap over the top of the truss/rafter, OR
- ☐ Metal connectors with a minimum of (1) strap that wraps over the top of the truss/rafter and does not meet the nail position requirements of C or D, but is secured with a minimum of (3) nails, OR
- ☐ Purpose-made metal connector(s) or structural fastener(s) with a substantiated wind allowable uplift capacity of 386 lbs. or greater installed per the manufacturer's installation specifications (requires site-specific documentation).

Recommendations for this home would be to install a hurricane shutter system over the windows and doors for maximum protection as well as (possibly) increased savings. (ALL GLAZED OPENINGS a.k.a. items with glass in them must be protected or impact rated).
