# Wind Mitigation Inspection Report

| <b>Name:</b> | Sun Ketch 2 Condo Assoc Inc Bldg 10 | | | | | | | | | |
| <b>Address:</b> | 12221-12237 Sun Vista Ct W | | | | | | | | | |

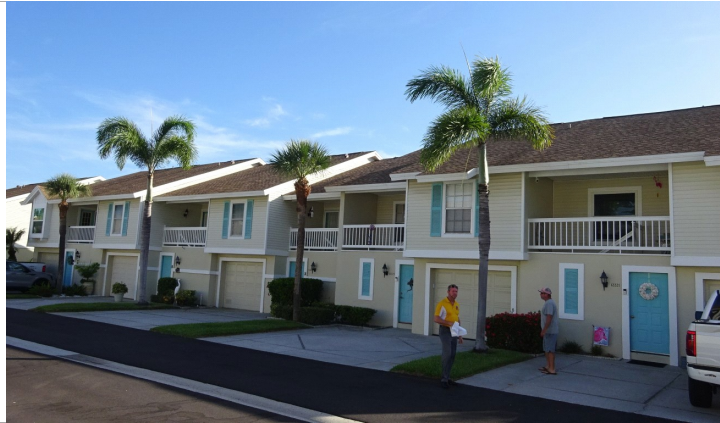
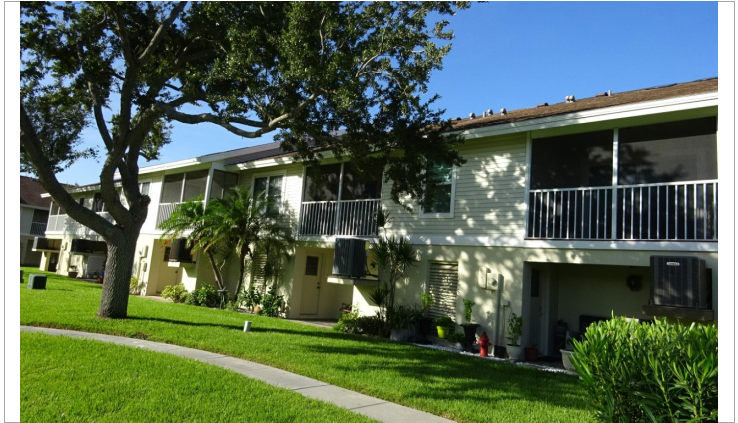
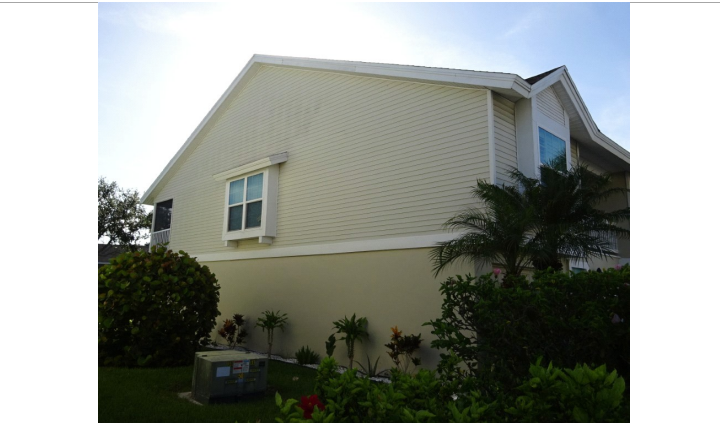
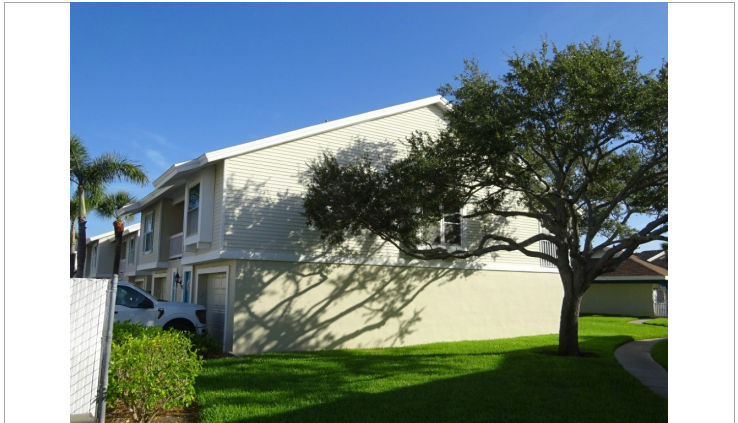
## Elevation and Roof Geometry

☒ C. Other Roof: Any roof that does not qualify as either (A) or (B) above.

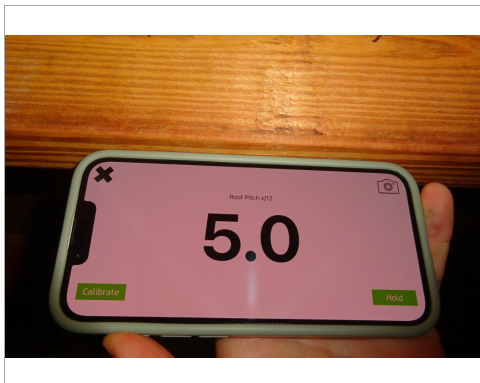
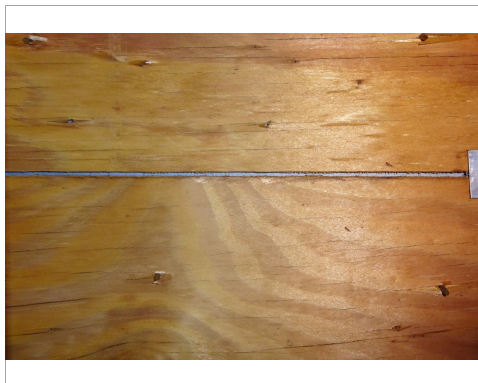
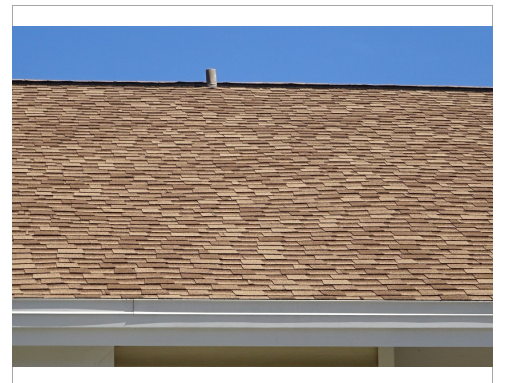
## Roof Covering Types, Roof Slope and Secondary Water Resistance

Permit Date: Nov 9, 2020

☐ Greater than or equal to ( ≥ 6:12) ☒ Less than (< 6:12).

| 4.1 Roof Covering Type: | Permit Application Date | FBC or MDC Product Approval # | Year of Original Installation or Replacement | No Information Provided for Compliance |
|---|---|---|---|---|
| <input checked="" type="checkbox"/> Asphalt/Fiberglass Shingle | <u>Nov 9, 2020</u> | <u>BLDC-001028-2020</u> | _____ | <input type="checkbox"/> |

☒ B. No Sealed Roof Deck.

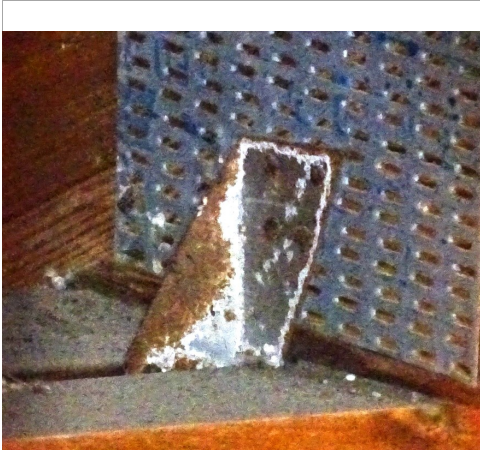
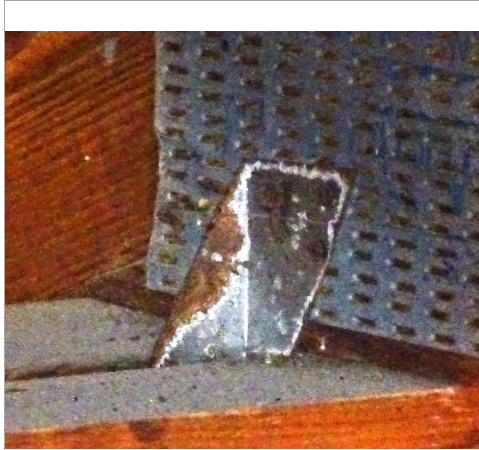
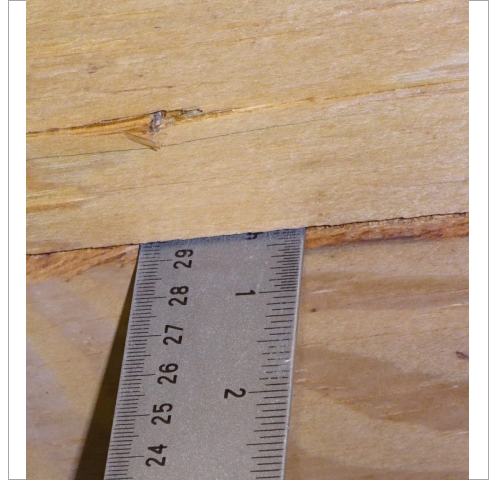
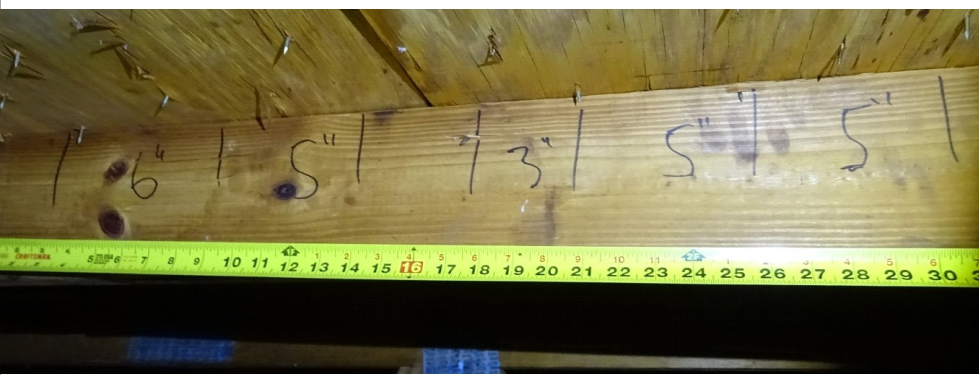
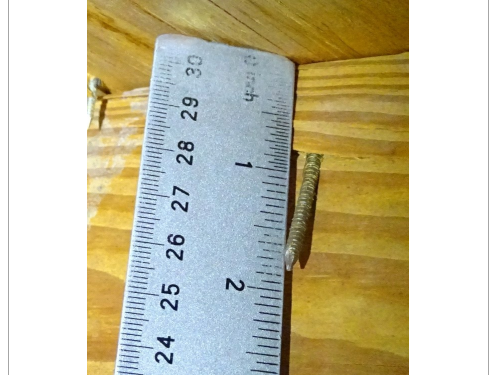
## Roof Deck Attachment and Roof to Wall Attachment

- ☒ C. Plywood/OSB roof sheathing with a minimum thickness of 7/16" attached to the roof truss/rafter (spaced a maximum of 24" o.c.) by 8d common nails spaced a maximum of 6" in the field. OR Dimensional lumber/Tongue Groove decking with a minimum of 2 nails per board (or 1 nail per board if each board is equal to or less than 6" in width). OR Any system of screws, nails, adhesives, other deck fastening system or truss/rafter spacing that is shown to have an equivalent or greater resistance than 8d common nails spaced a maximum of 6" in the field (max 24" truss/rafter spacing) or has a mean ultimate uplift resistance of at least 182 psf.

- ☒ 1. Metal connectors secured to truss/rafter with a minimum of three (3) nails, and attached to the side and/or bottom of the wall framing top plate, or embedded into the bond beam, with less than 1/2" gap from the blocking or truss/rafter, and blocked no more than 1 1/2" from the truss/rafter, and free of visible severe corrosion, OR
- ☐ 2. Metal connectors consisting of a single strap that wraps over the truss/rafter, are secured to the side of the wall and/or bottom of the top plate with a minimum of three nails on each side and free of visible severe corrosion, OR
- ☐ 3. Purpose-made metal connector(s) or structural fastener(s) installed per the manufacturer's installation specifications to meet the substantiated wind allowable capacity detailed below.

☒ B. Clips

- ☒ Metal connectors that do not wrap over the top of the truss/rafter, OR
- ☐ Metal connectors with a minimum of (1) strap that wraps over the top of the truss/rafter and does not meet the nail position requirements of C or D, but is secured with a minimum of (3) nails, OR
- ☐ Purpose-made metal connector(s) or structural fastener(s) with a substantiated wind allowable uplift capacity of 386 lbs. or greater installed per the manufacturer's installation specifications (requires site-specific documentation).
