# Wind Mitigation Inspection Report

| <b>Name:</b> | Sun Ketch 2 Condo Assoc Inc Bldg 11 | | | | | | | | | |
| <b>Address:</b> | 12241-12305 Sun Vista Ct W | | | | | | | | | |

# Uniform Mitigation Verification Inspection Form

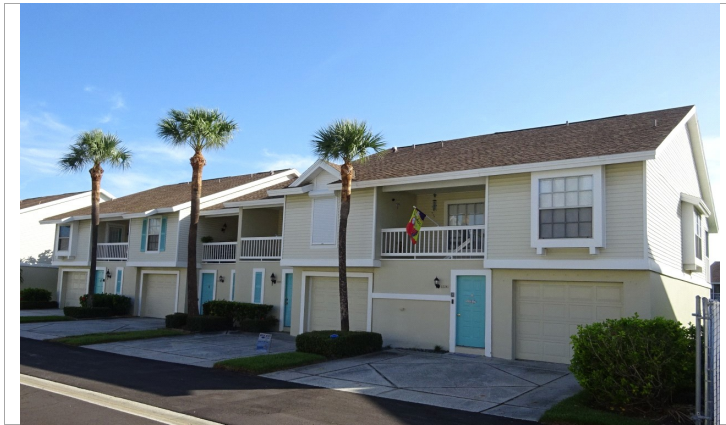
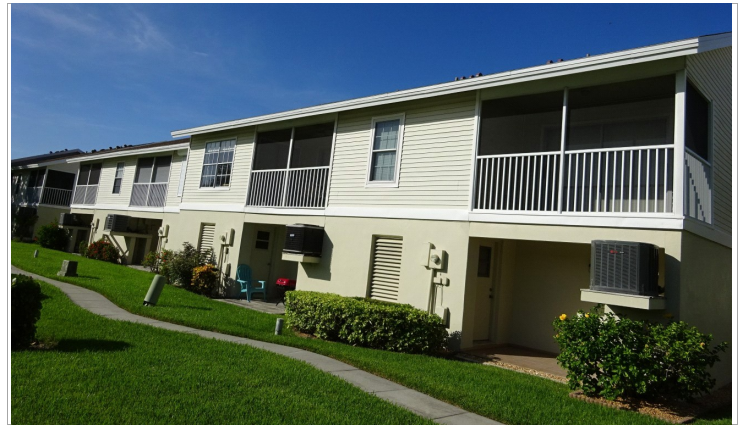
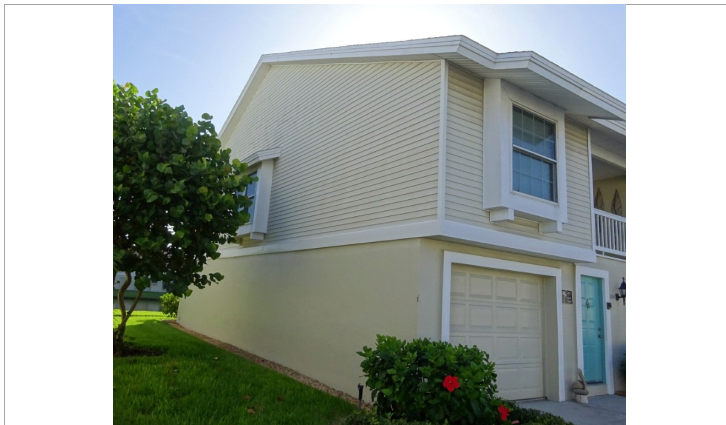
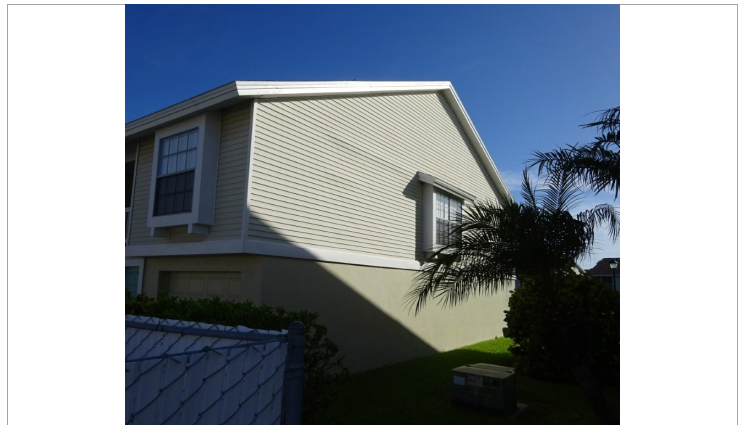
## Elevation and Roof Geometry

☒ C. Other Roof: Any roof that does not qualify as either (A) or (B) above.

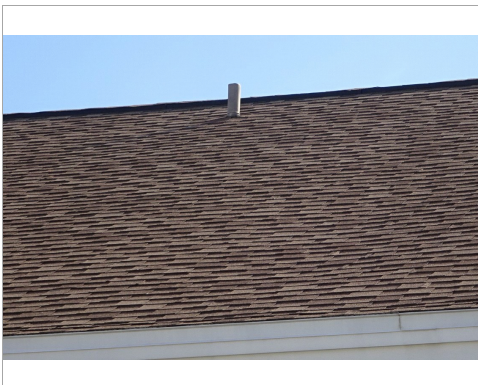
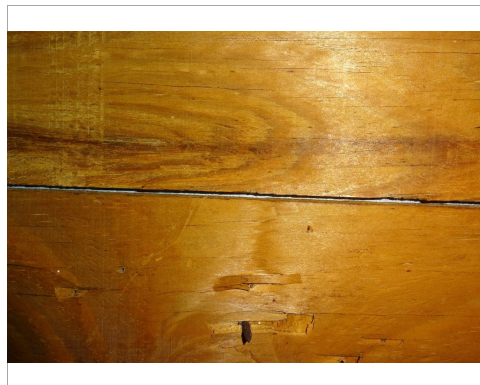
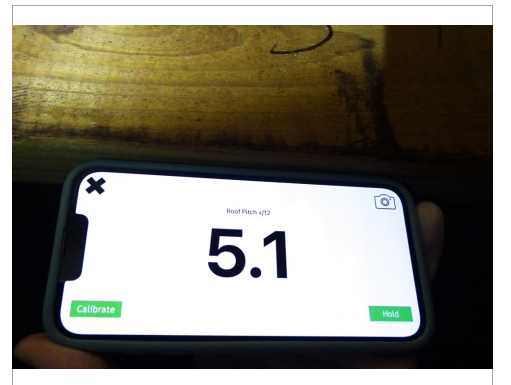
## Roof Covering Types, Roof Slope and Secondary Water Resistance

Permit Date: Nov 9, 2020

| Description: | RE-ROOF 21 BUILDINGS AND (1) POOL HOUSE. ALL BUILDINGS 5/12 PITCH. TEAR OFF DOWN TO WOOD DECK. FELT BUSTER UNDERLAYMENT.FL#18686-R2 GAF SHINGLES FL#10124-R27 | | | | |

☐ Greater than or equal to ( ≥ 6:12) ☒ Less than (< 6:12).

☒ B. No Sealed Roof Deck.

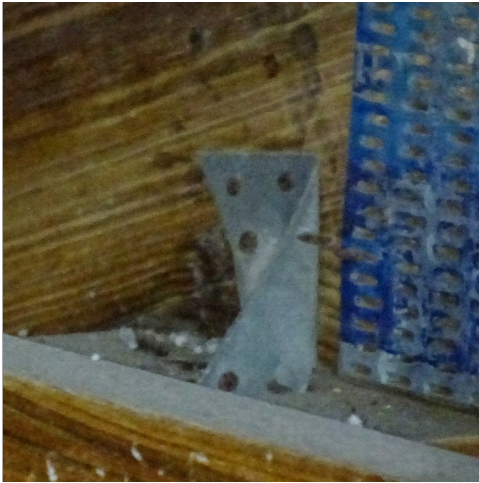
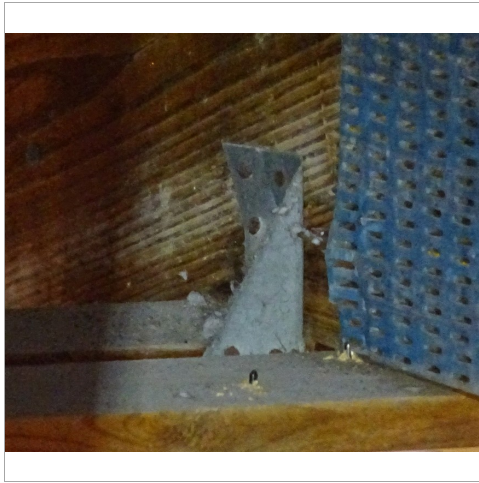
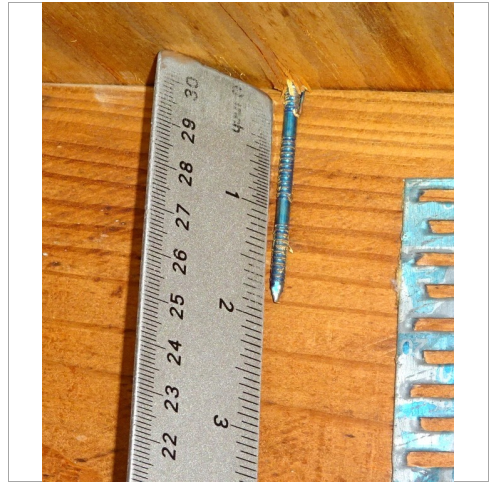
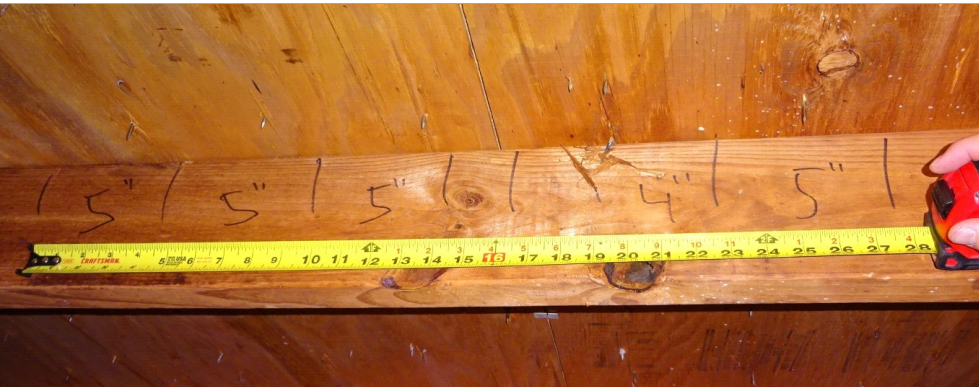
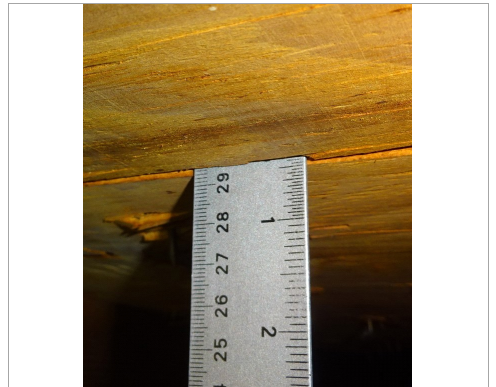
## Roof Deck Attachment and Roof to Wall Attachment

- ☒ C. Plywood/OSB roof sheathing with a minimum thickness of 7/16" attached to the roof truss/rafter (spaced a maximum of 24" o.c.) by 8d common nails spaced a maximum of 6" in the field. OR Dimensional lumber/Tongue Groove decking with a minimum of 2 nails per board (or 1 nail per board if each board is equal to or less than 6" in width). OR Any system of screws, nails, adhesives, other deck fastening system or truss/rafter spacing that is shown to have an equivalent or greater resistance than 8d common nails spaced a maximum of 6" in the field (max 24" truss/rafter spacing) or has a mean ultimate uplift resistance of at least 182 psf.

☒ B. Clips

- ☒ Metal connectors that do not wrap over the top of the truss/rafter, OR
- ☐ Metal connectors with a minimum of (1) strap that wraps over the top of the truss/rafter and does not meet the nail position requirements of C or D, but is secured with a minimum of (3) nails, OR
- ☐ Purpose-made metal connector(s) or structural fastener(s) with a substantiated wind allowable uplift capacity of 386 lbs. or greater installed per the manufacturer's installation specifications (requires site-specific documentation).
