# Wind Mitigation Inspection Report

| <b>Name:</b> | Sun Ketch 2 Condo Assoc Inc Bldg 12 | | | | | | | | | |
| <b>Address:</b> | 12309-12325 Sun Vista Ct W | | | | | | | | | |

# Uniform Mitigation Verification Inspection Form

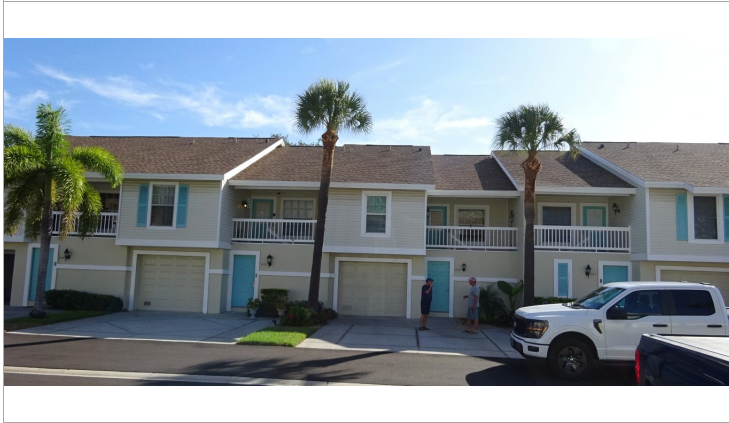
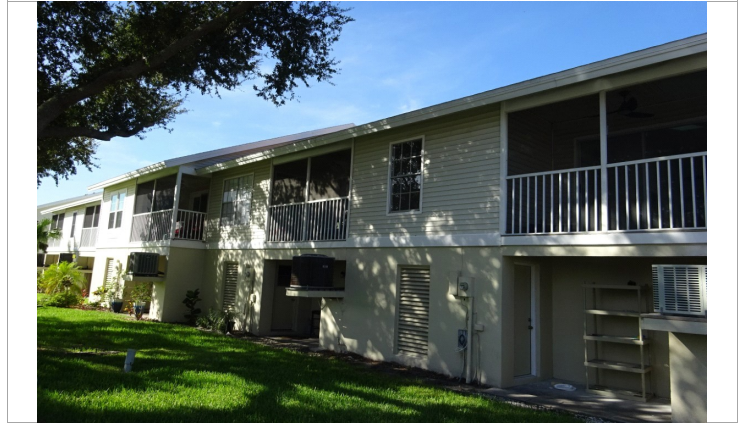
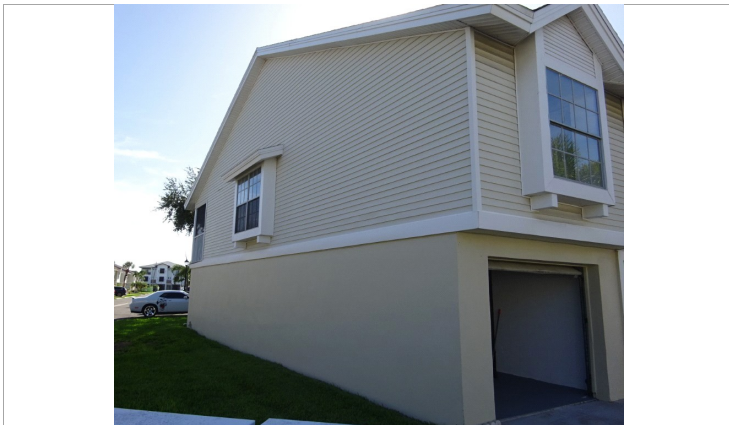
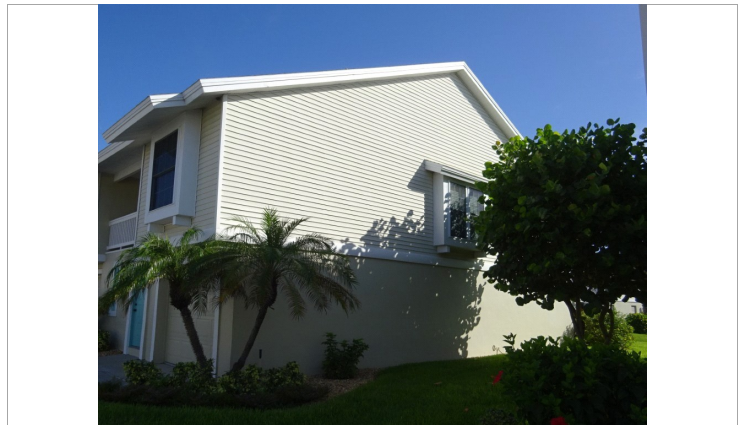
## Elevation and Roof Geometry

☒ C. Other Roof: Any roof that does not qualify as either (A) or (B) above.

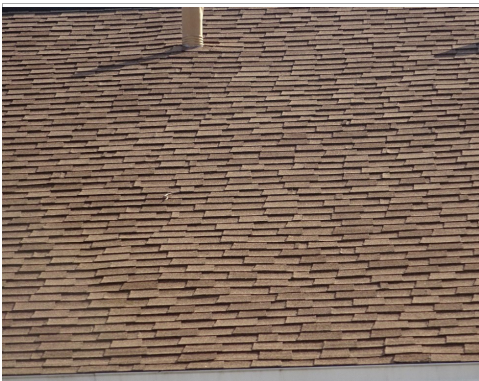
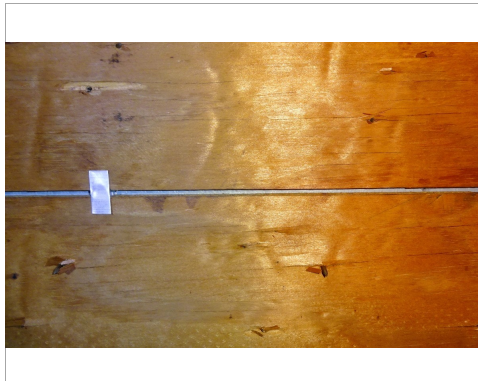
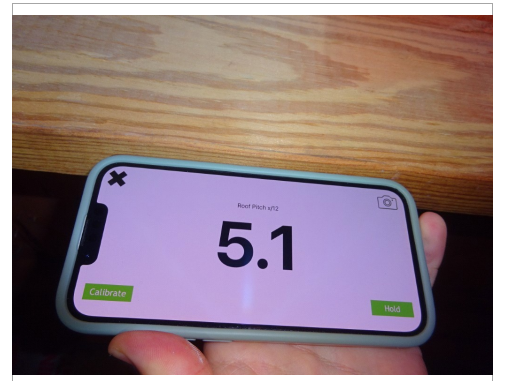
## Roof Covering Types, Roof Slope and Secondary Water Resistance

Permit Date: Nov 9, 2020

| Description: | RE-ROOF 21 BUILDINGS AND (1) POOL HOUSE. ALL BUILDINGS 5/12 PITCH. TEAR OFF DOWN TO WOOD DECK. FELT BUSTER UNDERLAYMENT. FL#18686-R2 GAF SHINGLES FL#10124-R27 | | | | |

- ☐ Greater than or equal to ( ≥ 6:12) ☒ Less than (< 6:12).

☒ B. No Sealed Roof Deck.

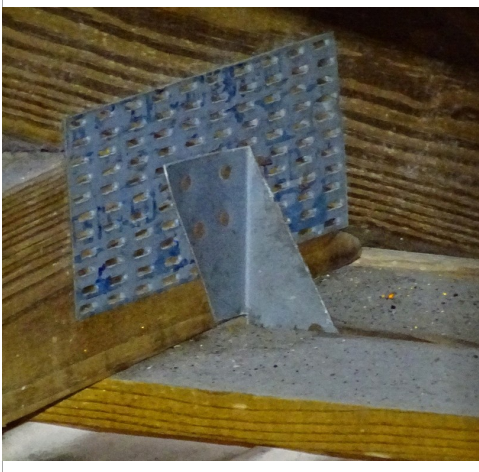
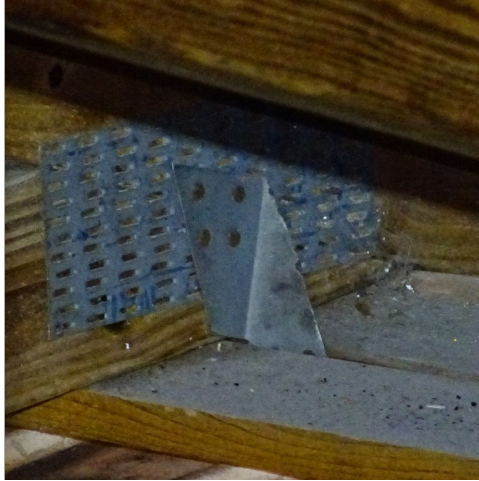
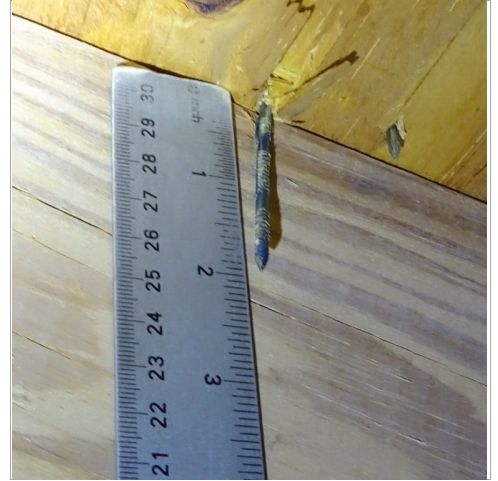
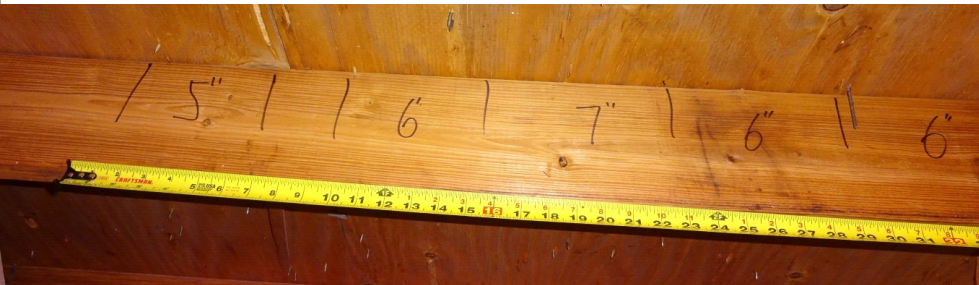
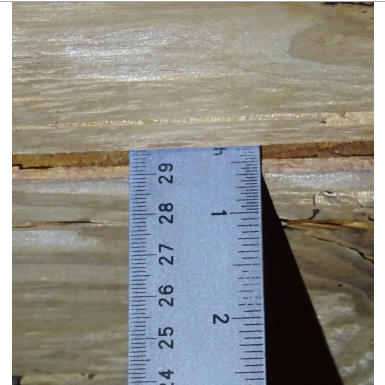
## Roof Deck Attachment and Roof to Wall Attachment

- ☒ C. Plywood/OSB roof sheathing with a minimum thickness of 7/16" attached to the roof truss/rafter (spaced a maximum of 24" o.c.) by 8d common nails spaced a maximum of 6" in the field. OR Dimensional lumber/Tongue Groove decking with a minimum of 2 nails per board (or 1 nail per board if each board is equal to or less than 6" in width). OR Any system of screws, nails, adhesives, other deck fastening system or truss/rafter spacing that is shown to have an equivalent or greater resistance than 8d common nails spaced a maximum of 6" in the field (max 24" truss/rafter spacing) or has a mean ultimate uplift resistance of at least 182 psf.

☒ B. Clips

- ☒ Metal connectors that do not wrap over the top of the truss/rafter, OR
- ☐ Metal connectors with a minimum of (1) strap that wraps over the top of the truss/rafter and does not meet the nail position requirements of C or D, but is secured with a minimum of (3) nails, OR
- ☐ Purpose-made metal connector(s) or structural fastener(s) with a substantiated wind allowable uplift capacity of 386 lbs. or greater installed per the manufacturer's installation specifications (requires site-specific documentation).

Recommendations for this home would be to install a hurricane shutter system over the windows and doors for maximum protection as well as (possibly) increased savings. (ALL GLAZED OPENINGS a.k.a. items with glass in them must be protected or impact rated).
