# Wind Mitigation Inspection Report

| <b>Name:</b> | Sun Ketch 2 Condo Assoc Inc Bldg 13 | | | | | | | | | |
| <b>Address:</b> | 208-218 Sun Vista Ct N | | | | | | | | | |

# Uniform Mitigation Verification Inspection Form

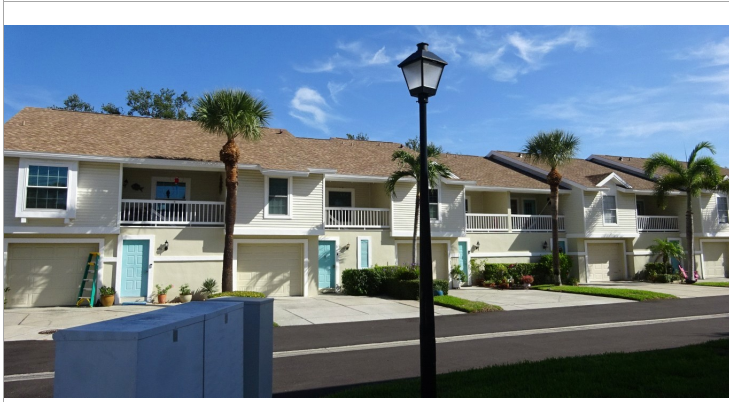
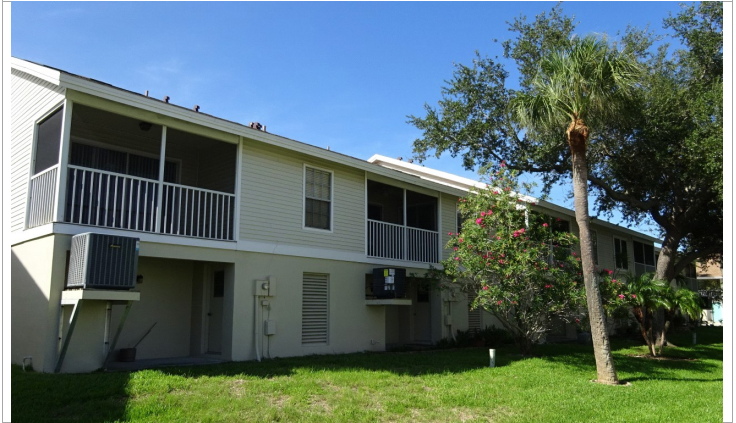
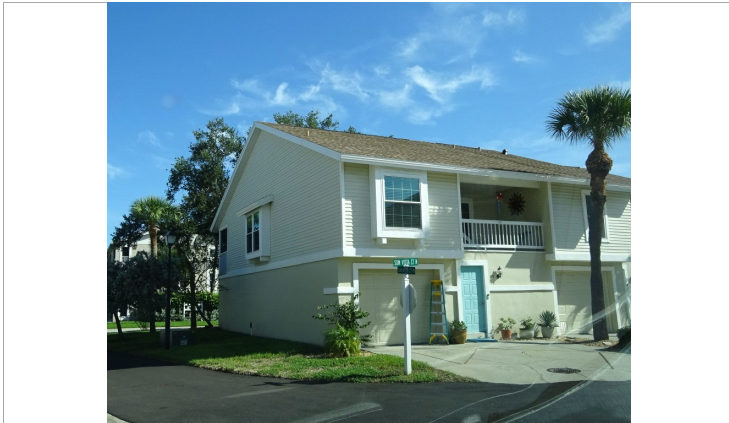
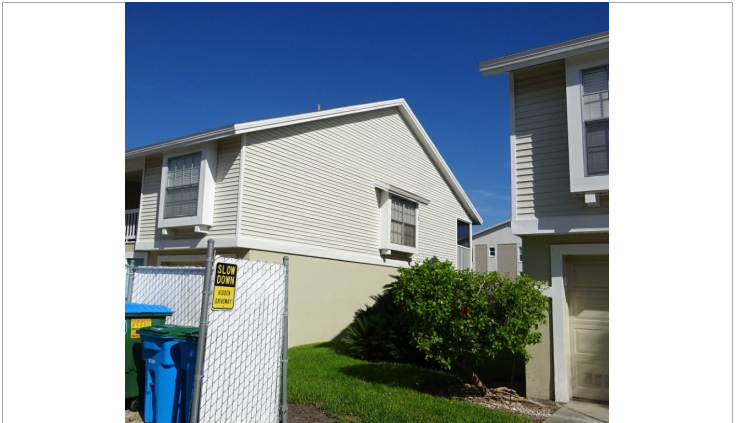
## Elevation and Roof Geometry

☒ C. Other Roof: Any roof that does not qualify as either (A) or (B) above.

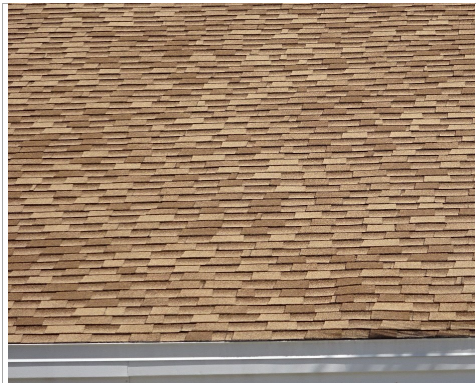
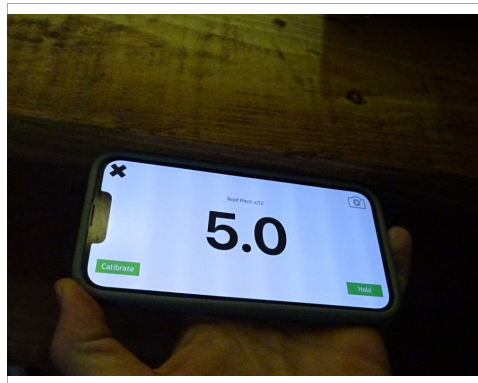
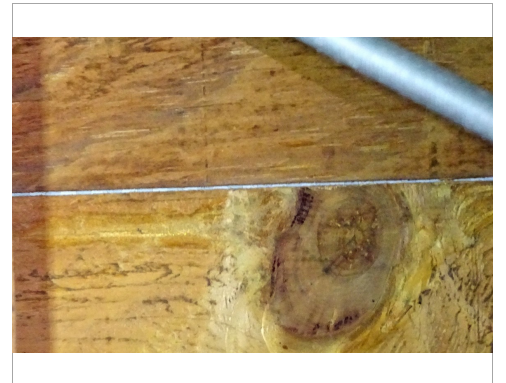
## Roof Covering Types, Roof Slope and Secondary Water Resistance

Permit Date: Nov 9, 2020

| Description: | RE-ROOF 21 BUILDINGS AND (1) POOL HOUSE. ALL BUILDINGS 5/12 PITCH. TEAR OFF DOWN TO WOOD DECK. FELT BUSTER UNDERLAYMENT.FL#18686-R2 GAF SHINGLES FL#10124-R27 | | | | |

Main Material Type: Shingle

☐ Greater than or equal to ( ≥ 6:12) ☒ Less than (< 6:12).

☒ B. No Sealed Roof Deck.

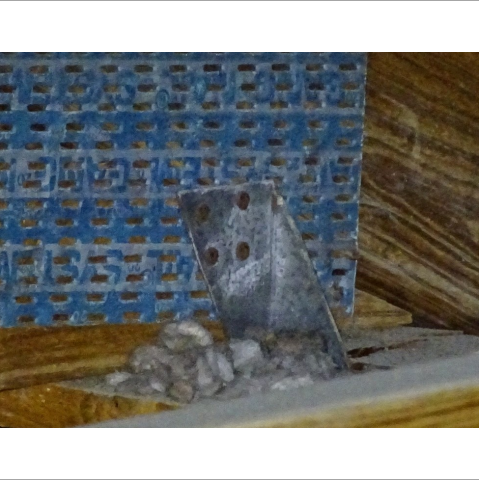
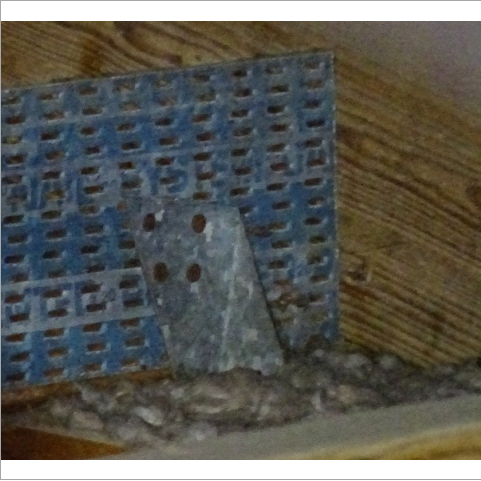
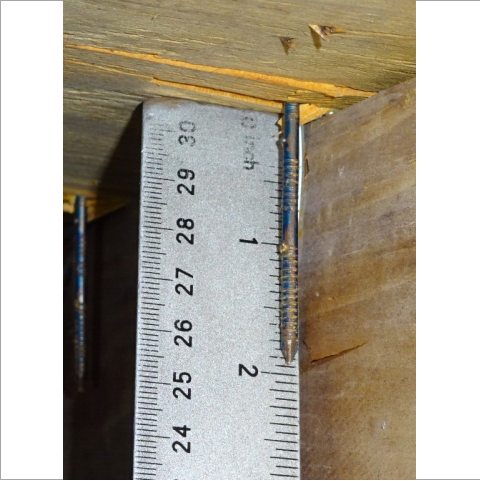
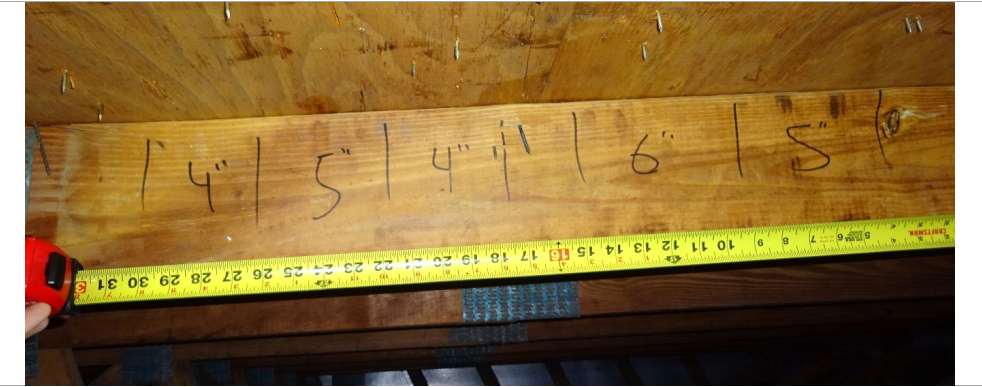
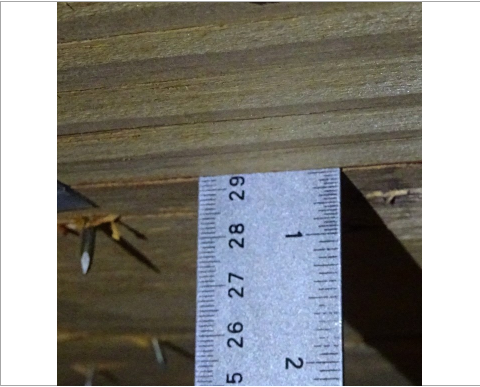
Roof Deck Attachment and Roof to Wall Attachment

- ☒ C. Plywood/OSB roof sheathing with a minimum thickness of 7/16" attached to the roof truss/rafter (spaced a maximum of 24" o.c.) by 8d common nails spaced a maximum of 6" in the field. OR Dimensional lumber/Tongue Groove decking with a minimum of 2 nails per board (or 1 nail per board if each board is equal to or less than 6" in width). OR Any system of screws, nails, adhesives, other deck fastening system or truss/rafter spacing that is shown to have an equivalent or greater resistance than 8d common nails spaced a maximum of 6" in the field (max 24" truss/rafter spacing) or has a mean ultimate uplift resistance of at least 182 psf.

☒ B. Clips

- ☒ Metal connectors that do not wrap over the top of the truss/rafter, OR
- ☐ Metal connectors with a minimum of (1) strap that wraps over the top of the truss/rafter and does not meet the nail position requirements of C or D, but is secured with a minimum of (3) nails, OR
- ☐ Purpose-made metal connector(s) or structural fastener(s) with a substantiated wind allowable uplift capacity of 386 lbs. or greater installed per the manufacturer's installation specifications (requires site-specific documentation).

Recommendations for this home would be to install a hurricane shutter system over the windows and doors for maximum protection as well as (possibly) increased savings. (ALL GLAZED OPENINGS a.k.a. items with glass in them must be protected or impact rated).
