# Wind Mitigation Inspection Report

| <b>Name:</b> | Sun Ketch 2 Condo Assoc Inc Bldg 14 | | | | | | | | | |
| <b>Address:</b> | 220-230 Sun Vista Ct N | | | | | | | | | |

# Uniform Mitigation Verification Inspection Form

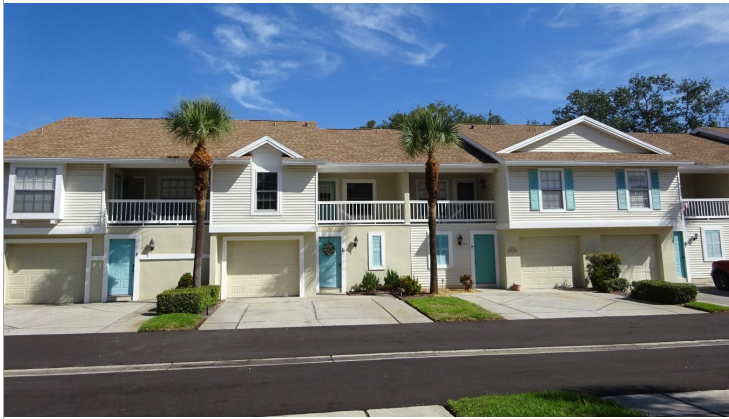
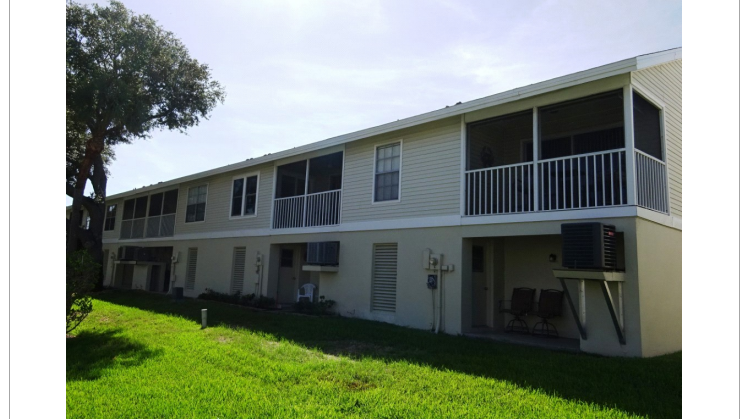
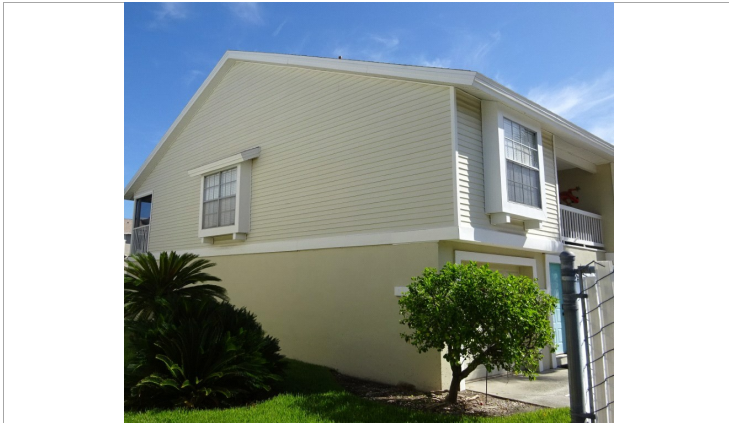
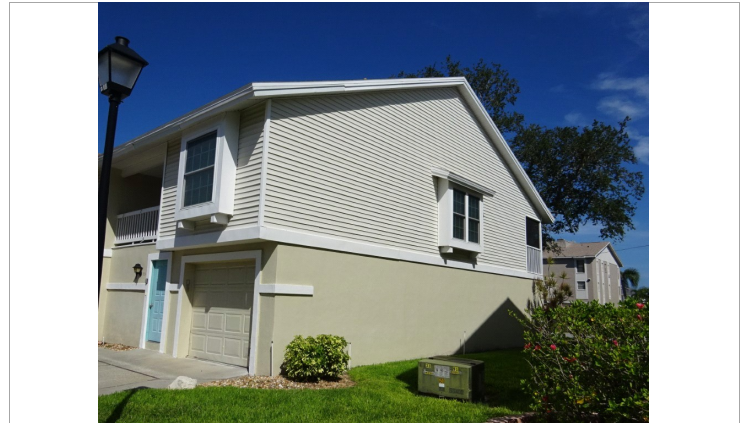
## Elevation and Roof Geometry

☒ C. Other Roof: Any roof that does not qualify as either (A) or (B) above.

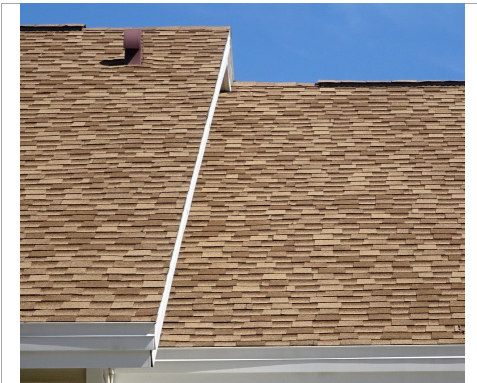
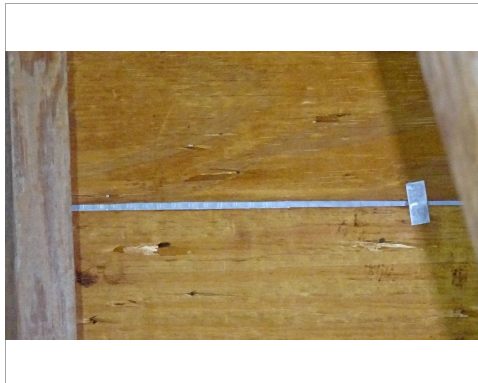
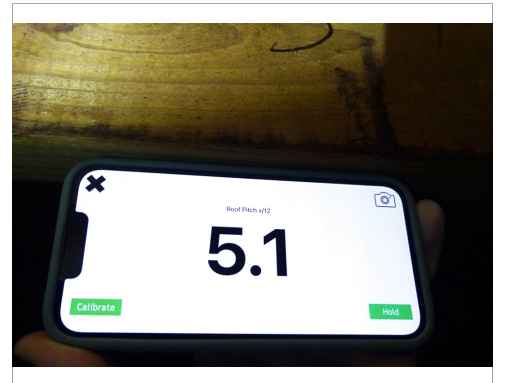
## Roof Covering Types, Roof Slope and Secondary Water Resistance

Permit Date: Nov 9, 2020

| Description: | RE-ROOF 21 BUILDINGS AND (1) POOL HOUSE. ALL BUILDINGS 5/12 PITCH. TEAR OFF DOWN TO WOOD DECK. FELT BUSTER UNDERLAYMENT.FL#18686-R2 GAF SHINGLES FL#10124-R27 | | | | |

☐ Greater than or equal to ( ≥ 6:12) ☒ Less than (< 6:12).

| 4.1 Roof Covering Type: | Permit<br>Application Date | FBC or MDC Product<br>Approval # | Year of Original<br>Installation or<br>Replacement | No Information<br>Provided for<br>Compliance |
|---|---|---|---|---|
| <input checked="" type="checkbox"/> Asphalt/Fiberglass Shingle | <u>Nov 9, 2020</u> | <u>BLDC-001028-2020</u> | _____ | <input type="checkbox"/> |

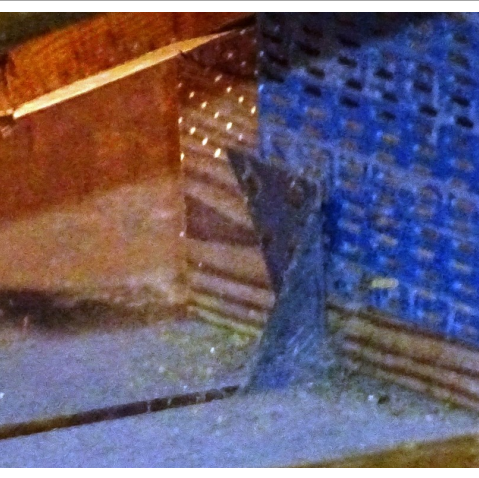
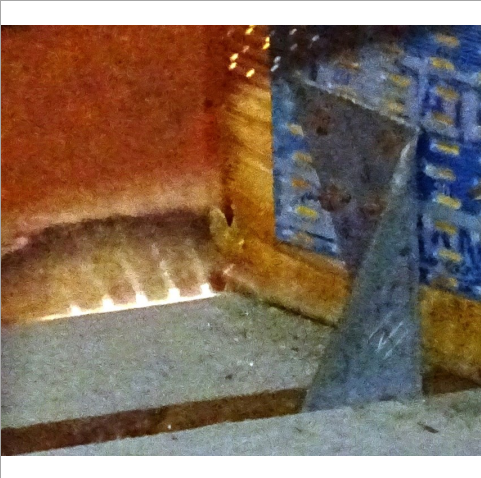
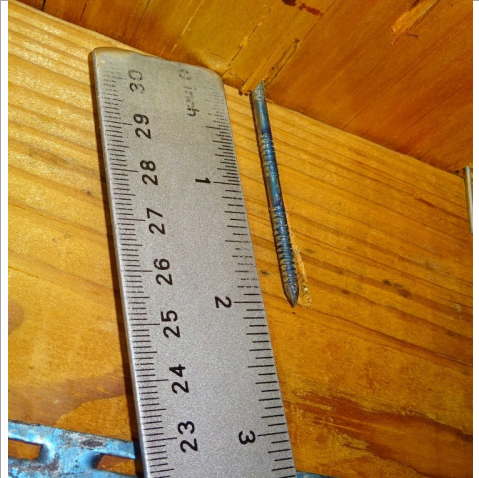
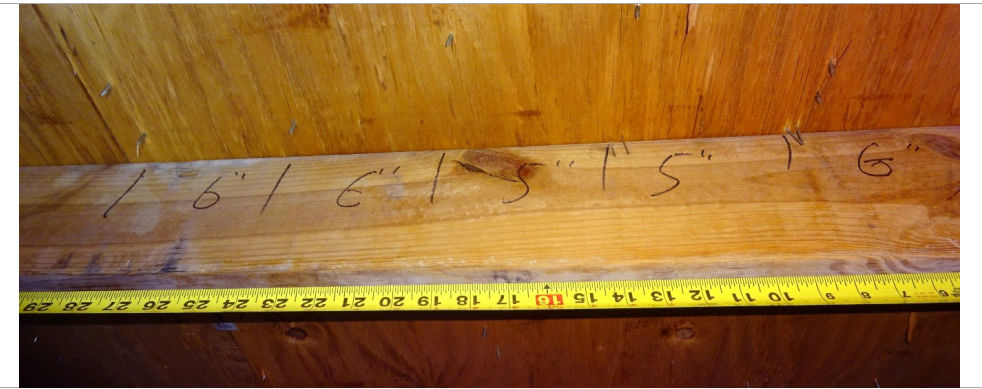
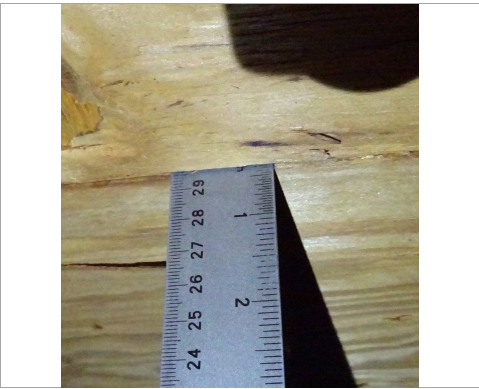
Roof Deck Attachment and Roof to Wall Attachment

- ☒ C. Plywood/OSB roof sheathing with a minimum thickness of 7/16" attached to the roof truss/rafter (spaced a maximum of 24" o.c.) by 8d common nails spaced a maximum of 6" in the field. OR Dimensional lumber/Tongue Groove decking with a minimum of 2 nails per board (or 1 nail per board if each board is equal to or less than 6" in width). OR Any system of screws, nails, adhesives, other deck fastening system or truss/rafter spacing that is shown to have an equivalent or greater resistance than 8d common nails spaced a maximum of 6" in the field (max 24" truss/rafter spacing) or has a mean ultimate uplift resistance of at least 182 psf.

☒ B. Clips

- ☒ Metal connectors that do not wrap over the top of the truss/rafter, OR
- ☐ Metal connectors with a minimum of (1) strap that wraps over the top of the truss/rafter and does not meet the nail position requirements of C or D, but is secured with a minimum of (3) nails, OR
- ☐ Purpose-made metal connector(s) or structural fastener(s) with a substantiated wind allowable uplift capacity of 386 lbs. or greater installed per the manufacturer's installation specifications (requires site-specific documentation).

Recommendations for this home would be to install a hurricane shutter system over the windows and doors for maximum protection as well as (possibly) increased savings. (ALL GLAZED OPENINGS a.k.a. items with glass in them must be protected or impact rated).
