# Wind Mitigation Inspection Report

| <b>Name:</b> | Sun Ketch 2 Condo Assoc Inc Bldg 15 | | | | | | | | | |
| <b>Address:</b> | 219-229 Sun Vista Ct N | | | | | | | | | |

# Uniform Mitigation Verification Inspection Form

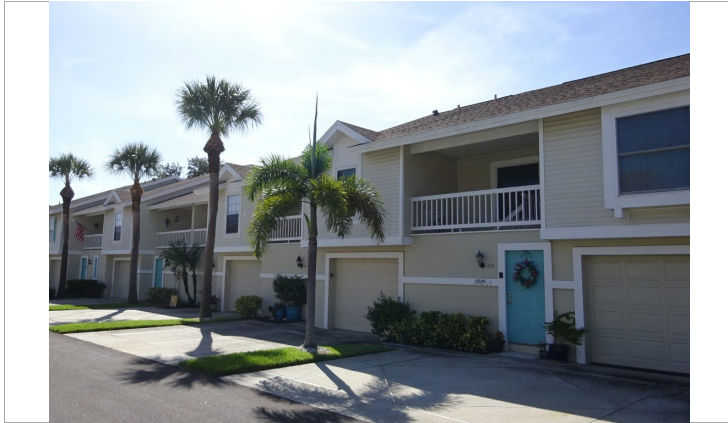
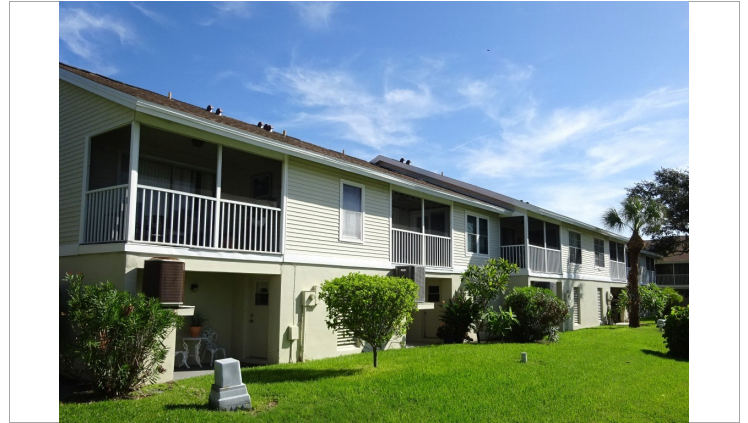
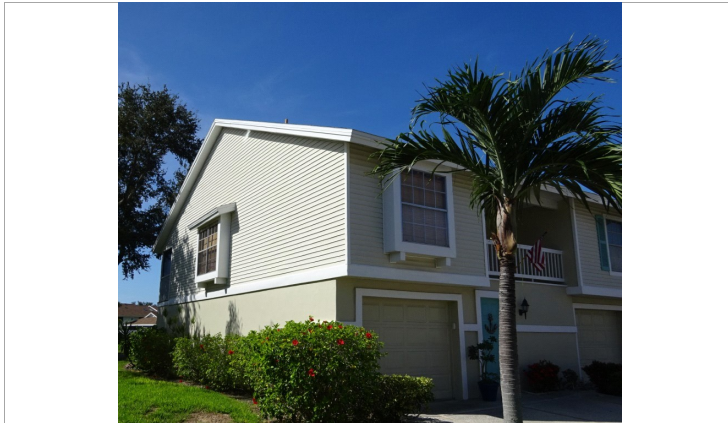
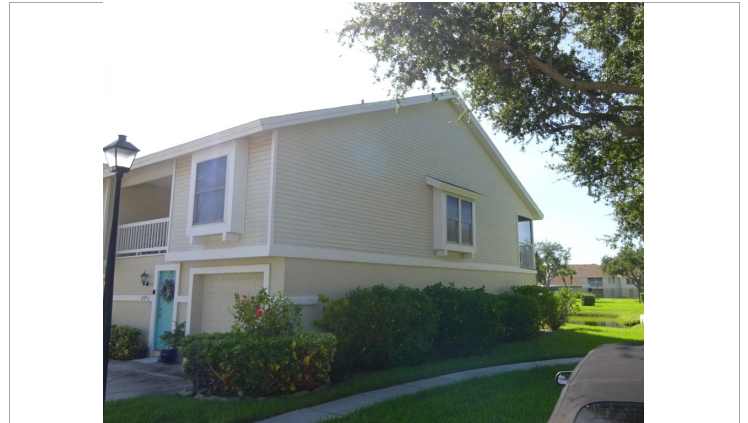
## Elevation and Roof Geometry

☒ C. Other Roof: Any roof that does not qualify as either (A) or (B) above.

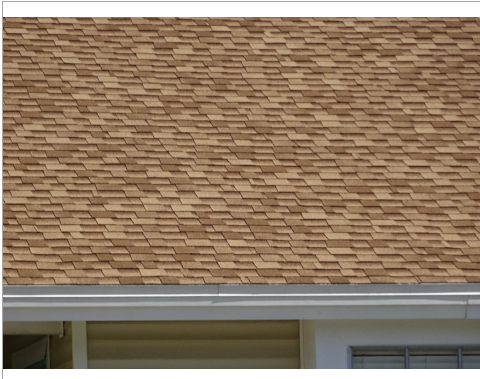
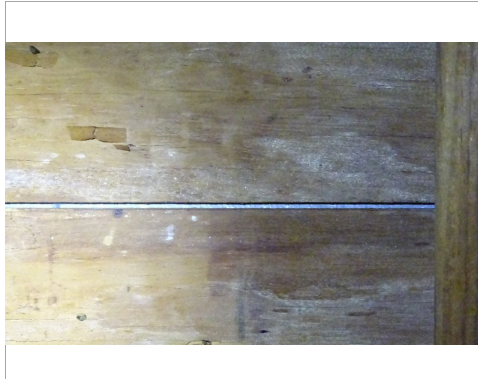
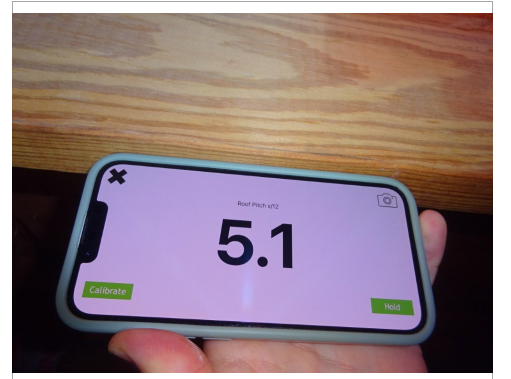
## Roof Covering Types, Roof Slope and Secondary Water Resistance

Permit Date: Nov 9, 2020

| Description: | RE-ROOF 21 BUILDINGS AND (1) POOL HOUSE. ALL BUILDINGS 5/12 PITCH. TEAR OFF DOWN TO WOOD DECK. FELT BUSTER UNDERLAYMENT. FL#18686-R2 GAF SHINGLES FL#10124-R27 | | | | |

- ☐ Greater than or equal to ( ≥ 6:12) ☒ Less than (< 6:12).

| 4.1 Roof Covering Type: | Permit<br>Application Date | FBC or MDC Product<br>Approval # | Year of Original<br>Installation or<br>Replacement | No Information<br>Provided for<br>Compliance |
|---|---|---|---|---|
| <input checked="" type="checkbox"/> Asphalt/Fiberglass Shingle | <u>Nov 9, 2020</u> | <u>BLDC-001028-2020</u> | _____ | <input type="checkbox"/> |

☒ B. No Sealed Roof Deck.

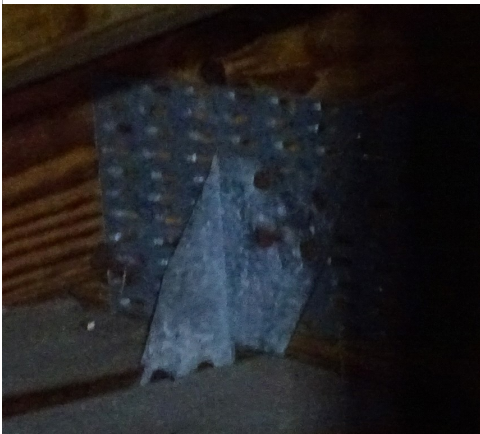
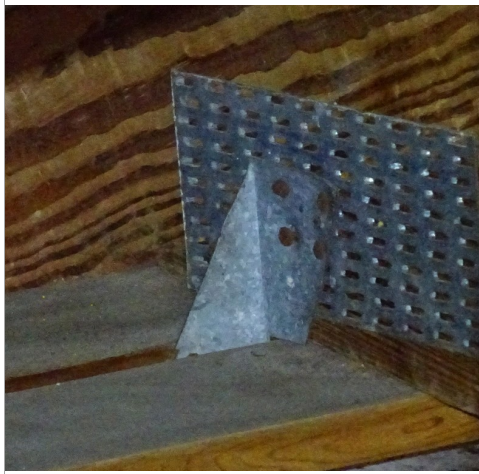
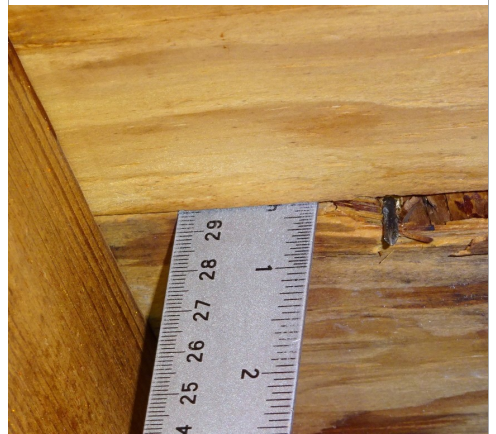
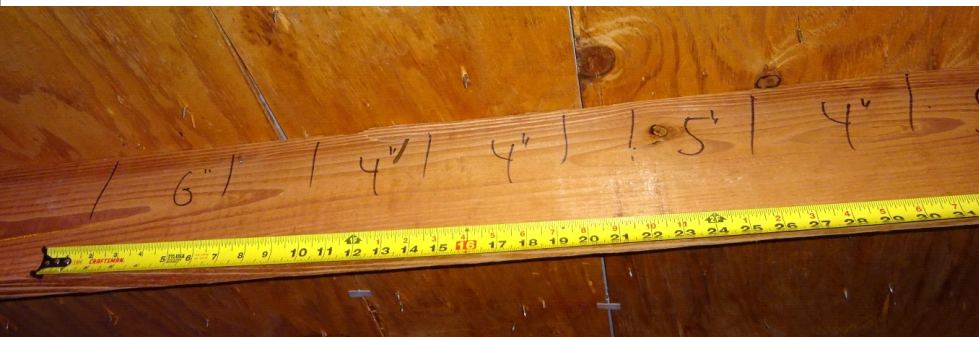
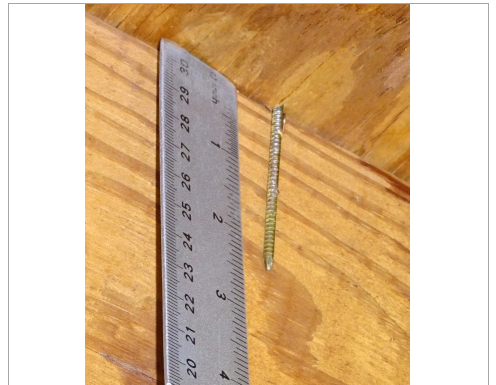
## Roof Deck Attachment and Roof to Wall Attachment

- ☒ C. Plywood/OSB roof sheathing with a minimum thickness of 7/16" attached to the roof truss/rafter (spaced a maximum of 24" o.c.) by 8d common nails spaced a maximum of 6" in the field. OR Dimensional lumber/Tongue Groove decking with a minimum of 2 nails per board (or 1 nail per board if each board is equal to or less than 6" in width). OR Any system of screws, nails, adhesives, other deck fastening system or truss/rafter spacing that is shown to have an equivalent or greater resistance than 8d common nails spaced a maximum of 6" in the field (max 24" truss/rafter spacing) or has a mean ultimate uplift resistance of at least 182 psf.

- ☒ 1. Metal connectors secured to truss/rafter with a minimum of three (3) nails, and attached to the side and/or bottom of the wall framing top plate, or embedded into the bond beam, with less than 1/2" gap from the blocking or truss/rafter, and blocked no more than 1 1/2" from the truss/rafter, and free of visible severe corrosion, OR
- ☐ 2. Metal connectors consisting of a single strap that wraps over the truss/rafter, are secured to the side of the wall and/or bottom of the top plate with a minimum of three nails on each side and free of visible severe corrosion, OR
- ☐ 3. Purpose-made metal connector(s) or structural fastener(s) installed per the manufacturer's installation specifications to meet the substantiated wind allowable capacity detailed below.

☒ B. Clips

- ☒ Metal connectors that do not wrap over the top of the truss/rafter, OR
- ☐ Metal connectors with a minimum of (1) strap that wraps over the top of the truss/rafter and does not meet the nail position requirements of C or D, but is secured with a minimum of (3) nails, OR
- ☐ Purpose-made metal connector(s) or structural fastener(s) with a substantiated wind allowable uplift capacity of 386 lbs. or greater installed per the manufacturer's installation specifications (requires site-specific documentation).
