# Wind Mitigation Inspection Report

| <b>Name:</b> | Sun Ketch 2 Condo Assoc Inc Bldg 16 | | | | | | | | | |
| <b>Address:</b> | 232-242 Sun Vista Ct N | | | | | | | | | |

# Uniform Mitigation Verification Inspection Form

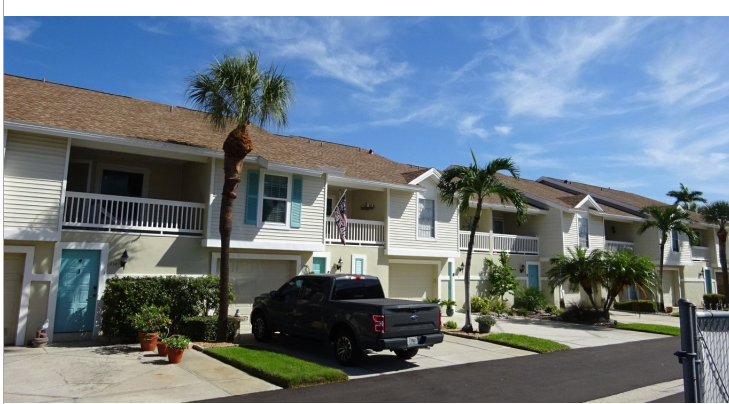
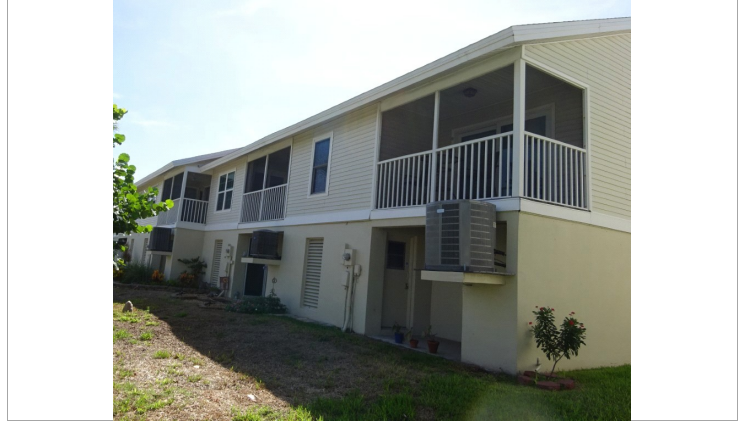
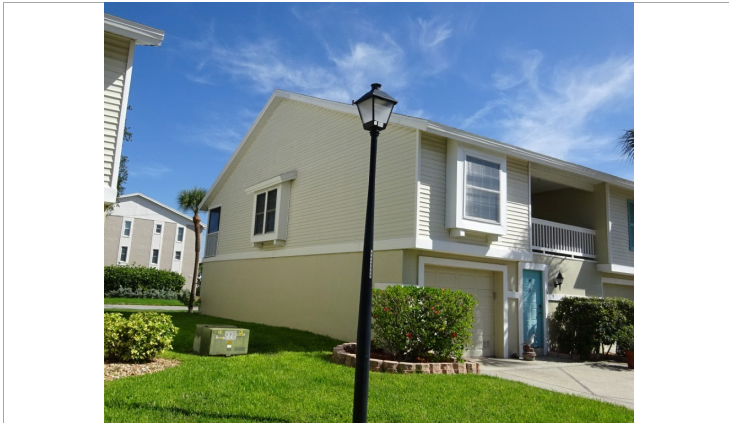
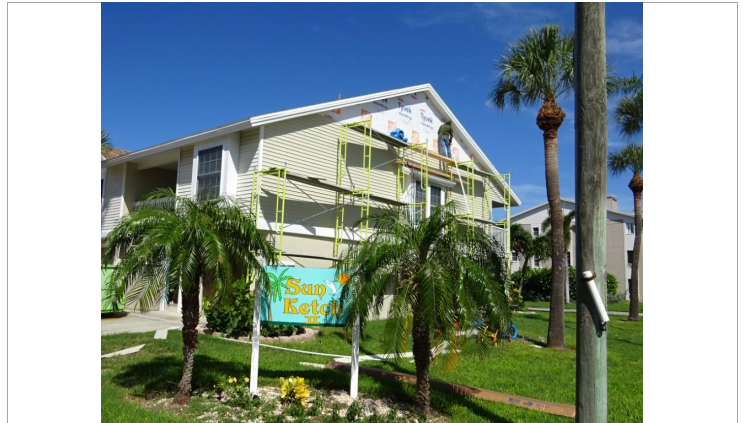
## Elevation and Roof Geometry

☒ C. Other Roof: Any roof that does not qualify as either (A) or (B) above.

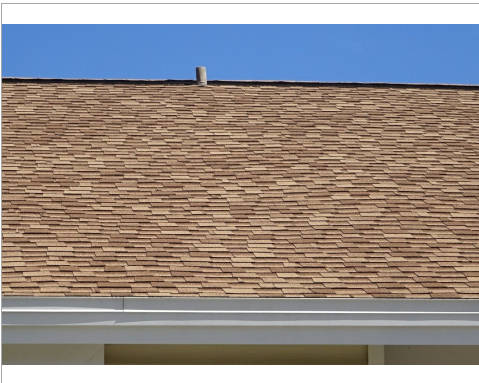
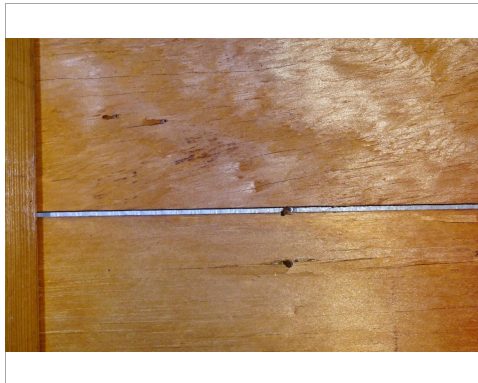
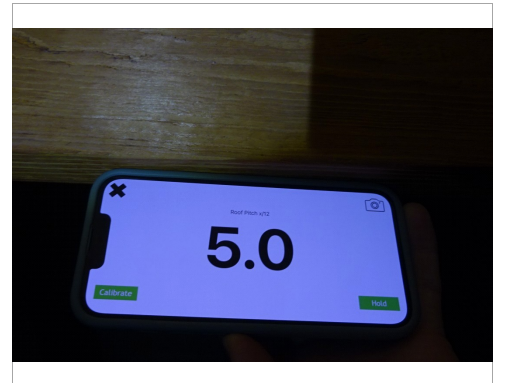
## Roof Covering Types, Roof Slope and Secondary Water Resistance

Permit Date: Nov 9, 2020

☐ Greater than or equal to ( ≥ 6:12) ☒ Less than (< 6:12).

| 4.1 Roof Covering Type: | Permit Application Date | FBC or MDC Product Approval # | Year of Original Installation or Replacement | No Information Provided for Compliance |
|---|---|---|---|---|
| <input checked="" type="checkbox"/> Asphalt/Fiberglass Shingle | <u>Nov 9, 2020</u> | <u>BLDC-001028-2020</u> | _____ | <input type="checkbox"/> |

☒ B. No Sealed Roof Deck.

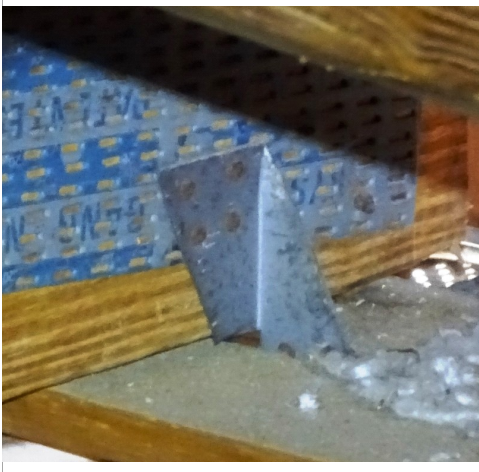
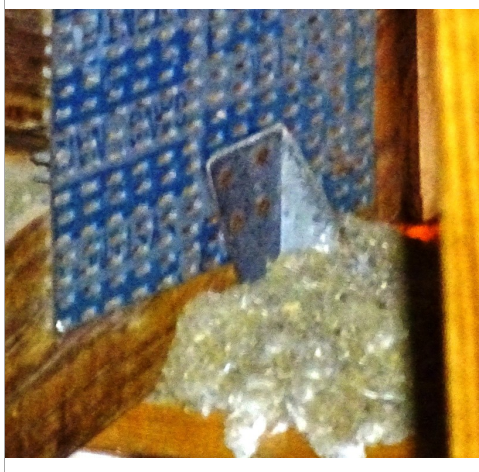
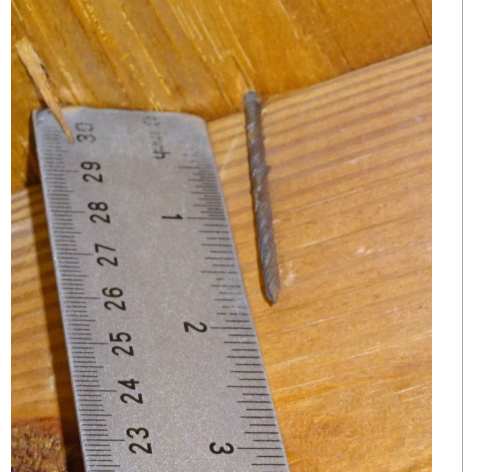
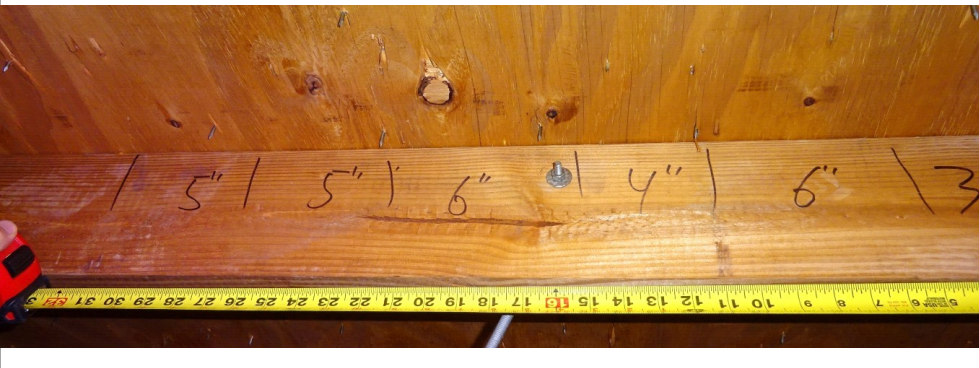
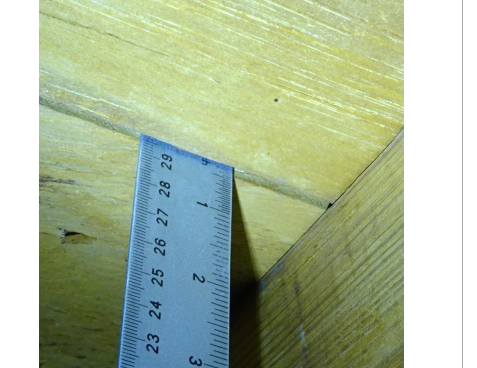
## Roof Deck Attachment and Roof to Wall Attachment

- ☒ C. Plywood/OSB roof sheathing with a minimum thickness of 7/16" attached to the roof truss/rafter (spaced a maximum of 24" o.c.) by 8d common nails spaced a maximum of 6" in the field. OR Dimensional lumber/Tongue Groove decking with a minimum of 2 nails per board (or 1 nail per board if each board is equal to or less than 6" in width). OR Any system of screws, nails, adhesives, other deck fastening system or truss/rafter spacing that is shown to have an equivalent or greater resistance than 8d common nails spaced a maximum of 6" in the field (max 24" truss/rafter spacing) or has a mean ultimate uplift resistance of at least 182 psf.

☒ B. Clips

- ☒ Metal connectors that do not wrap over the top of the truss/rafter, OR
- ☐ Metal connectors with a minimum of (1) strap that wraps over the top of the truss/rafter and does not meet the nail position requirements of C or D, but is secured with a minimum of (3) nails, OR
- ☐ Purpose-made metal connector(s) or structural fastener(s) with a substantiated wind allowable uplift capacity of 386 lbs. or greater installed per the manufacturer's installation specifications (requires site-specific documentation).
