# Wind Mitigation Inspection Report

| <b>Name:</b> | Sun Ketch 2 Condo Assoc Inc Bldg 17 | | | | | | | | | |
| <b>Address:</b> | 12302-12322 Sun Vista Ct E | | | | | | | | | |

# Uniform Mitigation Verification Inspection Form

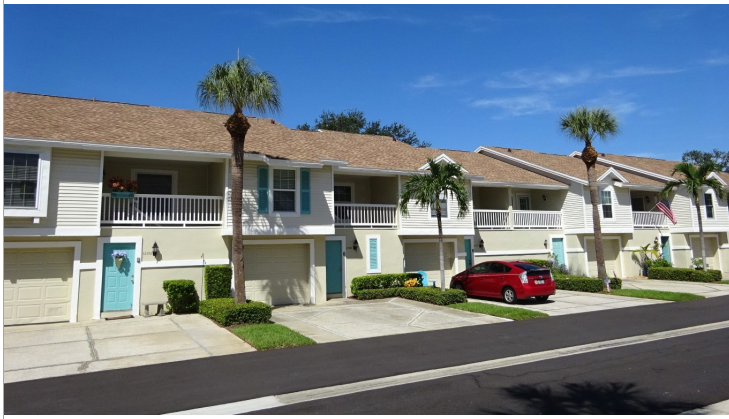
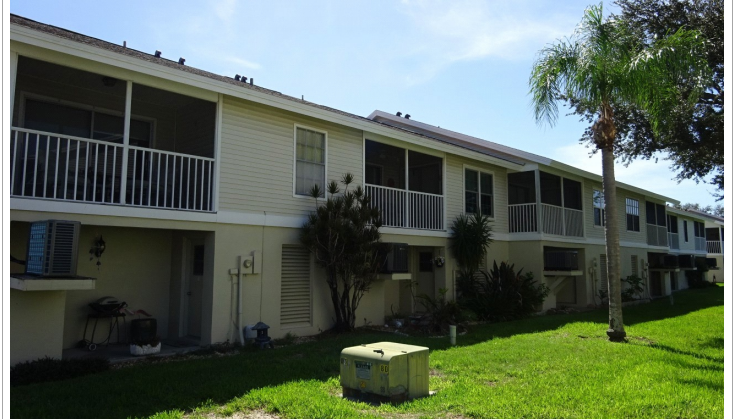
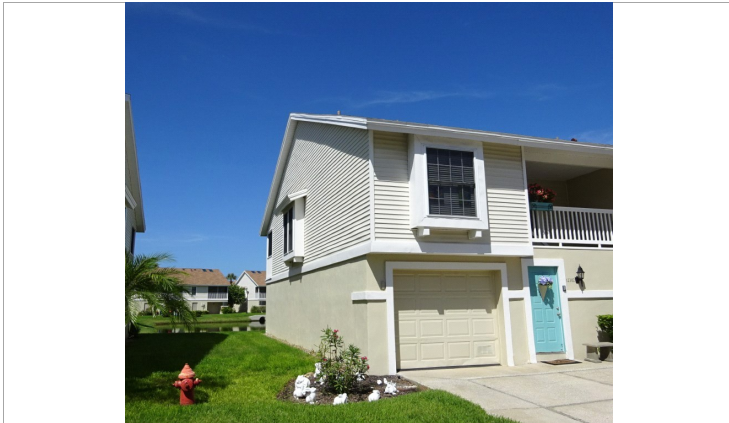
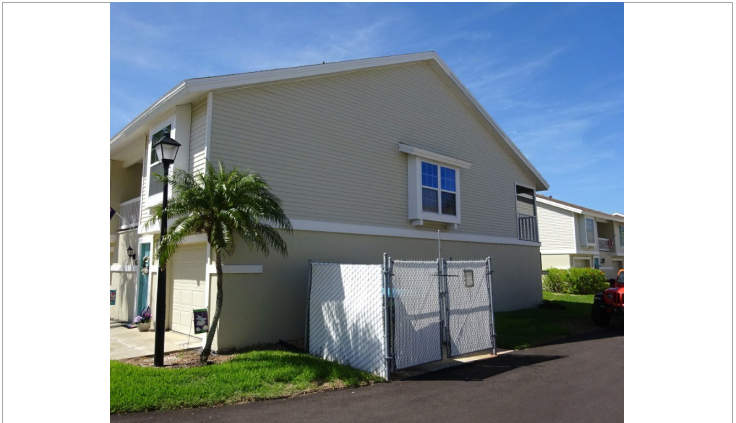
## Elevation and Roof Geometry

☒ C. Other Roof: Any roof that does not qualify as either (A) or (B) above.

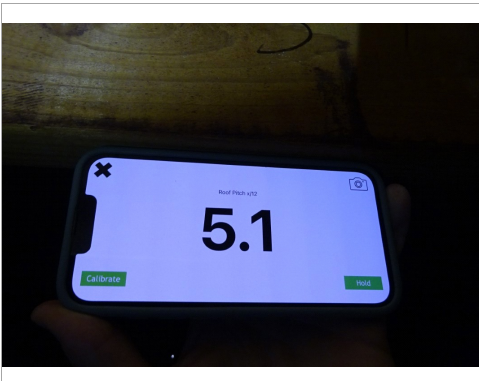
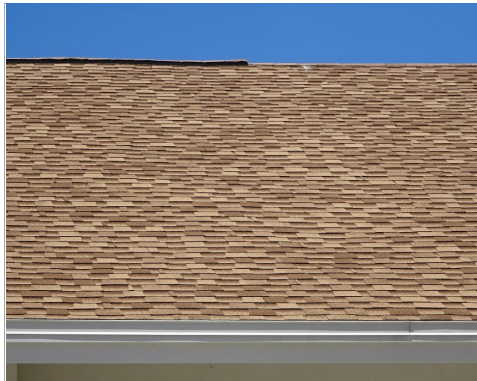
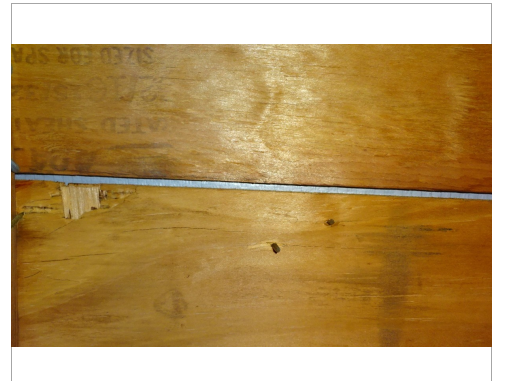
## Roof Covering Types, Roof Slope and Secondary Water Resistance

Permit Date: Nov 9, 2020

| Description: | RE-ROOF 21 BUILDINGS AND (1) POOL HOUSE. ALL BUILDINGS 5/12 PITCH. TEAR OFF DOWN TO WOOD DECK. FELT BUSTER UNDERLAYMENT. FL#18686-R2 GAF SHINGLES FL#10124-R27 | | | | |

☐ Greater than or equal to ( ≥ 6:12) ☒ Less than (< 6:12).

☒ B. No Sealed Roof Deck.

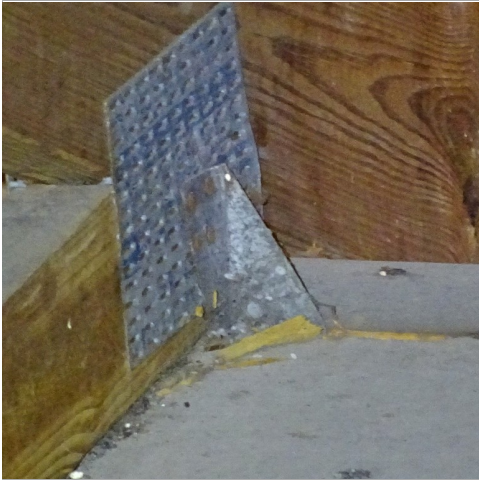
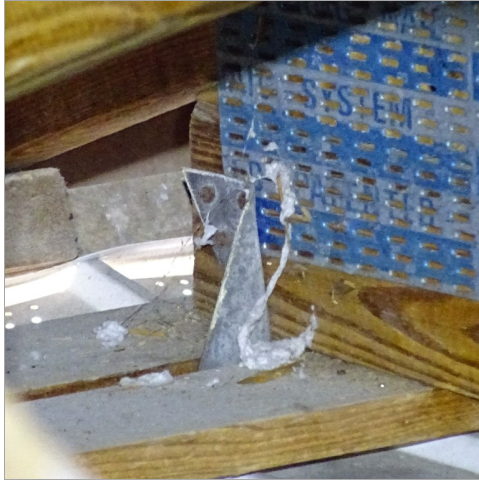
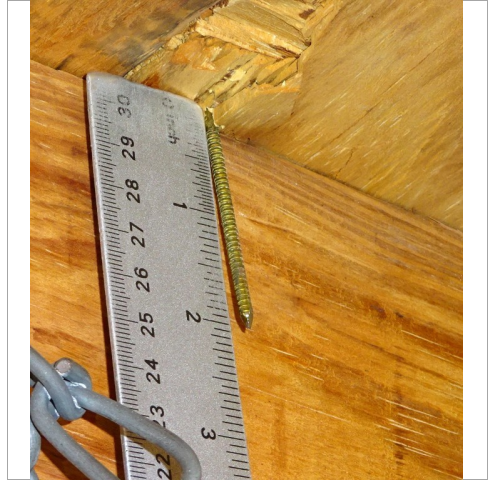
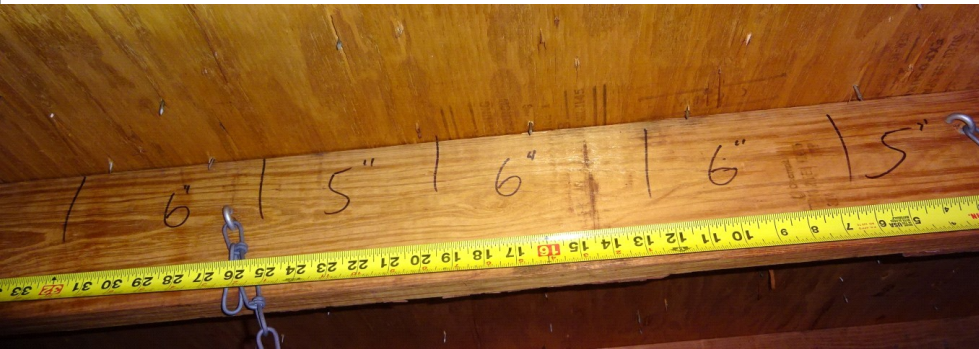
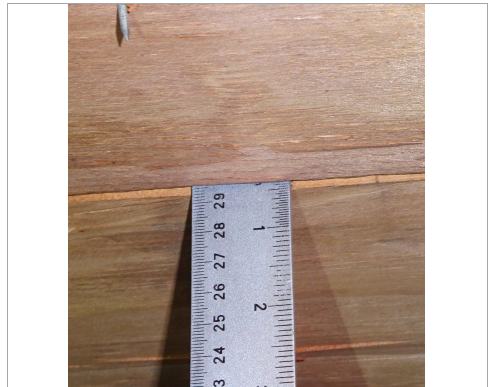
## Roof Deck Attachment and Roof to Wall Attachment

- ☒ C. Plywood/OSB roof sheathing with a minimum thickness of 7/16" attached to the roof truss/rafter (spaced a maximum of 24" o.c.) by 8d common nails spaced a maximum of 6" in the field. OR Dimensional lumber/Tongue Groove decking with a minimum of 2 nails per board (or 1 nail per board if each board is equal to or less than 6" in width). OR Any system of screws, nails, adhesives, other deck fastening system or truss/rafter spacing that is shown to have an equivalent or greater resistance than 8d common nails spaced a maximum of 6" in the field (max 24" truss/rafter spacing) or has a mean ultimate uplift resistance of at least 182 psf.

- ☒ 1. Metal connectors secured to truss/rafter with a minimum of three (3) nails, and attached to the side and/or bottom of the wall framing top plate, or embedded into the bond beam, with less than 1/2" gap from the blocking or truss/rafter, and blocked no more than 1 1/2" from the truss/rafter, and free of visible severe corrosion, OR
- ☐ 2. Metal connectors consisting of a single strap that wraps over the truss/rafter, are secured to the side of the wall and/or bottom of the top plate with a minimum of three nails on each side and free of visible severe corrosion, OR
- ☐ 3. Purpose-made metal connector(s) or structural fastener(s) installed per the manufacturer's installation specifications to meet the substantiated wind allowable capacity detailed below.

☒ B. Clips

- ☒ Metal connectors that do not wrap over the top of the truss/rafter, OR
- ☐ Metal connectors with a minimum of (1) strap that wraps over the top of the truss/rafter and does not meet the nail position requirements of C or D, but is secured with a minimum of (3) nails, OR
- ☐ Purpose-made metal connector(s) or structural fastener(s) with a substantiated wind allowable uplift capacity of 386 lbs. or greater installed per the manufacturer's installation specifications (requires site-specific documentation).
