# Wind Mitigation Inspection Report

| <b>Name:</b> | Sun Ketch 2 Condo Assoc Inc Bldg 18 | | | | | | | | | |
| <b>Address:</b> | 12226-12242 Sun Vista Ct E | | | | | | | | | |

# Uniform Mitigation Verification Inspection Form

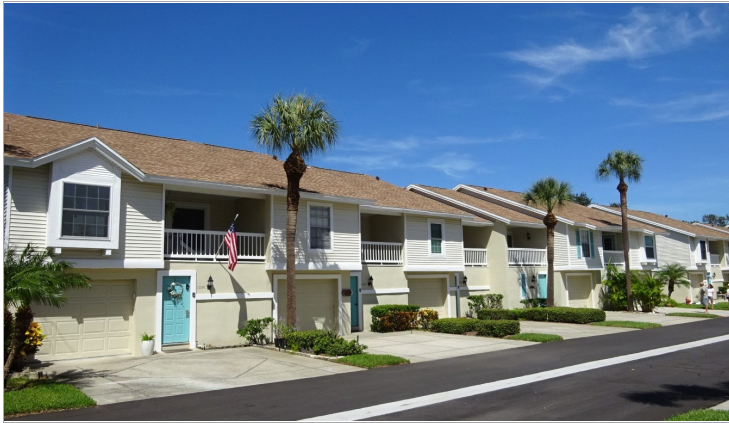
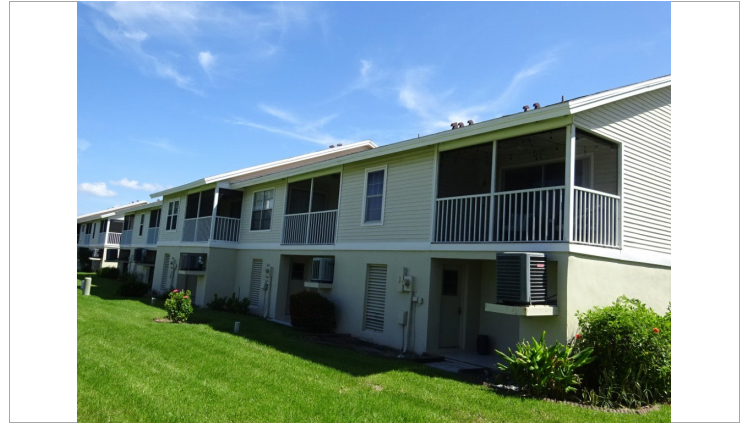
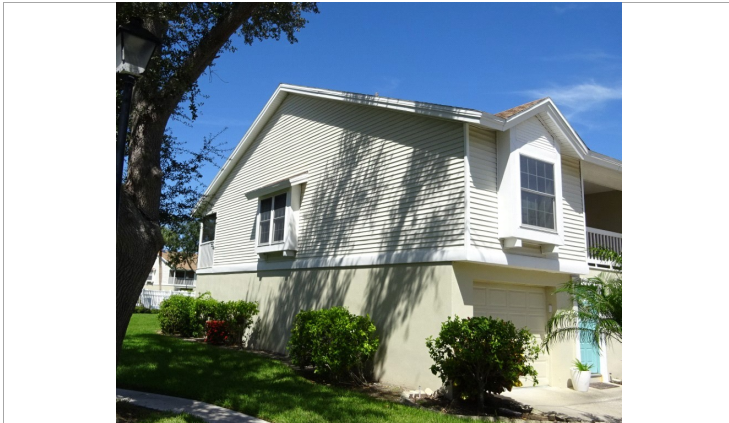
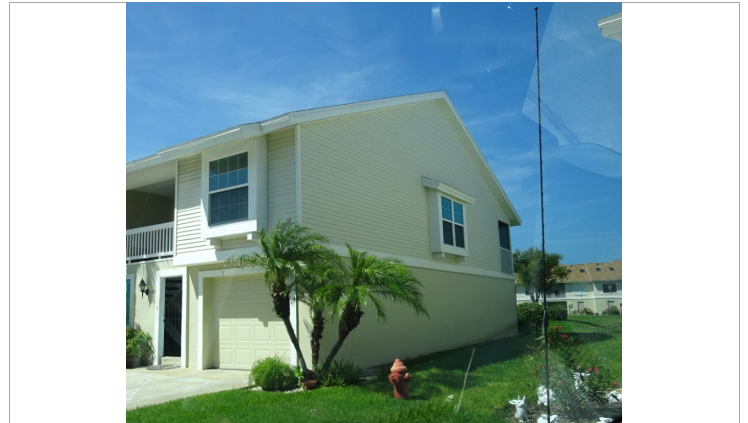
## Elevation and Roof Geometry

☒ C. Other Roof: Any roof that does not qualify as either (A) or (B) above.

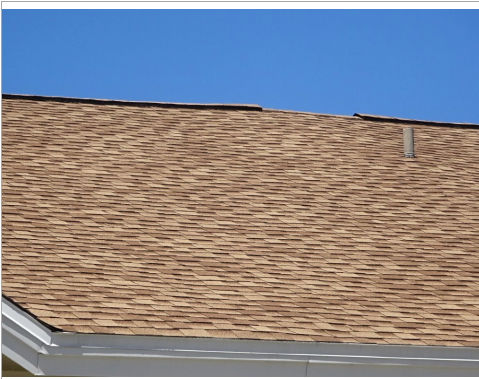
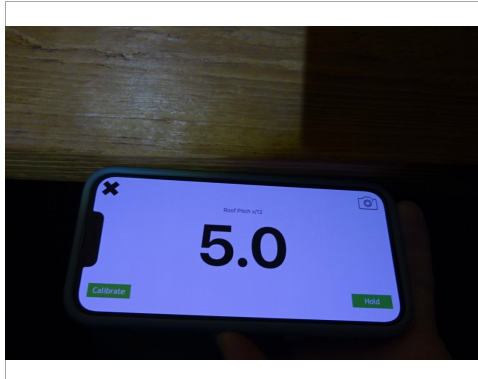
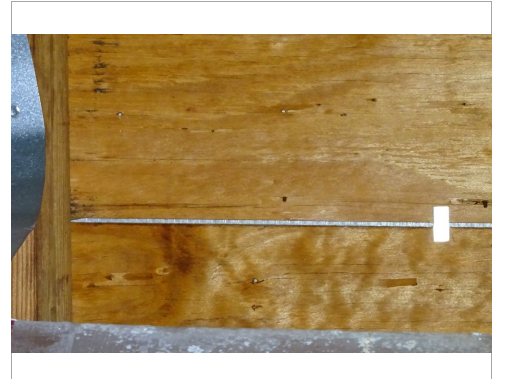
## Roof Covering Types, Roof Slope and Secondary Water Resistance

Permit Date: Nov 9, 2020

| Description: | RE-ROOF 21 BUILDINGS AND (1) POOL HOUSE. ALL BUILDINGS 5/12 PITCH. TEAR OFF DOWN TO WOOD DECK. FELT BUSTER UNDERLAYMENT.FL#18686-R2 GAF SHINGLES FL#10124-R27 | | | | |

☐ Greater than or equal to ( ≥ 6:12) ☒ Less than (< 6:12).

☒ B. No Sealed Roof Deck.

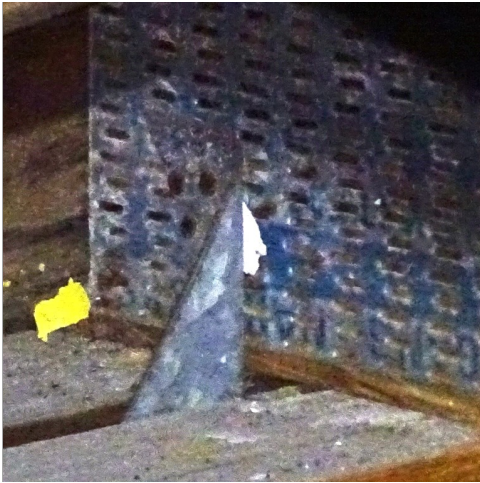
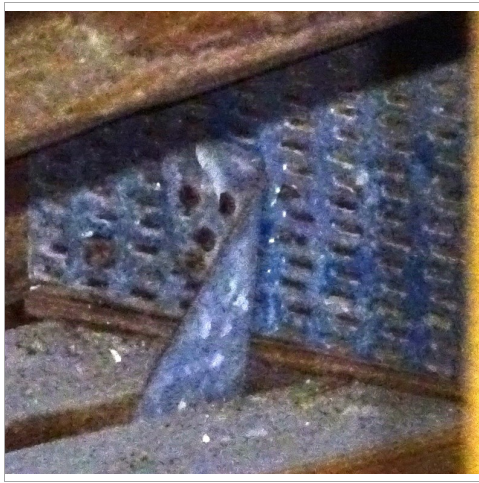
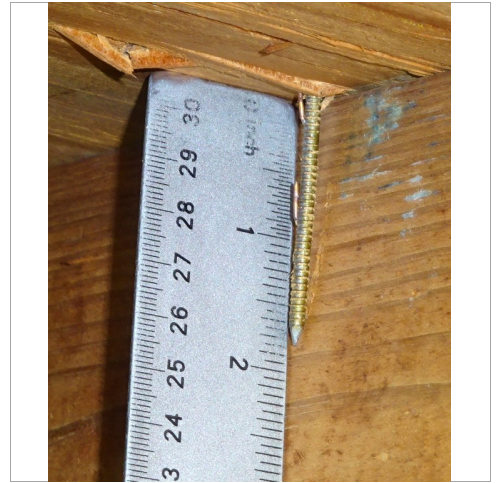
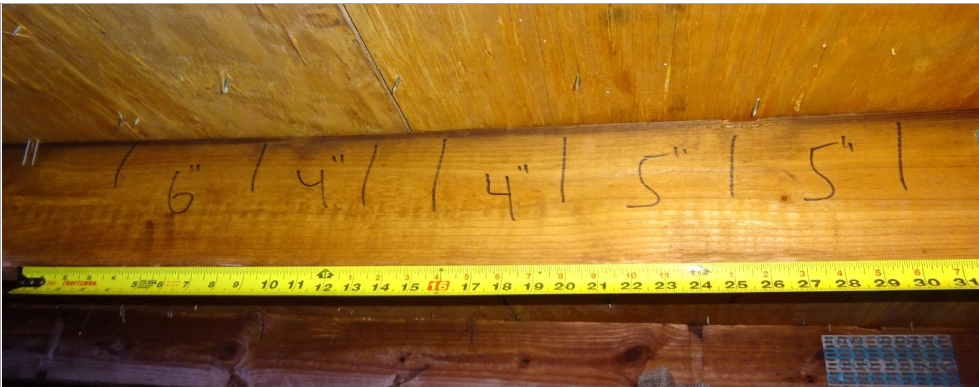
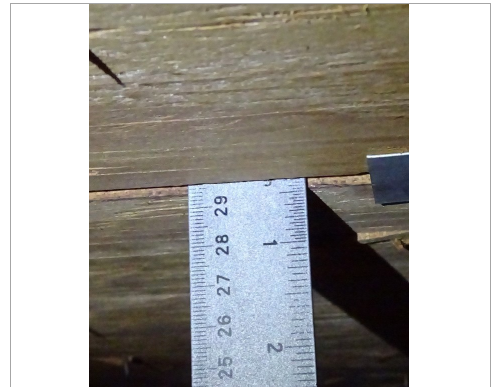
## Roof Deck Attachment and Roof to Wall Attachment

- ☒ C. Plywood/OSB roof sheathing with a minimum thickness of 7/16" attached to the roof truss/rafter (spaced a maximum of 24" o.c.) by 8d common nails spaced a maximum of 6" in the field. OR Dimensional lumber/Tongue Groove decking with a minimum of 2 nails per board (or 1 nail per board if each board is equal to or less than 6" in width). OR Any system of screws, nails, adhesives, other deck fastening system or truss/rafter spacing that is shown to have an equivalent or greater resistance than 8d common nails spaced a maximum of 6" in the field (max 24" truss/rafter spacing) or has a mean ultimate uplift resistance of at least 182 psf.

☒ B. Clips

- ☒ Metal connectors that do not wrap over the top of the truss/rafter, OR
- ☐ Metal connectors with a minimum of (1) strap that wraps over the top of the truss/rafter and does not meet the nail position requirements of C or D, but is secured with a minimum of (3) nails, OR
- ☐ Purpose-made metal connector(s) or structural fastener(s) with a substantiated wind allowable uplift capacity of 386 lbs. or greater installed per the manufacturer's installation specifications (requires site-specific documentation).
