# Wind Mitigation Inspection Report

| <b>Name:</b> | Sun Ketch 2 Condo Assoc Inc Bldg 19 | | | | | | | | | |
| <b>Address:</b> | 12303-12323 Sun Vista Ct E | | | | | | | | | |

# Uniform Mitigation Verification Inspection Form

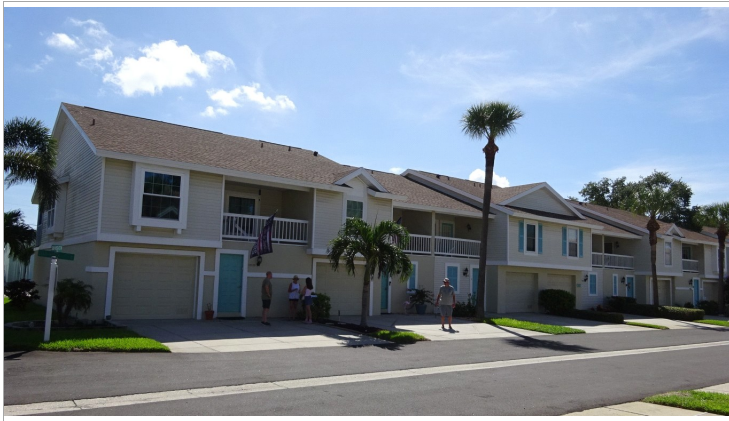
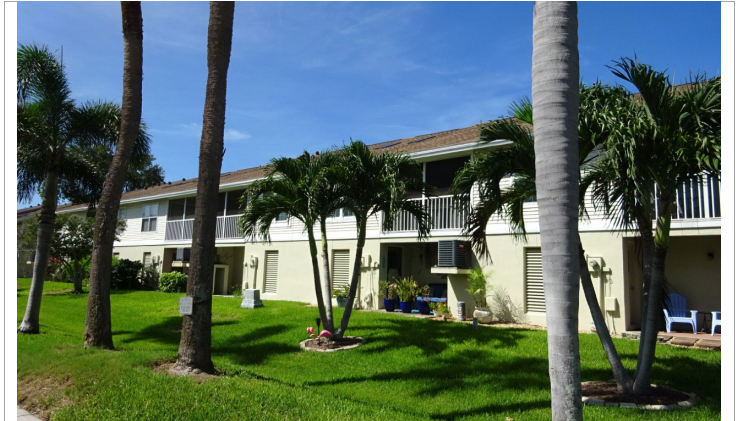
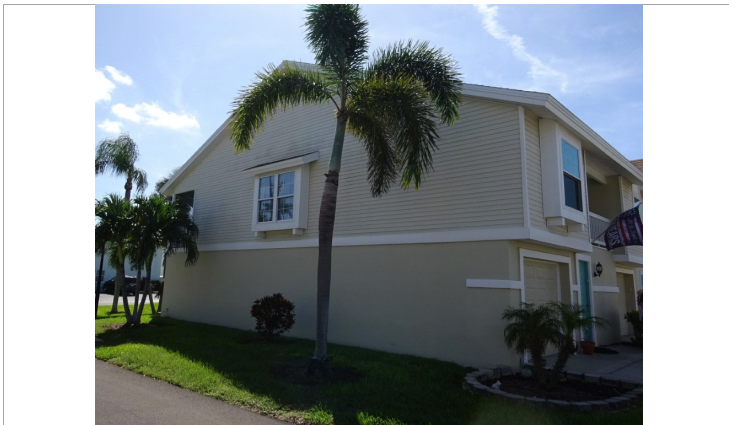
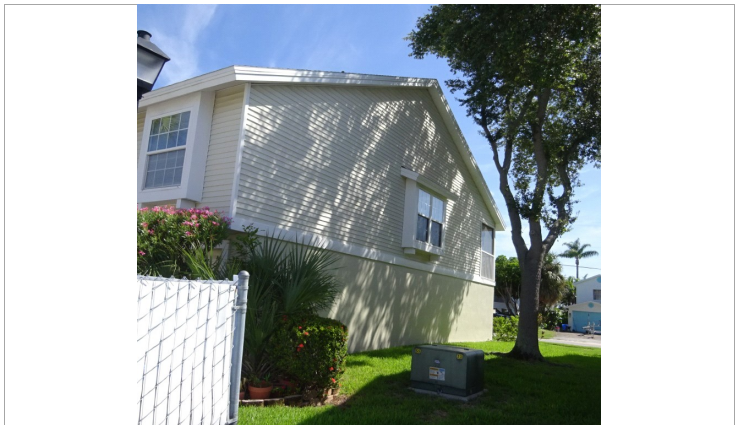
## Elevation and Roof Geometry

☒ C. Other Roof: Any roof that does not qualify as either (A) or (B) above.

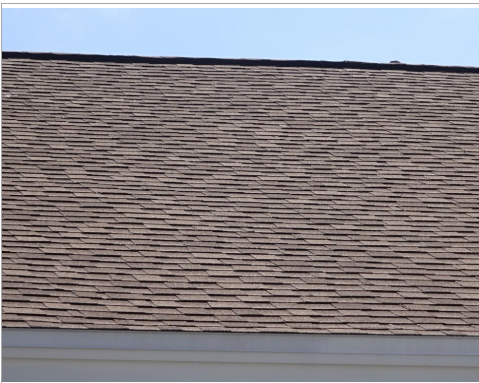
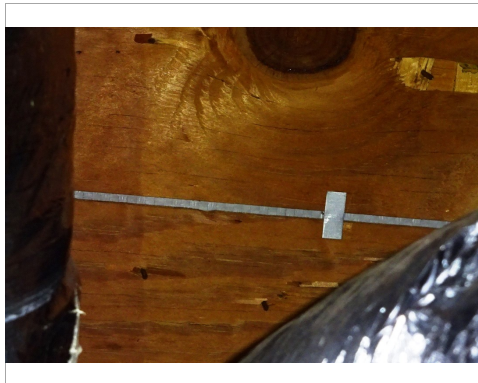
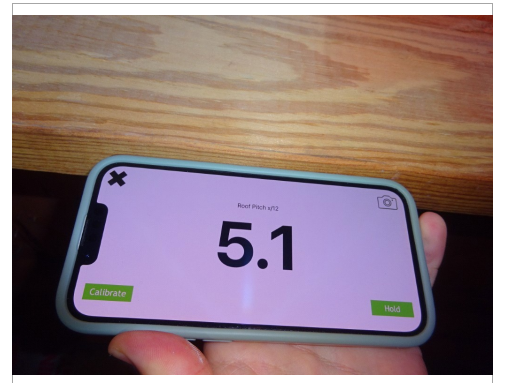
## Roof Covering Types, Roof Slope and Secondary Water Resistance

Permit Date: Nov 9, 2020

Main Material Type: Shingle

Date Replaced: Nov 9, 2020

- ☐ Greater than or equal to ( ≥ 6:12) ☒ Less than (< 6:12).

☒ B. No Sealed Roof Deck.

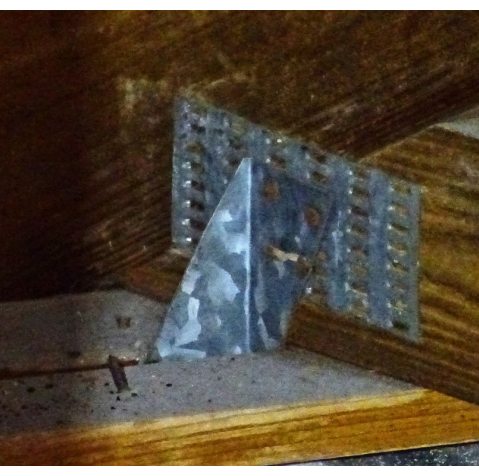
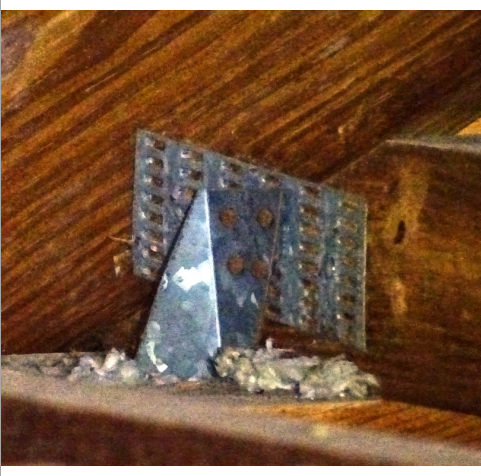
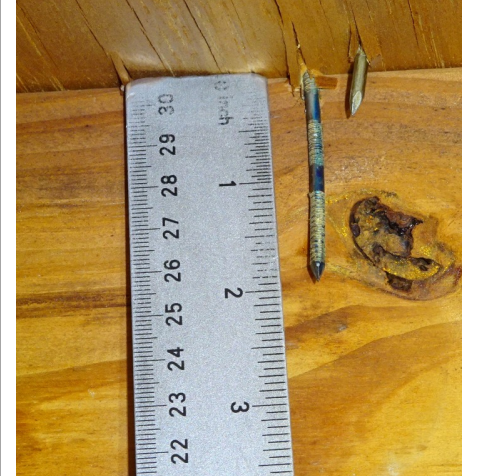
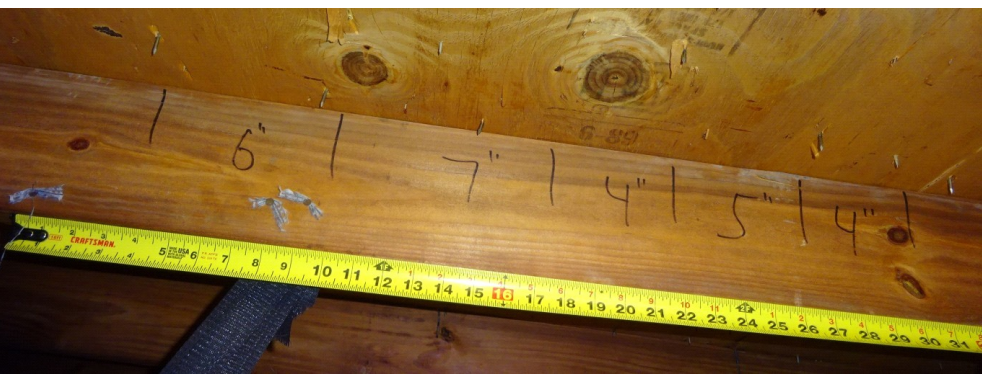
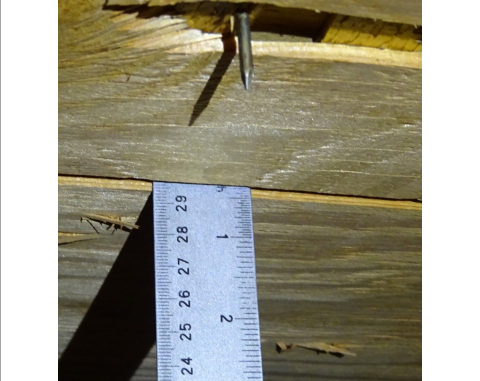
Roof Deck Attachment and Roof to Wall Attachment

- ☒ C. Plywood/OSB roof sheathing with a minimum thickness of 7/16" attached to the roof truss/rafter (spaced a maximum of 24" o.c.) by 8d common nails spaced a maximum of 6" in the field. OR Dimensional lumber/Tongue Groove decking with a minimum of 2 nails per board (or 1 nail per board if each board is equal to or less than 6" in width). OR Any system of screws, nails, adhesives, other deck fastening system or truss/rafter spacing that is shown to have an equivalent or greater resistance than 8d common nails spaced a maximum of 6" in the field (max 24" truss/rafter spacing) or has a mean ultimate uplift resistance of at least 182 psf.

☒ B. Clips

- ☒ Metal connectors that do not wrap over the top of the truss/rafter, OR
- ☐ Metal connectors with a minimum of (1) strap that wraps over the top of the truss/rafter and does not meet the nail position requirements of C or D, but is secured with a minimum of (3) nails, OR
- ☐ Purpose-made metal connector(s) or structural fastener(s) with a substantiated wind allowable uplift capacity of 386 lbs. or greater installed per the manufacturer's installation specifications (requires site-specific documentation).

Recommendations for this home would be to install a hurricane shutter system over the windows and doors for maximum protection as well as (possibly) increased savings. (ALL GLAZED OPENINGS a.k.a. items with glass in them must be protected or impact rated).
