# Wind Mitigation Inspection Report

| <b>Name:</b> | Sun Ketch 2 Condo Assoc Inc Bldg 2 | | | | | | | | | |
| <b>Address:</b> | 215-221 Sun Vista Ct S | | | | | | | | | |

# Uniform Mitigation Verification Inspection Form

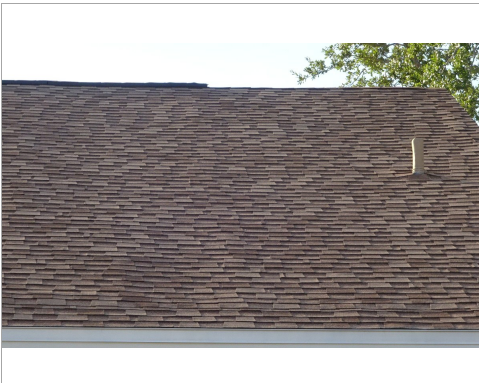
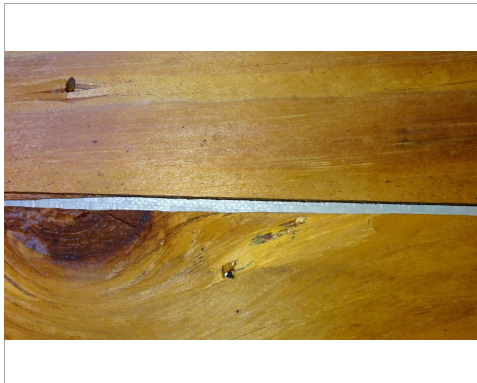
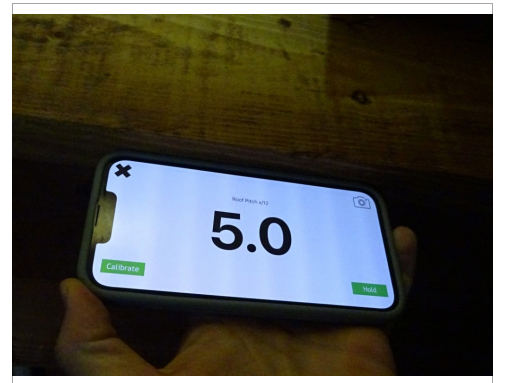
## Roof Covering Types, Roof Slope and Secondary Water Resistance

Permit Date: Nov 9, 2020

| Description: | RE-ROOF 21 BUILDINGS AND (1) POOL HOUSE. ALL BUILDINGS 5/12 PITCH. TEAR OFF DOWN TO WOOD DECK. FELT BUSTER UNDERLAYMENT. FL#18686-R2 GAF SHINGLES FL#10124-R27 | | | | |

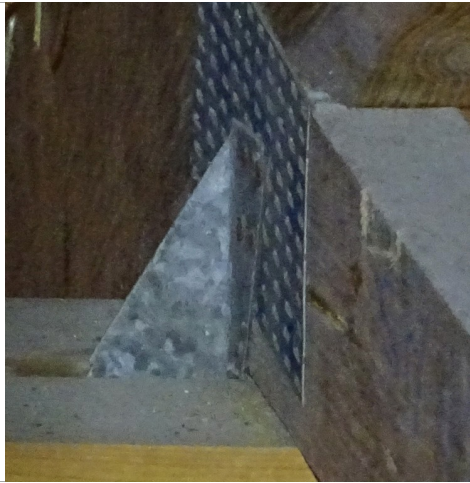
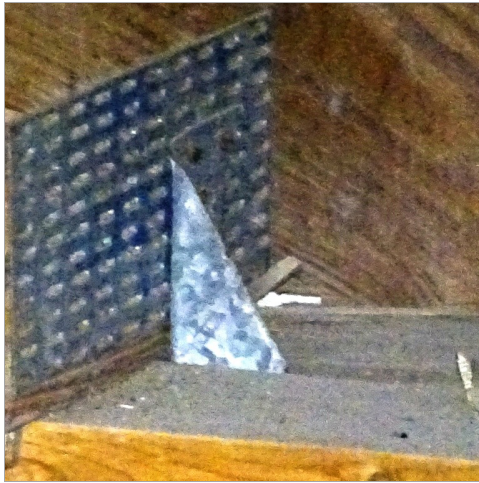
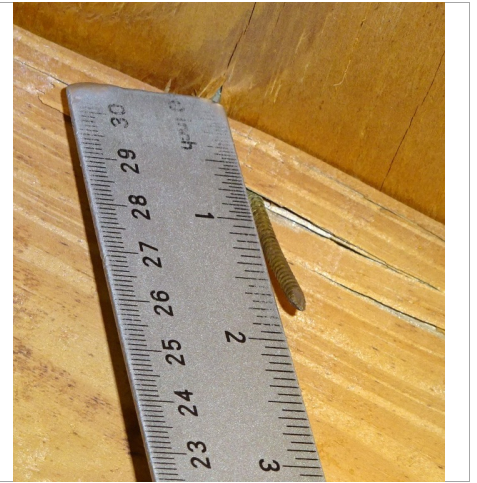
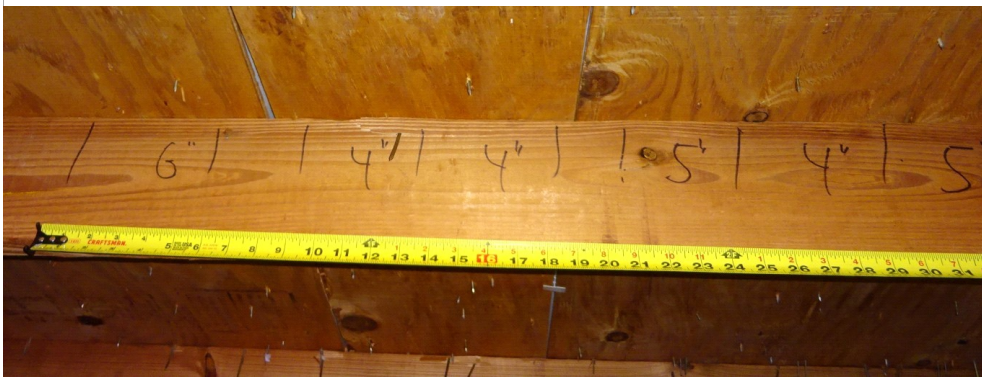
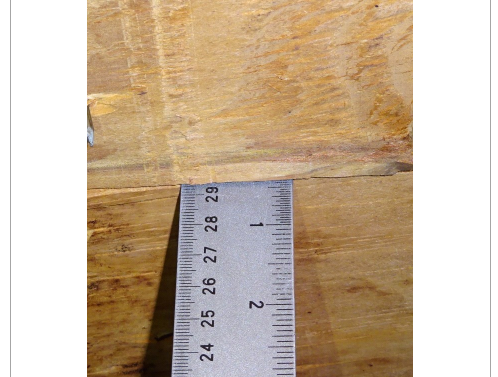
## Roof Deck Attachment and Roof to Wall Attachment

- ☒ C. Plywood/OSB roof sheathing with a minimum thickness of 7/16" attached to the roof truss/rafter (spaced a maximum of 24" o.c.) by 8d common nails spaced a maximum of 6" in the field. OR Dimensional lumber/Tongue Groove decking with a minimum of 2 nails per board (or 1 nail per board if each board is equal to or less than 6" in width). OR Any system of screws, nails, adhesives, other deck fastening system or truss/rafter spacing that is shown to have an equivalent or greater resistance than 8d common nails spaced a maximum of 6" in the field (max 24" truss/rafter spacing) or has a mean ultimate uplift resistance of at least 182 psf.

- ☒ 1. Metal connectors secured to truss/rafter with a minimum of three (3) nails, and attached to the side and/or bottom of the wall framing top plate, or embedded into the bond beam, with less than 1/2" gap from the blocking or truss/rafter, and blocked no more than 1 1/2" from the truss/rater, and free of visible severe corrosion, OR
- ☐ 2. Metal connectors consisting of a single strap that wraps over the truss/rafter, are secured to the side of the wall and/ or bottom of the top plate with a minimum of three nails on each side and free of visible severe corrosion, OR
- ☐ 3. Purpose-made metal connector(s) or structural fastener(s) installed per the manufacturer's installation specifications to meet the substantiated wind allowable capacity detailed below.

☒ B. Clips

- ☒ Metal connectors that do not wrap over the top of the truss/rafter, OR
- ☐ Metal connectors with a minimum of (1) strap that wraps over the top of the truss/rafter and does not meet the nail position requirements of C or D, but is secured with a minimum of (3) nails, OR
- ☐ Purpose-made metal connector(s) or structural fastener(s) with a substantiated wind allowable uplift capacity of 386 lbs. or greater installed per the manufacturer's installation specifications (requires site-specific documentation).
