# Wind Mitigation Inspection Report

| <b>Name:</b> | Sun Ketch 2 Condo Assoc Inc Bldg 20 | | | | | | | | | |
| <b>Address:</b> | 12223-12243 Sun Vista Ct E | | | | | | | | | |

# Uniform Mitigation Verification Inspection Form

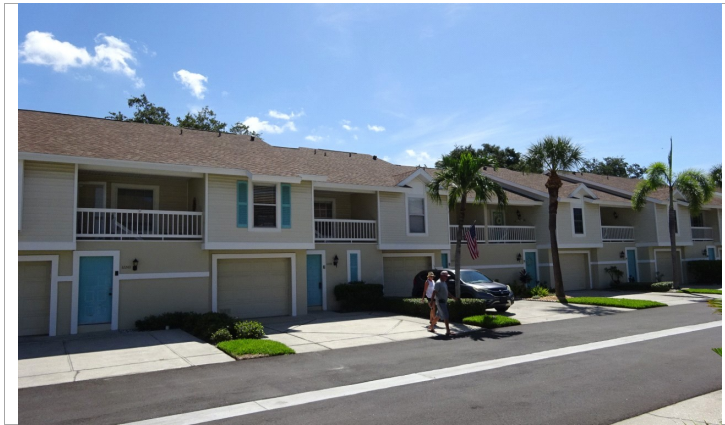
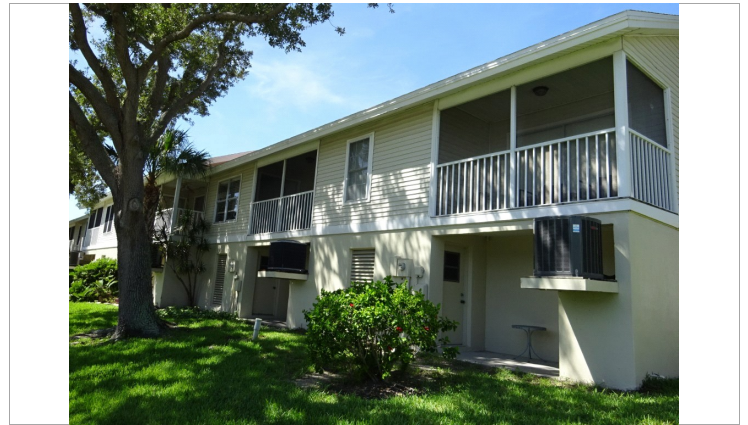
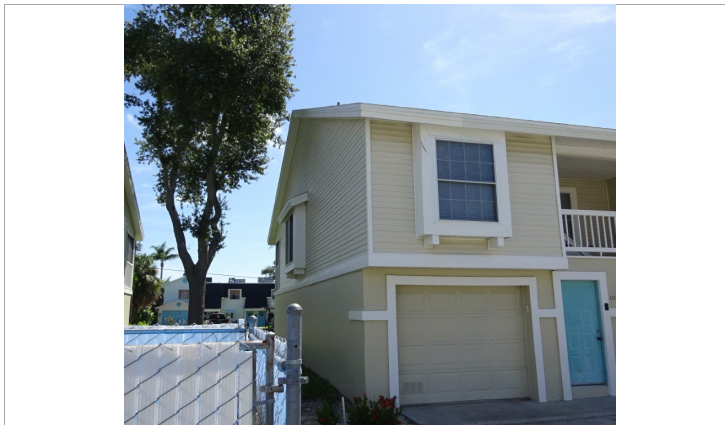
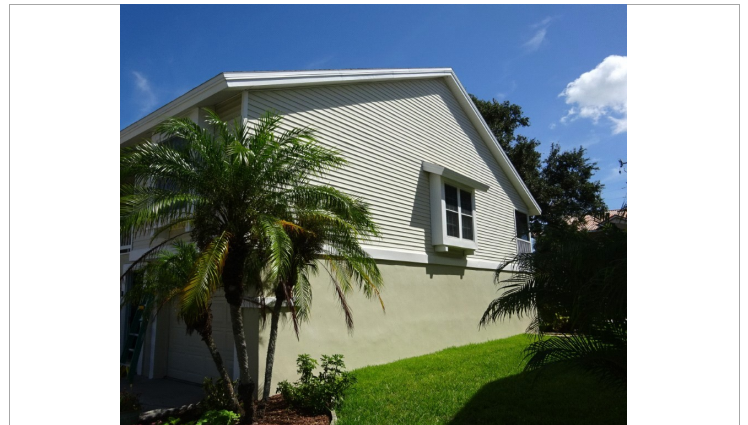
## Elevation and Roof Geometry

☒ C. Other Roof: Any roof that does not qualify as either (A) or (B) above.

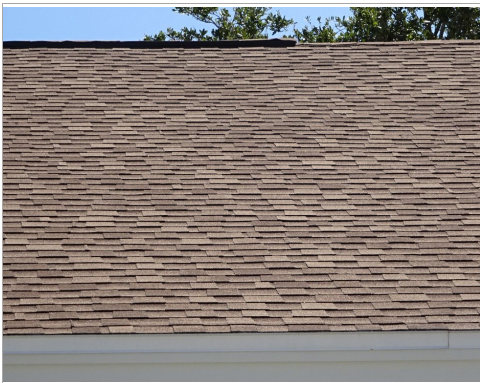
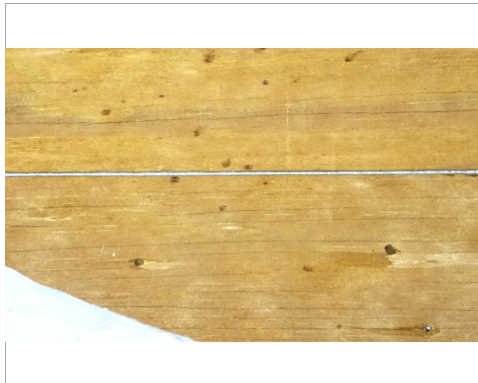
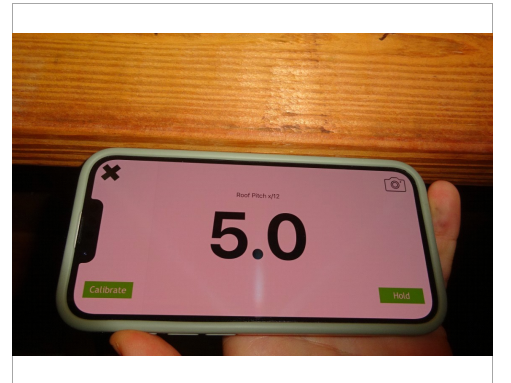
## Roof Covering Types, Roof Slope and Secondary Water Resistance

Permit Date: Nov 9, 2020

| Description: | RE-ROOF 21 BUILDINGS AND (1) POOL HOUSE. ALL BUILDINGS 5/12 PITCH. TEAR OFF DOWN TO WOOD DECK. FELT BUSTER UNDERLAYMENT.FL#18686-R2 GAF SHINGLES FL#10124-R27 | | | | |

Main Material Type: Shingle

☐ Greater than or equal to ( ≥ 6:12) ☒ Less than (< 6:12).

☒ B. No Sealed Roof Deck.

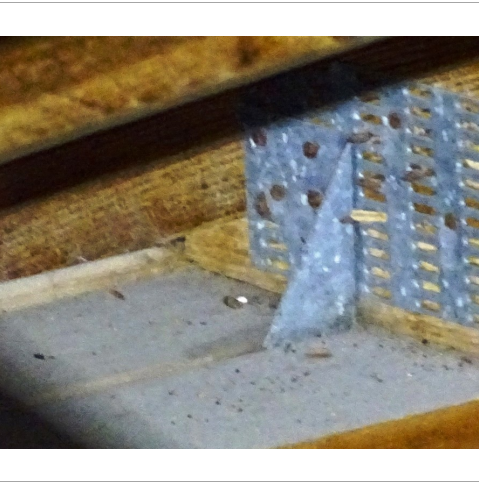
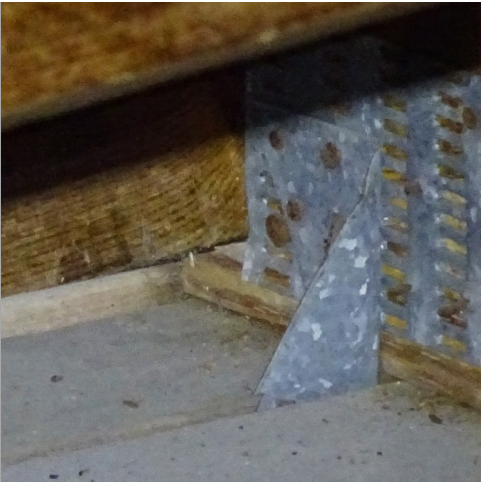
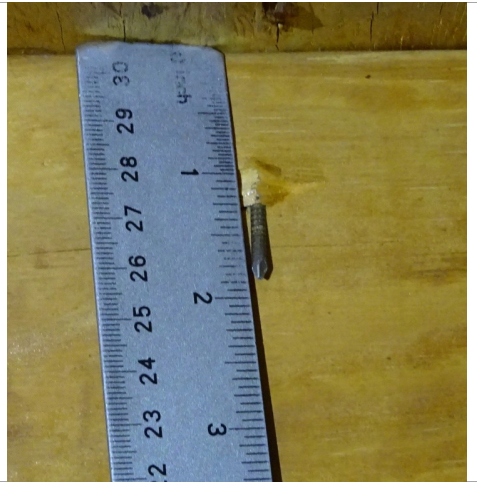
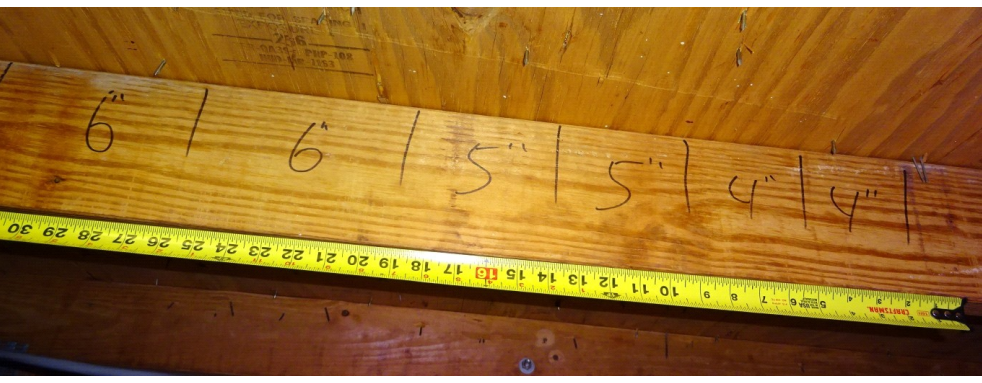
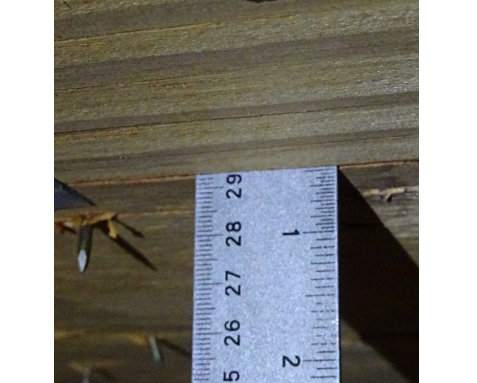
Roof Deck Attachment and Roof to Wall Attachment

- ☒ C. Plywood/OSB roof sheathing with a minimum thickness of 7/16" attached to the roof truss/rafter (spaced a maximum of 24" o.c.) by 8d common nails spaced a maximum of 6" in the field. OR Dimensional lumber/Tongue Groove decking with a minimum of 2 nails per board (or 1 nail per board if each board is equal to or less than 6" in width). OR Any system of screws, nails, adhesives, other deck fastening system or truss/rafter spacing that is shown to have an equivalent or greater resistance than 8d common nails spaced a maximum of 6" in the field (max 24" truss/rafter spacing) or has a mean ultimate uplift resistance of at least 182 psf.

- ☒ 1. Metal connectors secured to truss/rafter with a minimum of three (3) nails, and attached to the side and/or bottom of the wall framing top plate, or embedded into the bond beam, with less than 1/2" gap from the blocking or truss/rafter, and blocked no more than 1 1/2" from the truss/rater, and free of visible severe corrosion, OR
- ☐ 2. Metal connectors consisting of a single strap that wraps over the truss/rafter, are secured to the side of the wall and/ or bottom of the top plate with a minimum of three nails on each side and free of visible severe corrosion, OR
- ☐ 3. Purpose-made metal connector(s) or structural fastener(s) installed per the manufacturer's installation specifications to meet the substantiated wind allowable capacity detailed below.

☒ B. Clips

- ☒ Metal connectors that do not wrap over the top of the truss/rafter, OR
- ☐ Metal connectors with a minimum of (1) strap that wraps over the top of the truss/rafter and does not meet the nail position requirements of C or D, but is secured with a minimum of (3) nails, OR
- ☐ Purpose-made metal connector(s) or structural fastener(s) with a substantiated wind allowable uplift capacity of 386 lbs. or greater installed per the manufacturer's installation specifications (requires site-specific documentation).
