# Wind Mitigation Inspection Report

| <b>Name:</b> | Sun Ketch 2 Condo Assoc Inc Bldg 3 | | | | | | | | | |
| <b>Address:</b> | 223-229 Sun Vista Ct S | | | | | | | | | |

# Uniform Mitigation Verification Inspection Form

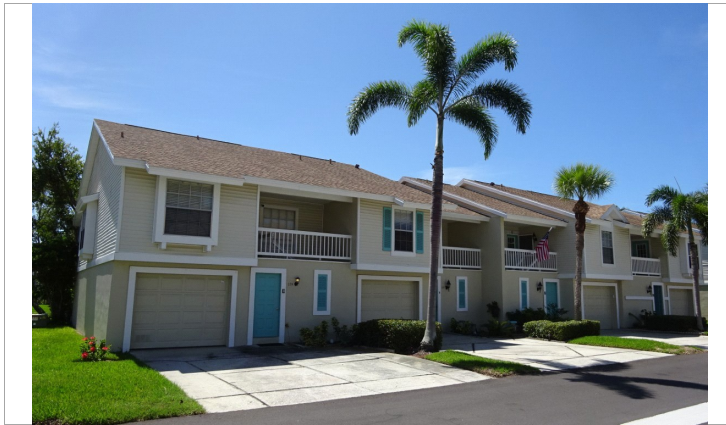
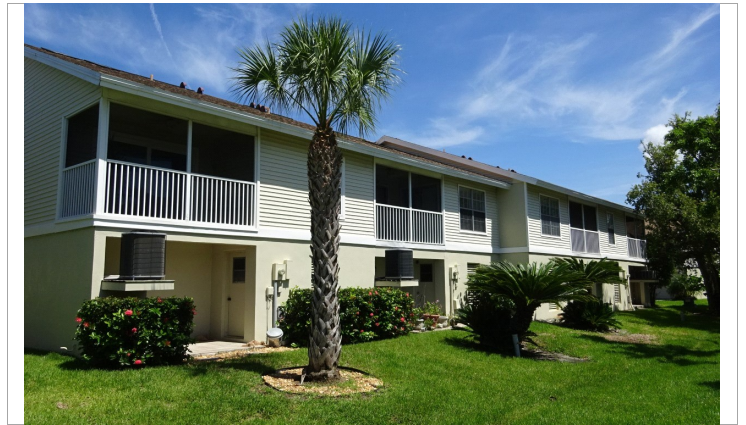
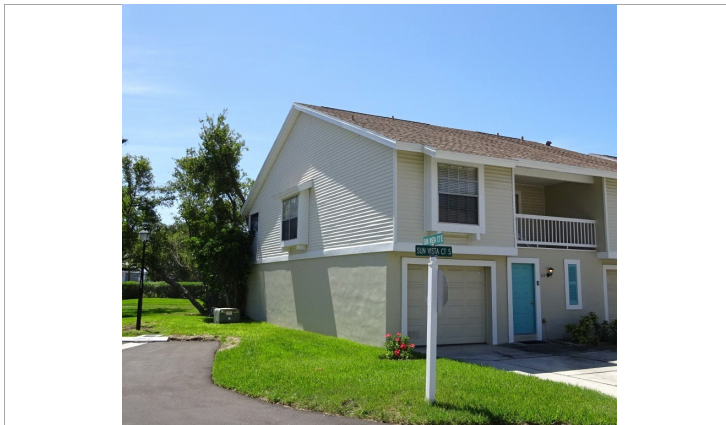
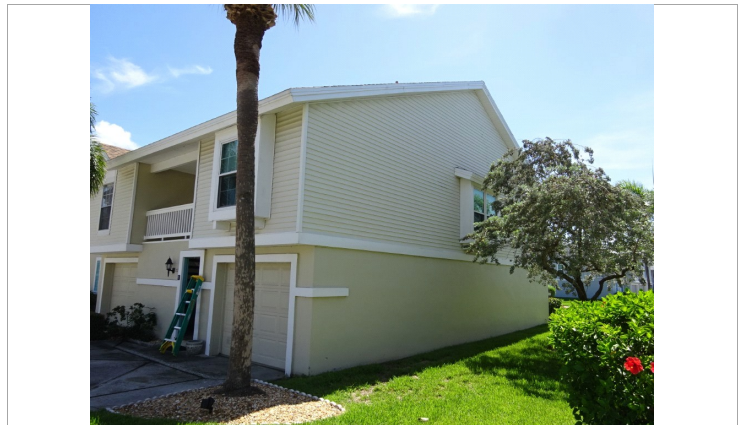
## Elevation and Roof Geometry

☒ C. Other Roof: Any roof that does not qualify as either (A) or (B) above.

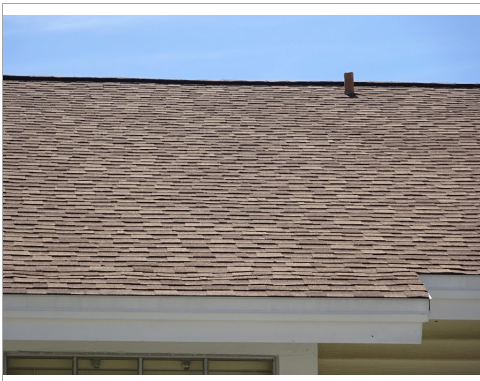
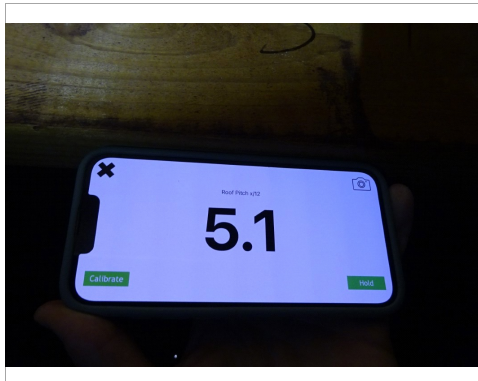
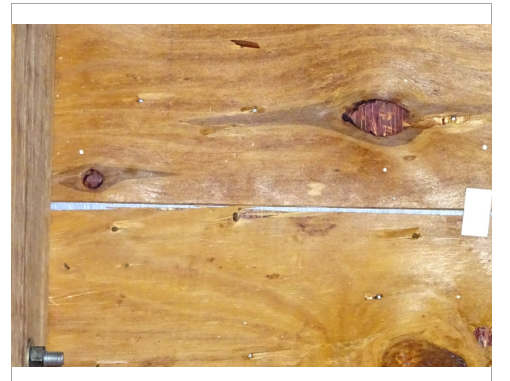
## Roof Covering Types, Roof Slope and Secondary Water Resistance

Permit Date: Nov 9, 2020

☐ Greater than or equal to ( ≥ 6:12) ☒ Less than (< 6:12).

| 4.1 Roof Covering Type: | Permit Application Date | FBC or MDC Product Approval # | Year of Original Installation or Replacement | No Information Provided for Compliance |
|---|---|---|---|---|
| <input checked="" type="checkbox"/> Asphalt/Fiberglass Shingle | <u>Nov 9, 2020</u> | <u>BLDC-001028-2020</u> | _____ | <input type="checkbox"/> |

☒ B. No Sealed Roof Deck.

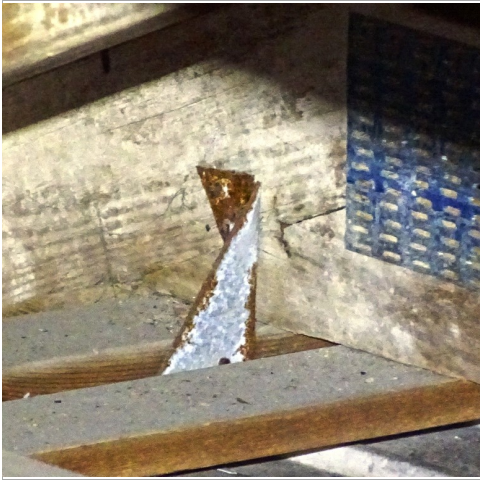
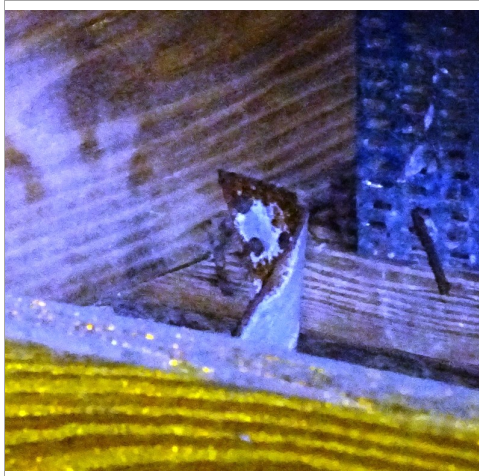
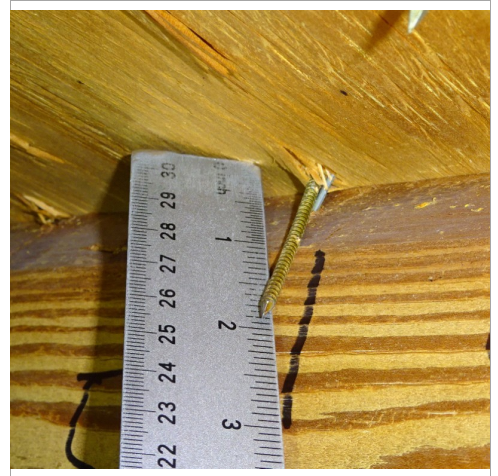
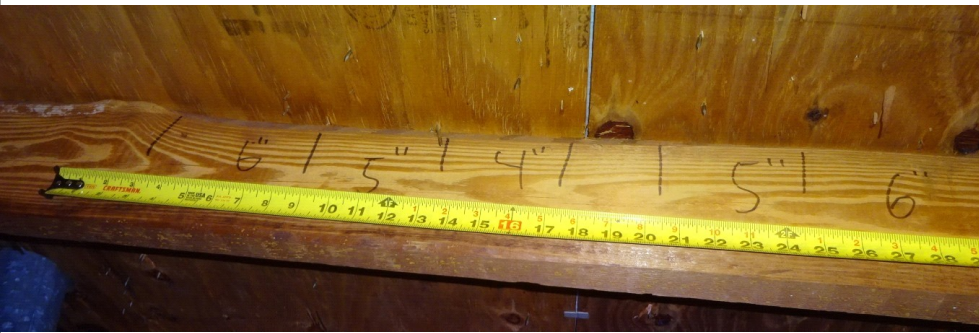
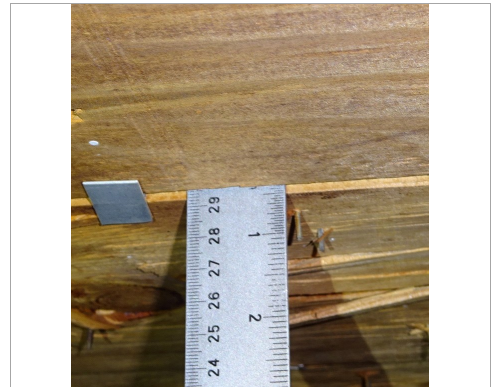
## Roof Deck Attachment and Roof to Wall Attachment

- ☒ C. Plywood/OSB roof sheathing with a minimum thickness of 7/16" attached to the roof truss/rafter (spaced a maximum of 24" o.c.) by 8d common nails spaced a maximum of 6" in the field. OR Dimensional lumber/Tongue Groove decking with a minimum of 2 nails per board (or 1 nail per board if each board is equal to or less than 6" in width). OR Any system of screws, nails, adhesives, other deck fastening system or truss/rafter spacing that is shown to have an equivalent or greater resistance than 8d common nails spaced a maximum of 6" in the field (max 24" truss/rafter spacing) or has a mean ultimate uplift resistance of at least 182 psf.

- ☒ 1. Metal connectors secured to truss/rafter with a minimum of three (3) nails, and attached to the side and/or bottom of the wall framing top plate, or embedded into the bond beam, with less than 1/2" gap from the blocking or truss/rafter, and blocked no more than 1 1/2" from the truss/rafter, and free of visible severe corrosion, OR
- ☐ 2. Metal connectors consisting of a single strap that wraps over the truss/rafter, are secured to the side of the wall and/or bottom of the top plate with a minimum of three nails on each side and free of visible severe corrosion, OR
- ☐ 3. Purpose-made metal connector(s) or structural fastener(s) installed per the manufacturer's installation specifications to meet the substantiated wind allowable capacity detailed below.

☒ B. Clips

- ☒ Metal connectors that do not wrap over the top of the truss/rafter, OR
- ☐ Metal connectors with a minimum of (1) strap that wraps over the top of the truss/rafter and does not meet the nail position requirements of C or D, but is secured with a minimum of (3) nails, OR
- ☐ Purpose-made metal connector(s) or structural fastener(s) with a substantiated wind allowable uplift capacity of 386 lbs. or greater installed per the manufacturer's installation specifications (requires site-specific documentation).
