# Wind Mitigation Inspection Report

| <b>Name:</b> | Sun Ketch 2 Condo Assoc Inc Bldg 4 | | | | | | | | | |
| <b>Address:</b> | 214-222 Sun Vista Ct S | | | | | | | | | |

# Uniform Mitigation Verification Inspection Form

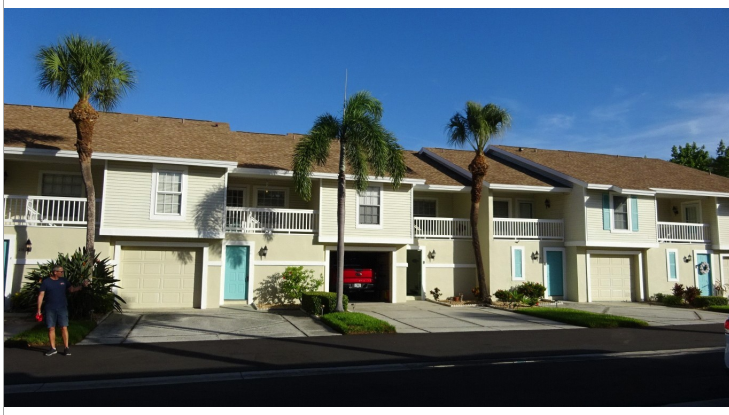
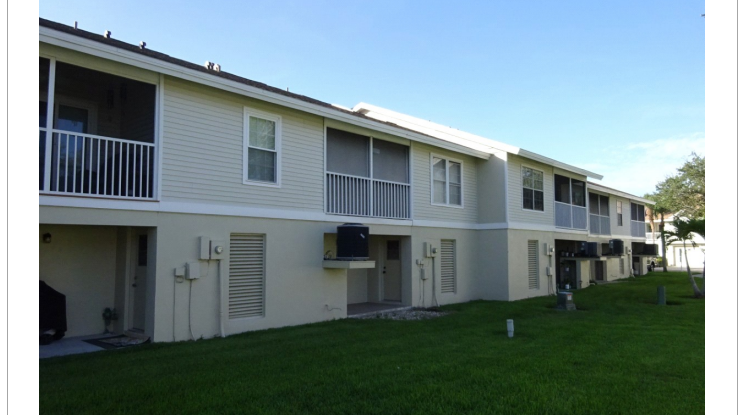
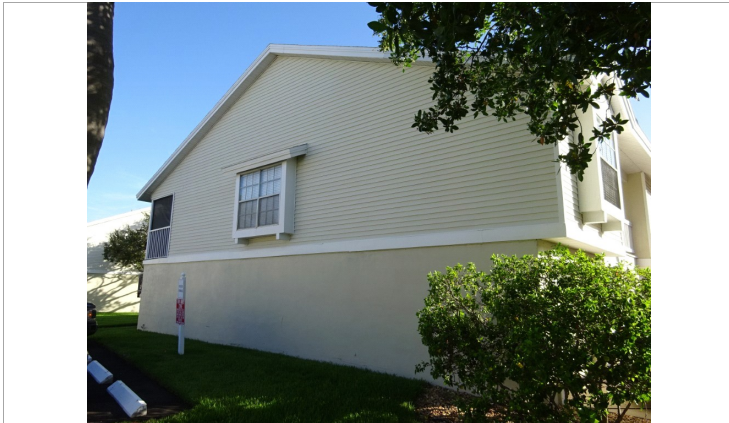
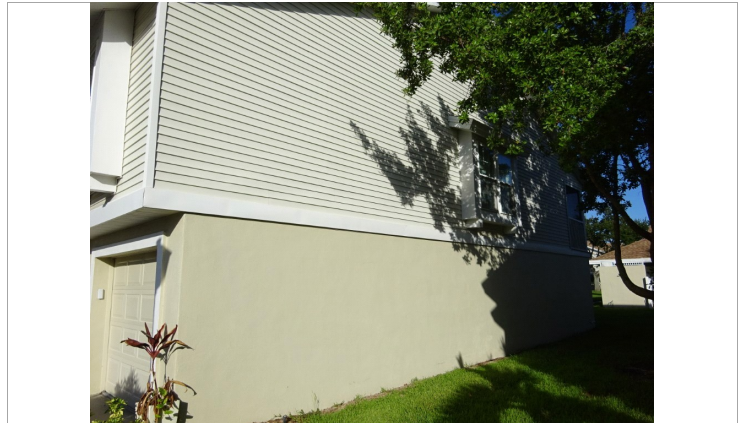
## Elevation and Roof Geometry

☒ C. Other Roof: Any roof that does not qualify as either (A) or (B) above.

Recommendations for this home would be to install a hurricane shutter system over the windows and doors for maximum protection as well as (possibly) increased savings. (ALL GLAZED OPENINGS a.k.a. items with glass in them must be protected or impact rated).

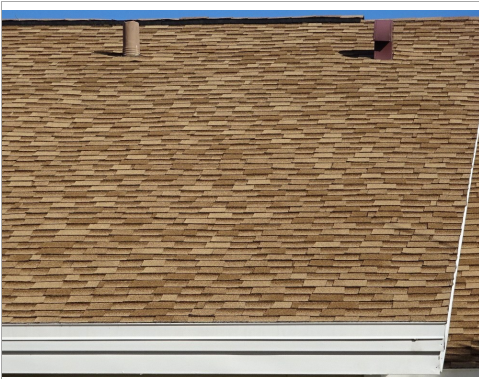
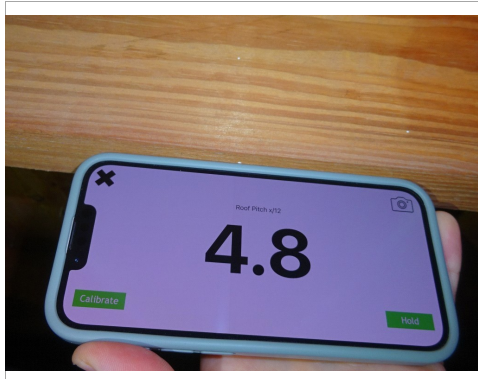
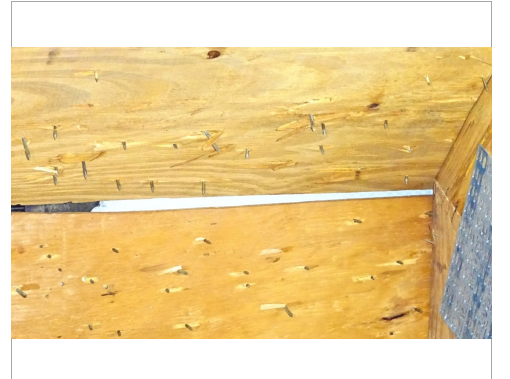
## Roof Covering Types, Roof Slope and Secondary Water Resistance

Permit Date: Nov 9, 2020

| Description: | RE-ROOF 21 BUILDINGS AND (1) POOL HOUSE. ALL BUILDINGS 5/12 PITCH. TEAR OFF DOWN TO WOOD DECK. FELT BUSTER UNDERLAYMENT. FL#18686-R2 GAF SHINGLES FL#10124-R27 | | | | |

Main Material Type: Shingle

Date Replaced: Nov 9, 2020

☐ Greater than or equal to ( ≥ 6:12) ☒ Less than (< 6:12).

☒ B. No Sealed Roof Deck.

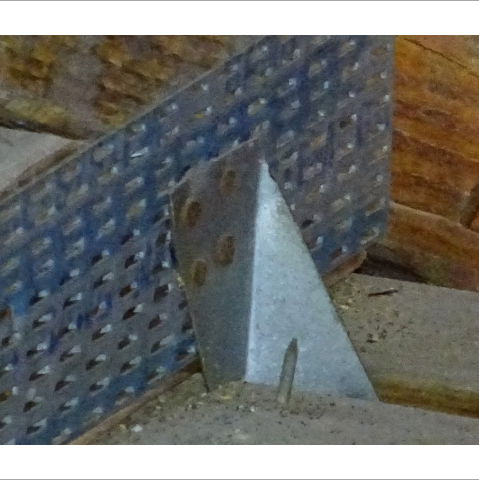
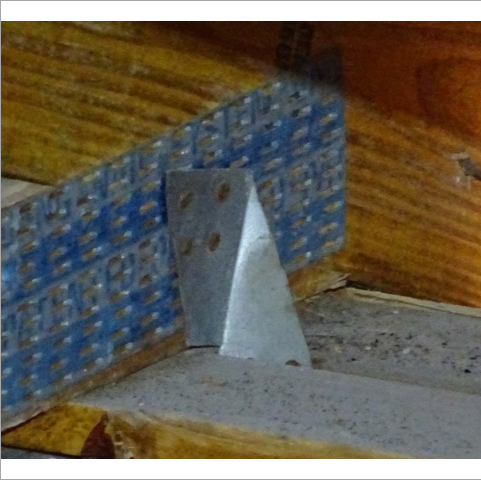
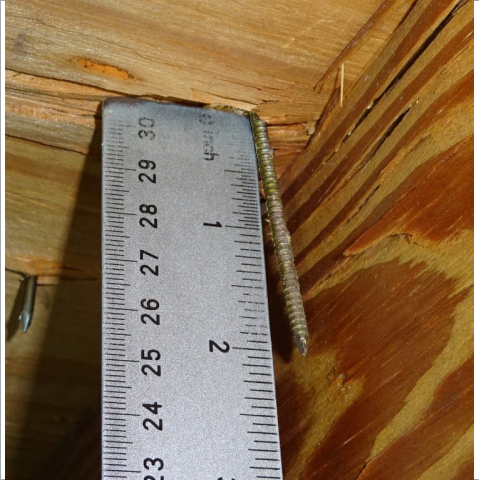
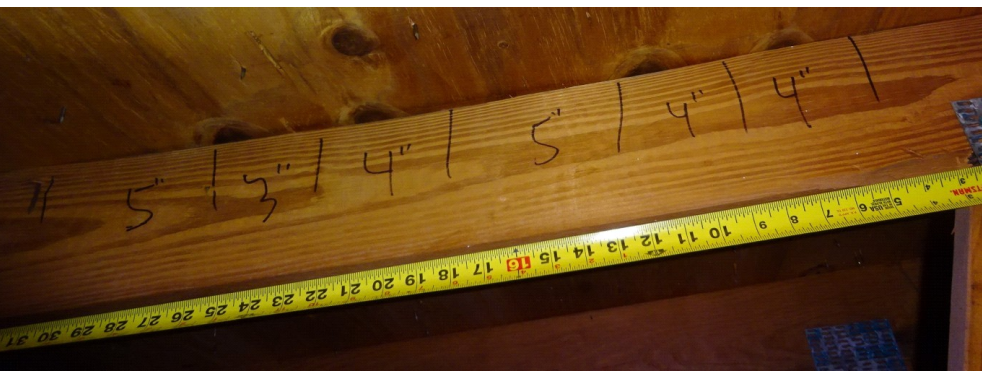
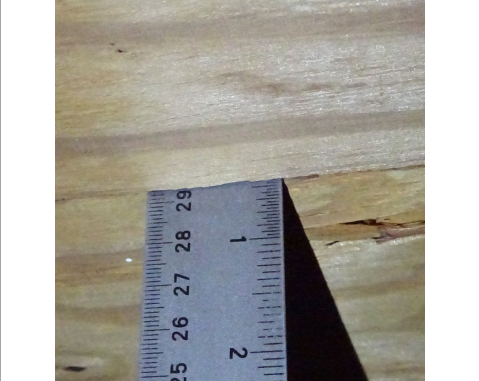
Roof Deck Attachment and Roof to Wall Attachment

- ☒ C. Plywood/OSB roof sheathing with a minimum thickness of 7/16" attached to the roof truss/rafter (spaced a maximum of 24" o.c.) by 8d common nails spaced a maximum of 6" in the field. OR Dimensional lumber/Tongue Groove decking with a minimum of 2 nails per board (or 1 nail per board if each board is equal to or less than 6" in width). OR Any system of screws, nails, adhesives, other deck fastening system or truss/rafter spacing that is shown to have an equivalent or greater resistance than 8d common nails spaced a maximum of 6" in the field (max 24" truss/rafter spacing) or has a mean ultimate uplift resistance of at least 182 psf.

☒ B. Clips

- ☒ Metal connectors that do not wrap over the top of the truss/rafter, OR
- ☐ Metal connectors with a minimum of (1) strap that wraps over the top of the truss/rafter and does not meet the nail position requirements of C or D, but is secured with a minimum of (3) nails, OR
- ☐ Purpose-made metal connector(s) or structural fastener(s) with a substantiated wind allowable uplift capacity of 386 lbs. or greater installed per the manufacturer's installation specifications (requires site-specific documentation).
