# Wind Mitigation Inspection Report

| <b>Name:</b> | Sun Ketch 2 Condo Assoc Inc Bldg 5 | | | | | <b>Windspeed Region:</b> | Region 1 | | <b>Inspected By:</b> | |
| <b>Address:</b> | 224-230 Sun Vista Ct S | | | | | | | | | |

# Uniform Mitigation Verification Inspection Form

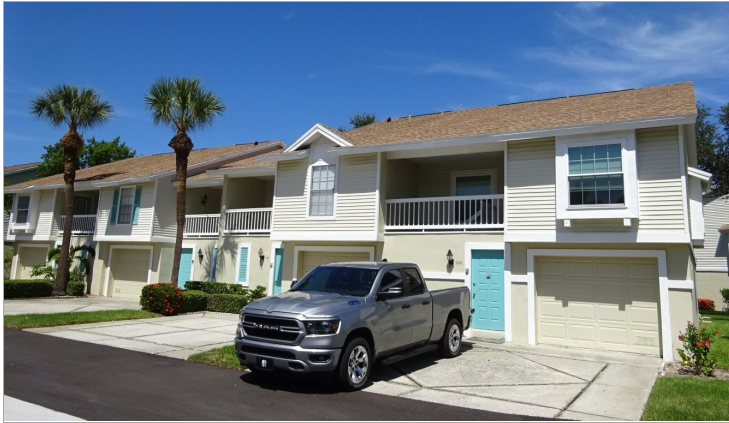
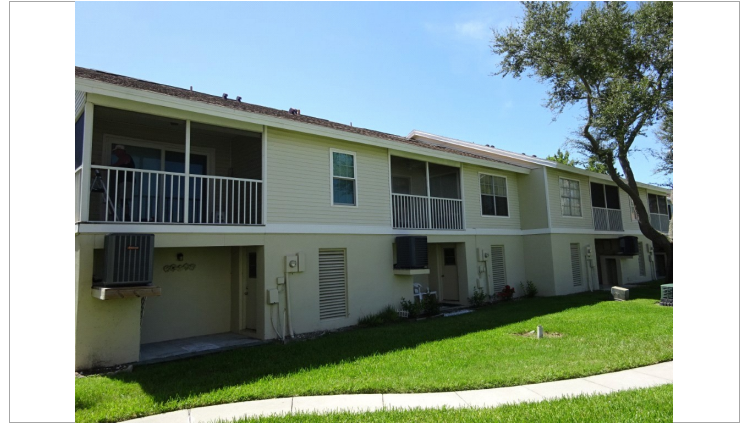
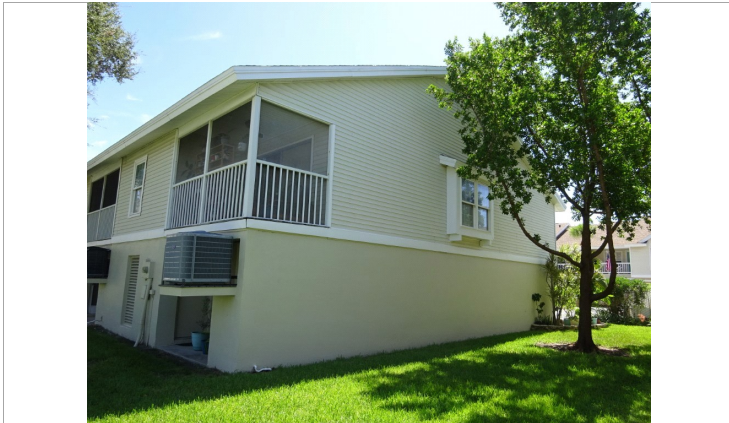
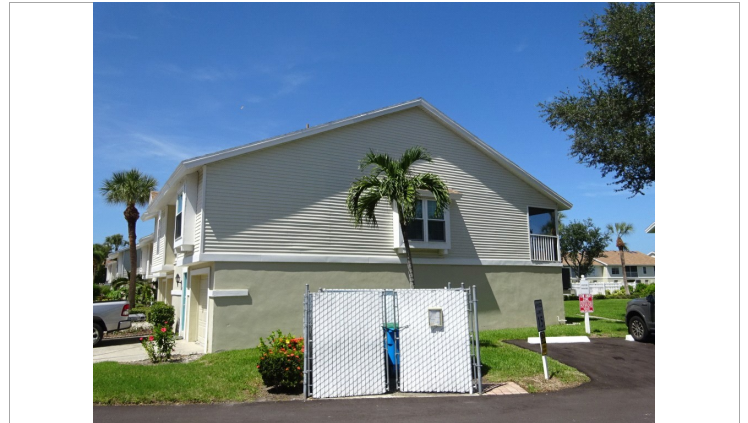
## Elevation and Roof Geometry

☒ C. Other Roof: Any roof that does not qualify as either (A) or (B) above.

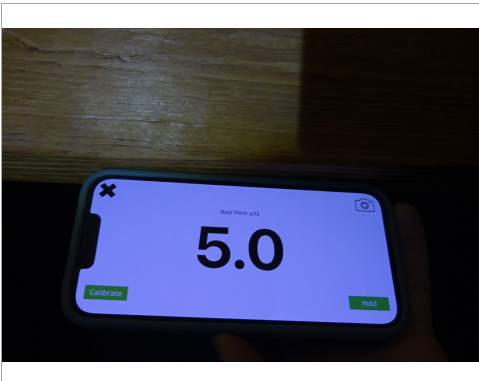
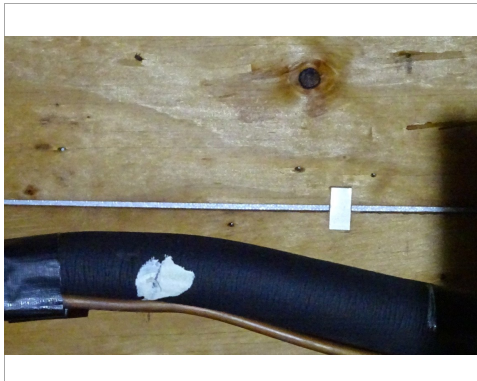
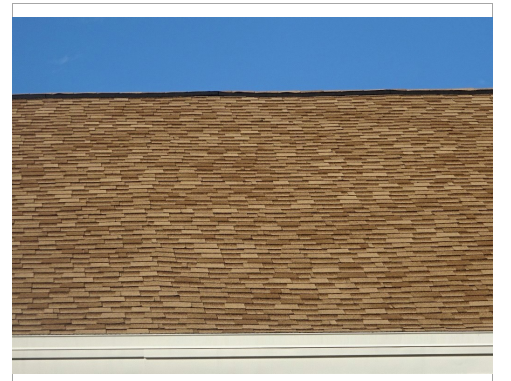
## Roof Covering Types, Roof Slope and Secondary Water Resistance

Permit Date: Nov 9, 2020

| Description: | RE-ROOF 21 BUILDINGS AND (1) POOL HOUSE. ALL BUILDINGS 5/12 PITCH. TEAR OFF DOWN TO WOOD DECK. FELT BUSTER UNDERLAYMENT.FL#18686-R2 GAF SHINGLES FL#10124-R27 | | | | |

Main Material Type: Shingle

☐ Greater than or equal to ( ≥ 6:12) ☒ Less than (< 6:12).

☒ B. No Sealed Roof Deck.

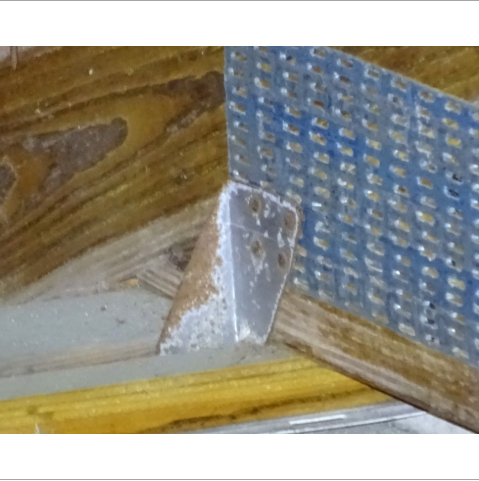
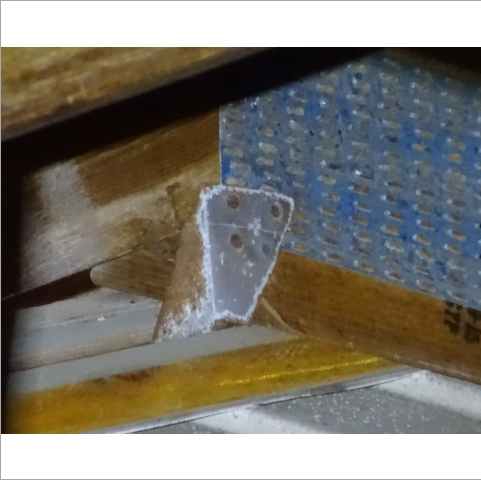
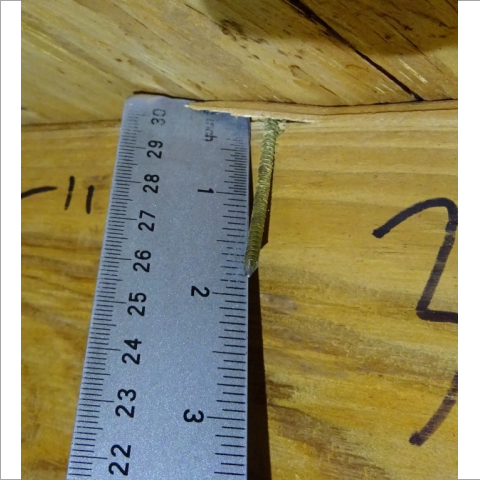
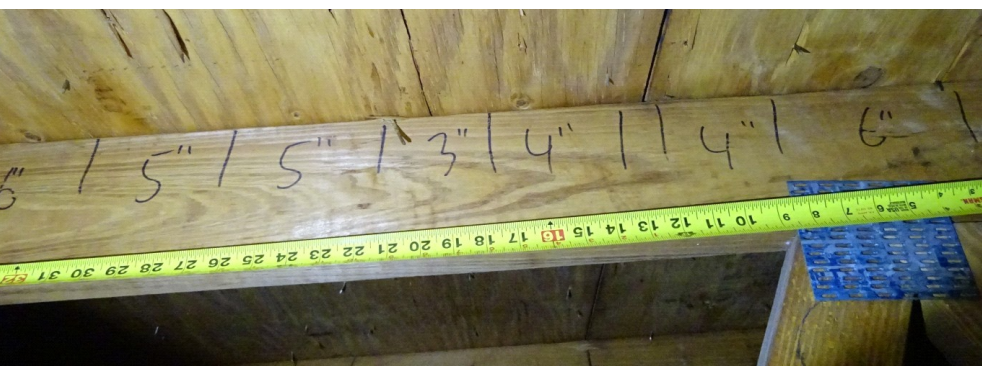
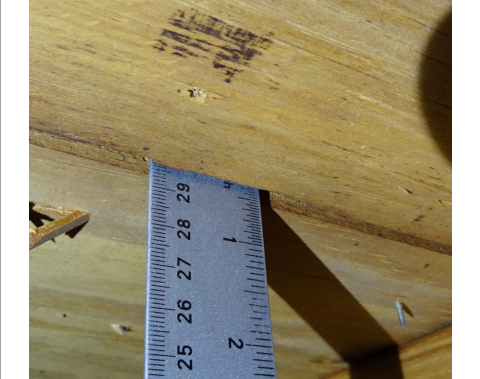
Roof Deck Attachment and Roof to Wall Attachment

- ☒ C. Plywood/OSB roof sheathing with a minimum thickness of 7/16" attached to the roof truss/rafter (spaced a maximum of 24" o.c.) by 8d common nails spaced a maximum of 6" in the field. OR Dimensional lumber/Tongue Groove decking with a minimum of 2 nails per board (or 1 nail per board if each board is equal to or less than 6" in width). OR Any system of screws, nails, adhesives, other deck fastening system or truss/rafter spacing that is shown to have an equivalent or greater resistance than 8d common nails spaced a maximum of 6" in the field (max 24" truss/rafter spacing) or has a mean ultimate uplift resistance of at least 182 psf.

☒ B. Clips

- ☒ Metal connectors that do not wrap over the top of the truss/rafter, OR
- ☐ Metal connectors with a minimum of (1) strap that wraps over the top of the truss/rafter and does not meet the nail position requirements of C or D, but is secured with a minimum of (3) nails, OR
- ☐ Purpose-made metal connector(s) or structural fastener(s) with a substantiated wind allowable uplift capacity of 386 lbs. or greater installed per the manufacturer's installation specifications (requires site-specific documentation).
