# Wind Mitigation Inspection Report

| <b>Name:</b> | Sun Ketch 2 Condo Assoc Inc Bldg 6 | | | | | | | | | |
| <b>Address:</b> | 12200-12220 Sun Vista Ct W | | | | | | | | | |

# Uniform Mitigation Verification Inspection Form

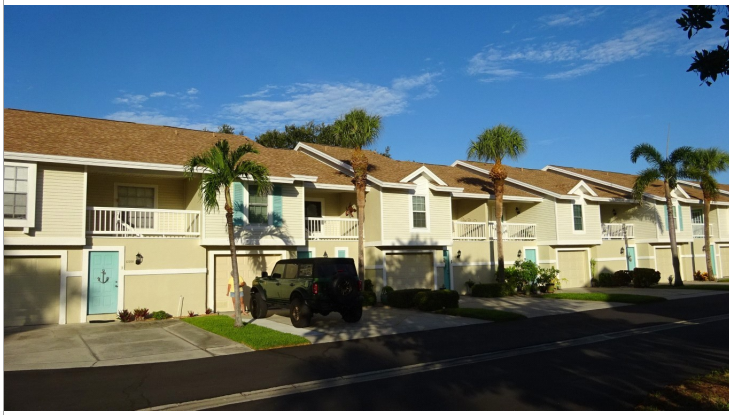
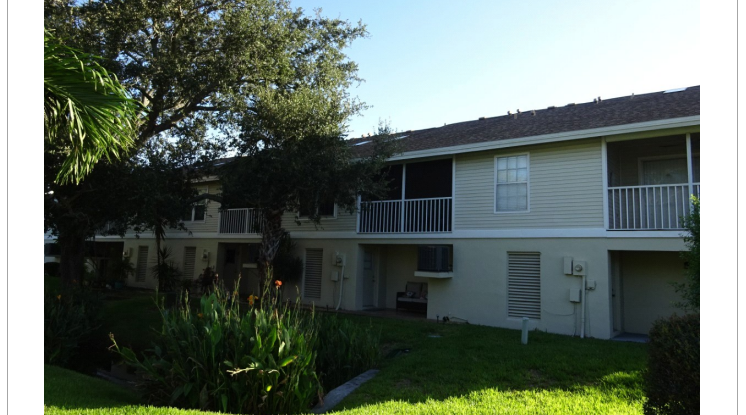
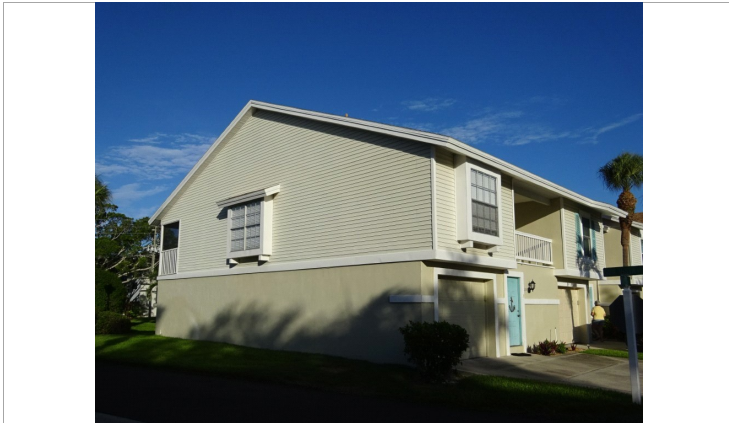
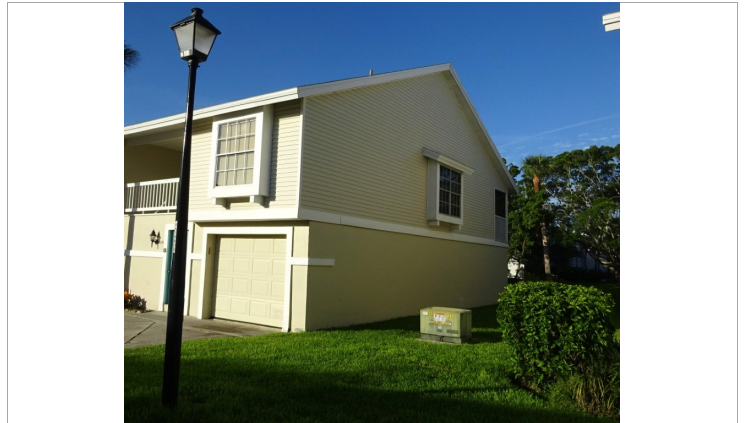
## Elevation and Roof Geometry

☒ C. Other Roof: Any roof that does not qualify as either (A) or (B) above.

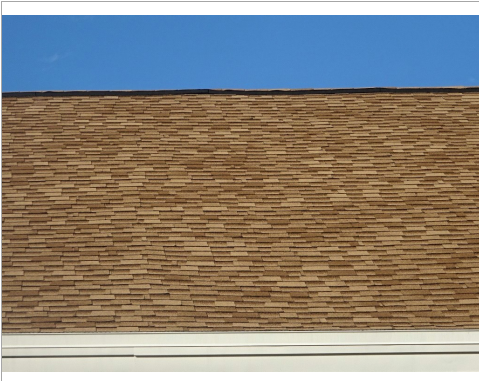
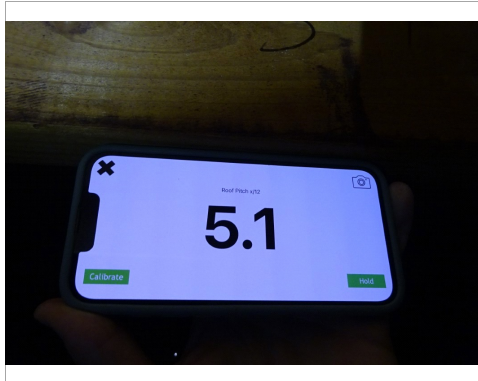
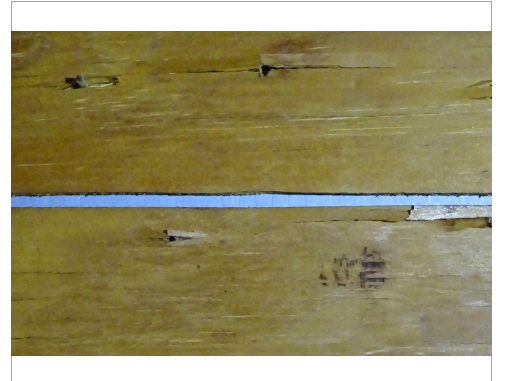
## Roof Covering Types, Roof Slope and Secondary Water Resistance

Permit Date: Nov 9, 2020

☐ Greater than or equal to ( ≥ 6:12) ☒ Less than (< 6:12).

| 4.1 Roof Covering Type: | Permit<br>Application Date | FBC or MDC Product<br>Approval # | Year of Original<br>Installation or<br>Replacement | No Information<br>Provided for<br>Compliance |
|---|---|---|---|---|
| <input checked="" type="checkbox"/> Asphalt/Fiberglass Shingle | <u>Nov 9, 2020</u> | <u>BLDC-001028-2020</u> | _____ | <input type="checkbox"/> |

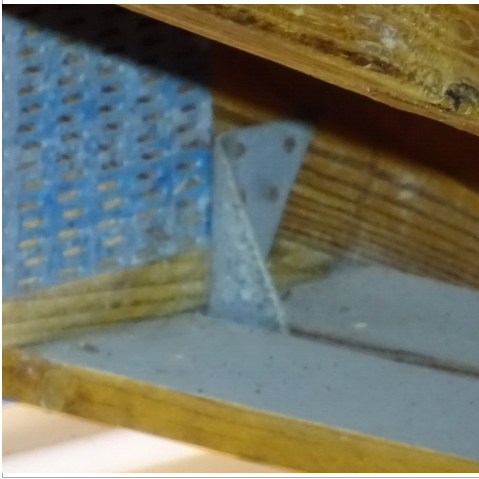
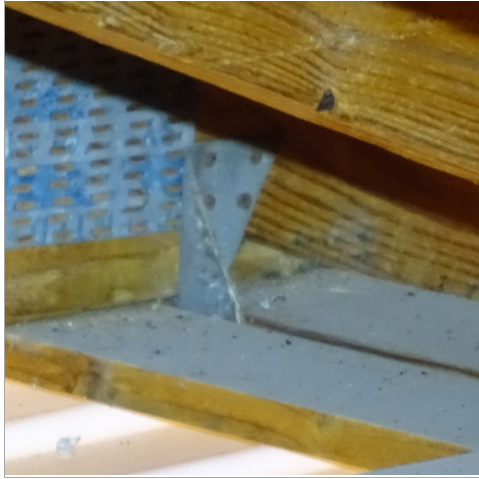
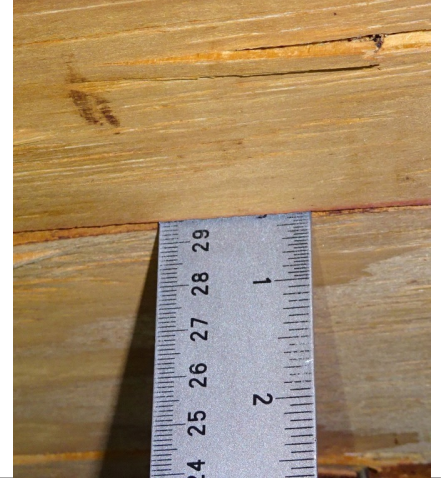
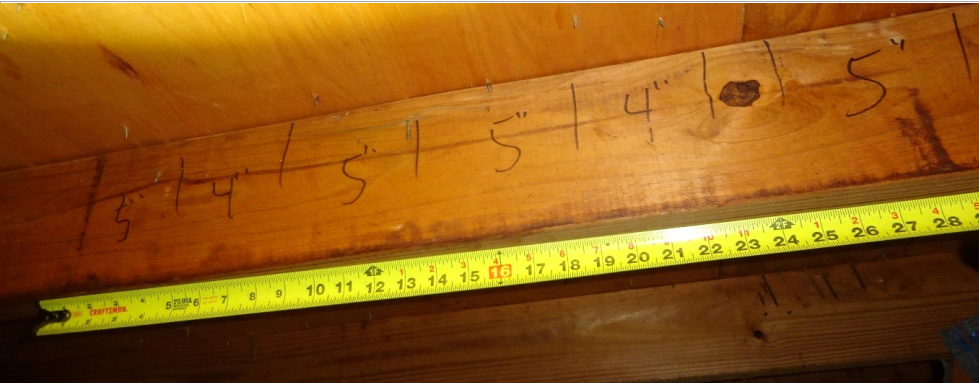
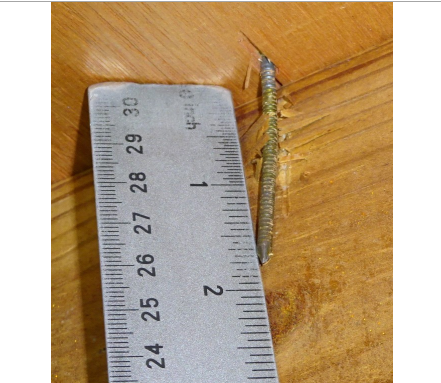
## Roof Deck Attachment and Roof to Wall Attachment

- ☒ C. Plywood/OSB roof sheathing with a minimum thickness of 7/16" attached to the roof truss/rafter (spaced a maximum of 24" o.c.) by 8d common nails spaced a maximum of 6" in the field. OR Dimensional lumber/Tongue Groove decking with a minimum of 2 nails per board (or 1 nail per board if each board is equal to or less than 6" in width). OR Any system of screws, nails, adhesives, other deck fastening system or truss/rafter spacing that is shown to have an equivalent or greater resistance than 8d common nails spaced a maximum of 6" in the field (max 24" truss/rafter spacing) or has a mean ultimate uplift resistance of at least 182 psf.

☒ B. Clips

- ☒ Metal connectors that do not wrap over the top of the truss/rafter, OR
- ☐ Metal connectors with a minimum of (1) strap that wraps over the top of the truss/rafter and does not meet the nail position requirements of C or D, but is secured with a minimum of (3) nails, OR
- ☐ Purpose-made metal connector(s) or structural fastener(s) with a substantiated wind allowable uplift capacity of 386 lbs. or greater installed per the manufacturer's installation specifications (requires site-specific documentation).
