# Wind Mitigation Inspection Report

| <b>Name:</b> | Sun Ketch 2 Condo Assoc Inc Bldg 7 | | | | | | | | | |
| <b>Address:</b> | 12224-12244 Sun Vista Ct W | | | | | | | | | |

# Uniform Mitigation Verification Inspection Form

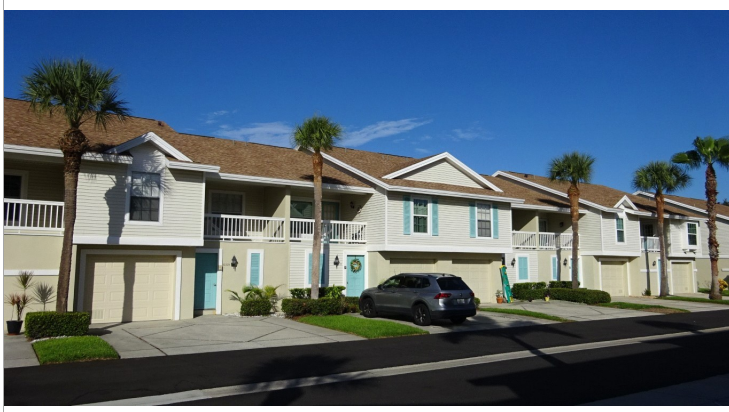
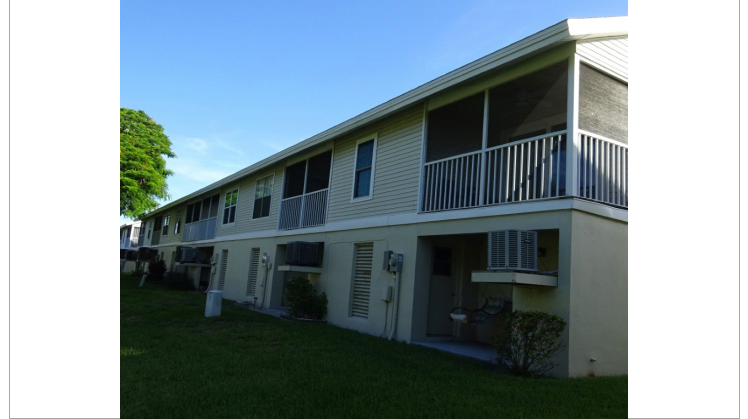
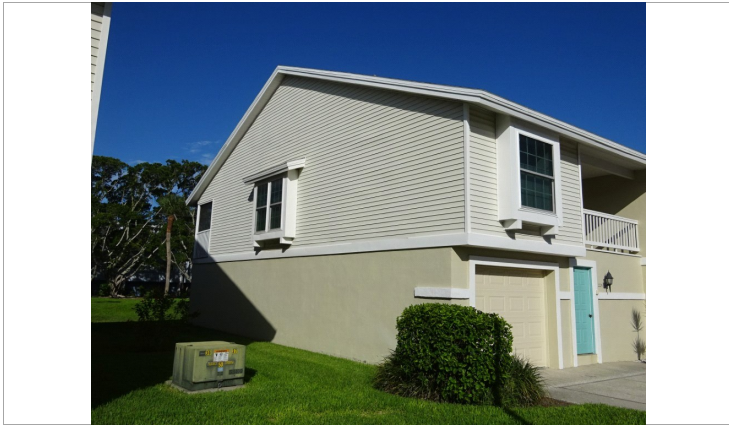
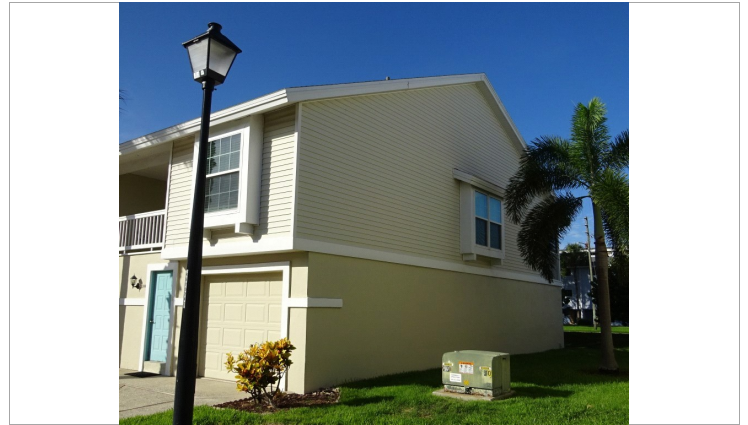
## Elevation and Roof Geometry

☒ C. Other Roof: Any roof that does not qualify as either (A) or (B) above.

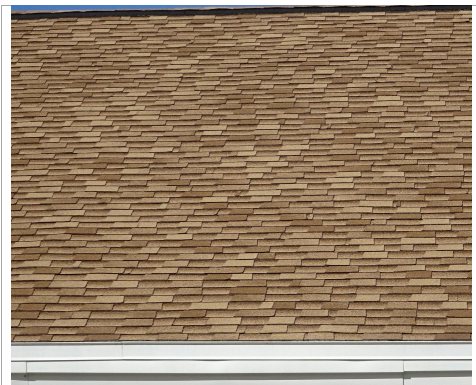
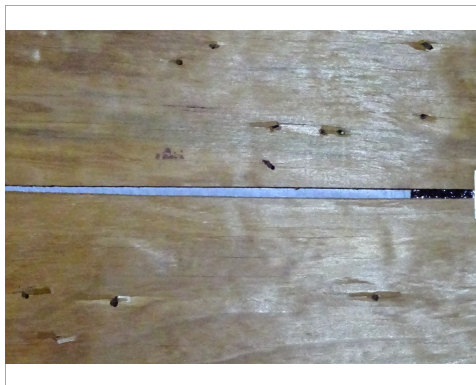
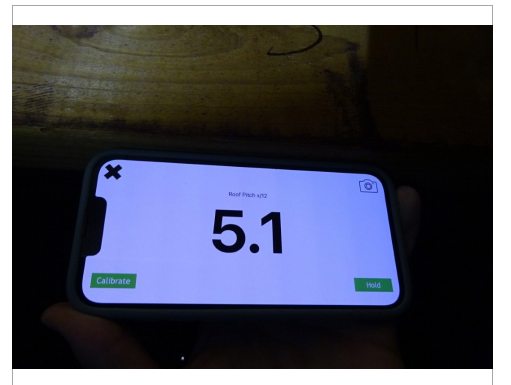
## Roof Covering Types, Roof Slope and Secondary Water Resistance

Permit Date: Nov 9, 2020

Main Material Type: Shingle

Date Replaced: Nov 9, 2020

☐ Greater than or equal to ( ≥ 6:12) ☒ Less than (< 6:12).

☒ B. No Sealed Roof Deck.

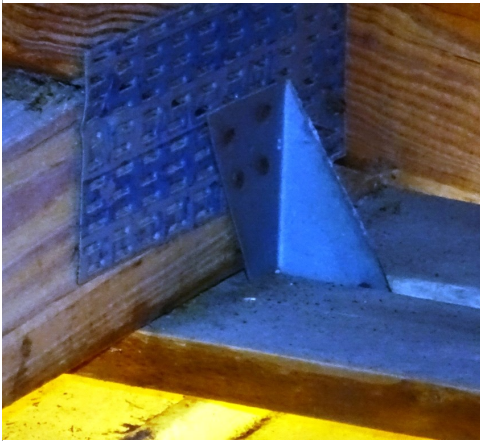
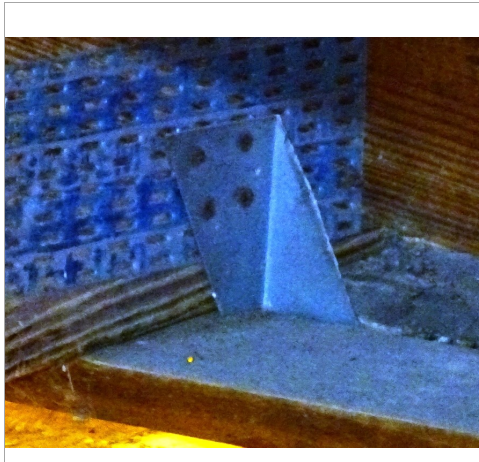
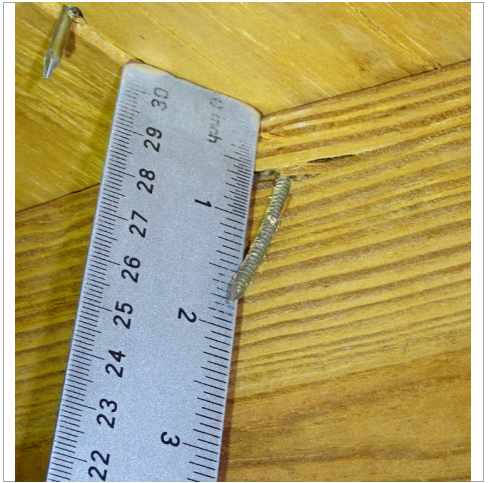
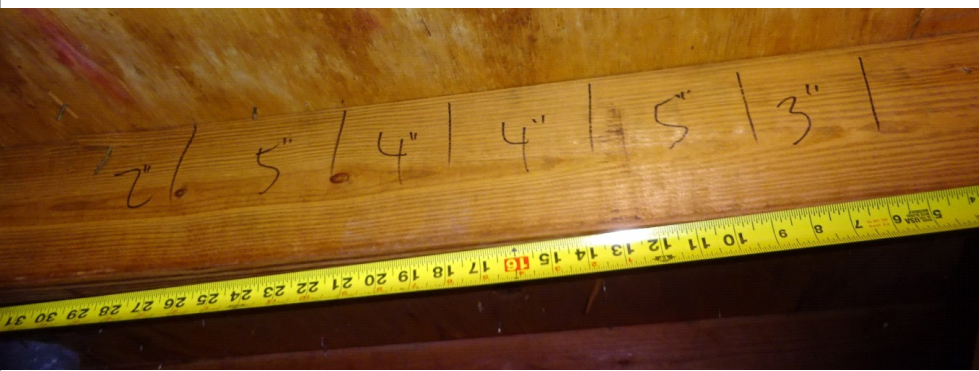
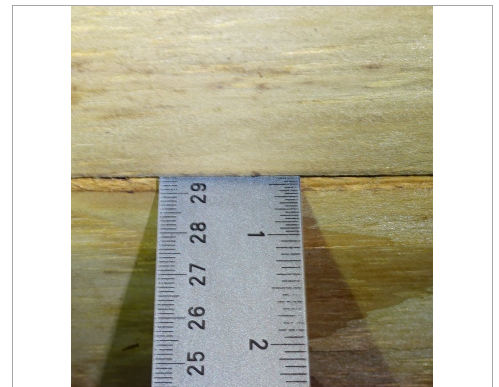
## Roof Deck Attachment and Roof to Wall Attachment

- ☒ C. Plywood/OSB roof sheathing with a minimum thickness of 7/16" attached to the roof truss/rafter (spaced a maximum of 24" o.c.) by 8d common nails spaced a maximum of 6" in the field. OR Dimensional lumber/Tongue Groove decking with a minimum of 2 nails per board (or 1 nail per board if each board is equal to or less than 6" in width). OR Any system of screws, nails, adhesives, other deck fastening system or truss/rafter spacing that is shown to have an equivalent or greater resistance than 8d common nails spaced a maximum of 6" in the field (max 24" truss/rafter spacing) or has a mean ultimate uplift resistance of at least 182 psf.

☒ B. Clips

- ☒ Metal connectors that do not wrap over the top of the truss/rafter, OR
- ☐ Metal connectors with a minimum of (1) strap that wraps over the top of the truss/rafter and does not meet the nail position requirements of C or D, but is secured with a minimum of (3) nails, OR
- ☐ Purpose-made metal connector(s) or structural fastener(s) with a substantiated wind allowable uplift capacity of 386 lbs. or greater installed per the manufacturer's installation specifications (requires site-specific documentation).

Recommendations for this home would be to install a hurricane shutter system over the windows and doors for maximum protection as well as (possibly) increased savings. (ALL GLAZED OPENINGS a.k.a. items with glass in them must be protected or impact rated).
