# Wind Mitigation Inspection Report

| <b>Name:</b> | Sun Ketch 2 Condo Assoc Inc Bldg 8 | | | | | | | | | |
| <b>Address:</b> | 12300-12320 Sun Vista Ct W | | | | | | | | | |

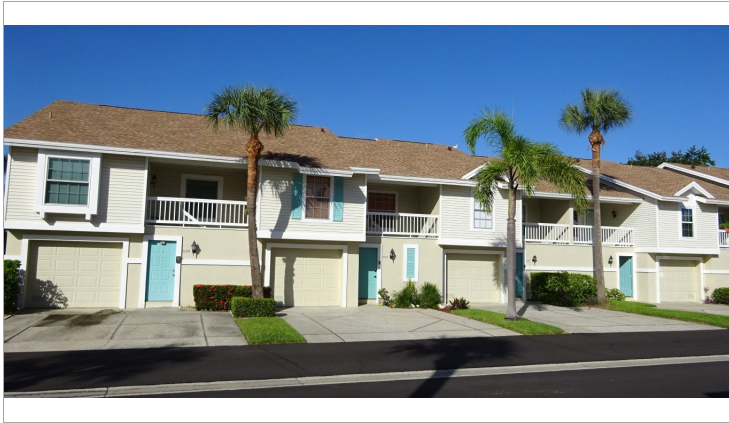
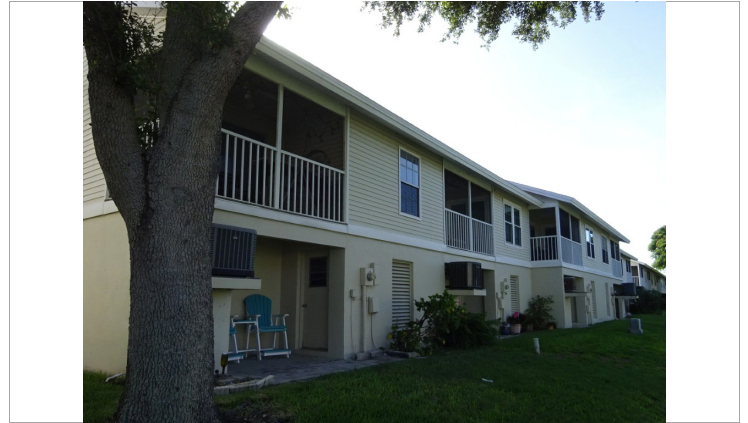
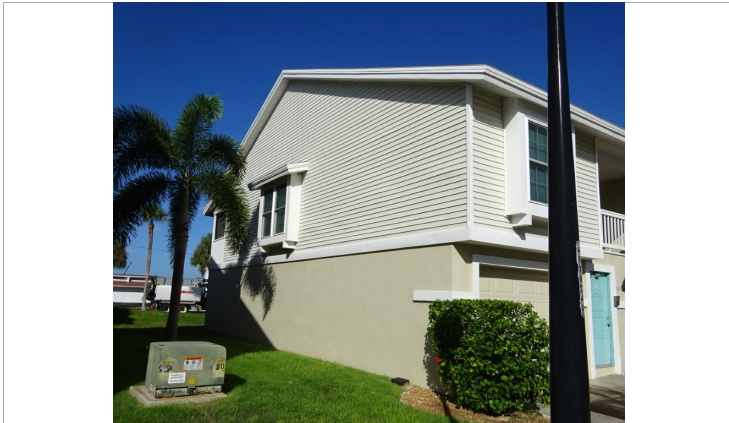
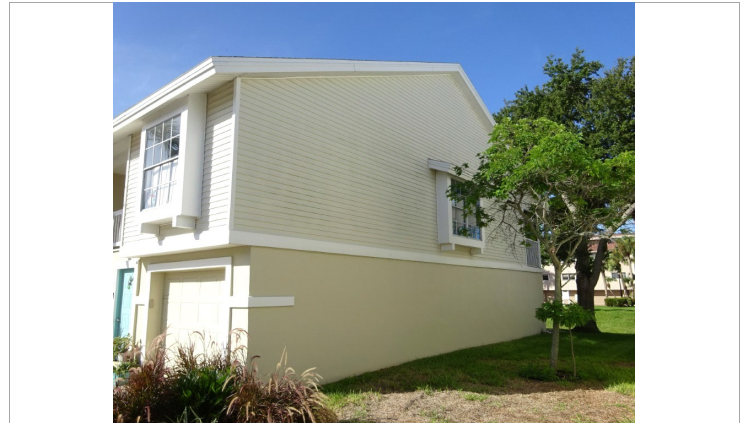
## Elevation and Roof Geometry

☒ C. Other Roof: Any roof that does not qualify as either (A) or (B) above.

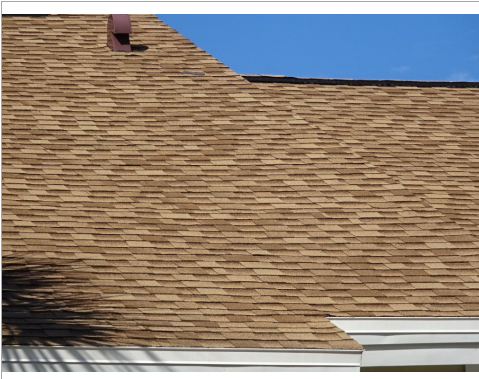
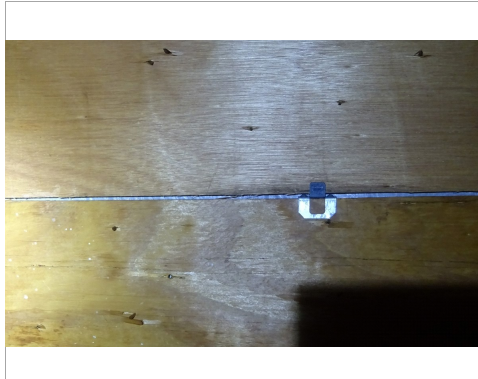
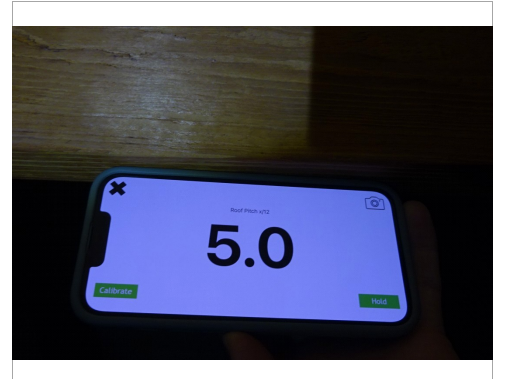
## Roof Covering Types, Roof Slope and Secondary Water Resistance

Permit Date: Nov 9, 2020

- ☐ Greater than or equal to ( ≥ 6:12) ☒ Less than (< 6:12).

| 4.1 Roof Covering Type: | Permit<br>Application Date | FBC or MDC Product<br>Approval # | Year of Original<br>Installation or<br>Replacement | No Information<br>Provided for<br>Compliance |
|---|---|---|---|---|
| <input checked="" type="checkbox"/> Asphalt/Fiberglass Shingle | <u>Nov 9, 2020</u> | <u>BLDC-001028-2020</u> | _____ | <input type="checkbox"/> |

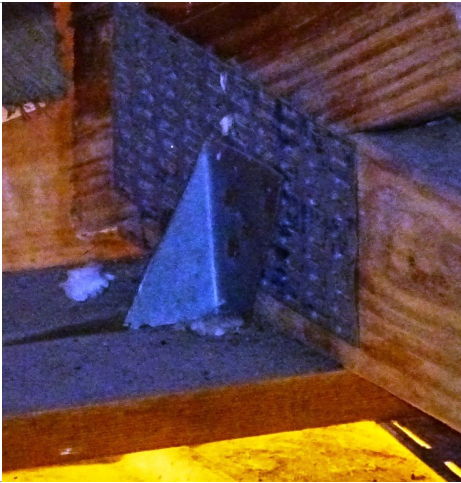
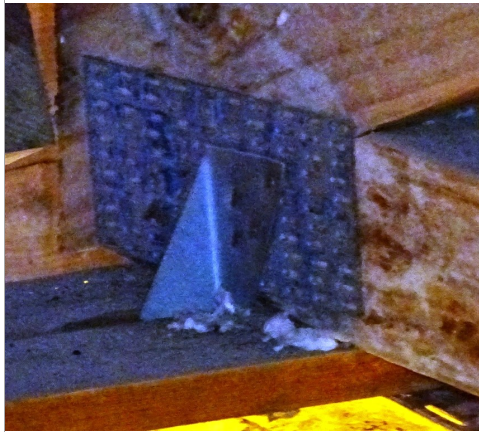
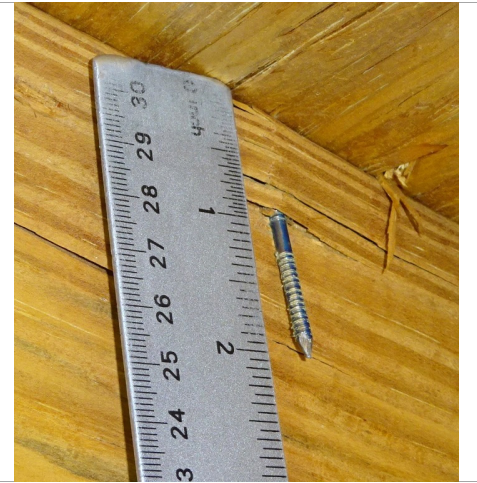
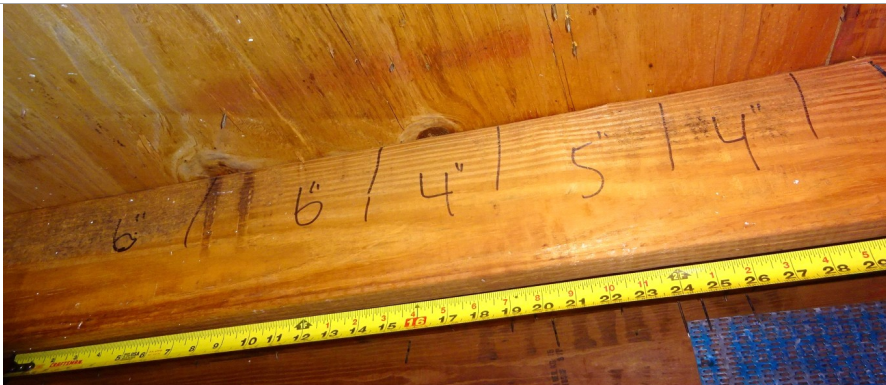
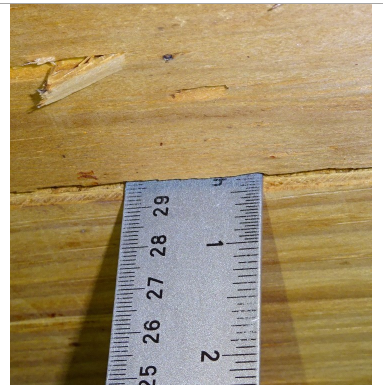
## Roof Deck Attachment and Roof to Wall Attachment

- ☒ C. Plywood/OSB roof sheathing with a minimum thickness of 7/16" attached to the roof truss/rafter (spaced a maximum of 24" o.c.) by 8d common nails spaced a maximum of 6" in the field. OR Dimensional lumber/Tongue Groove decking with a minimum of 2 nails per board (or 1 nail per board if each board is equal to or less than 6" in width). OR Any system of screws, nails, adhesives, other deck fastening system or truss/rafter spacing that is shown to have an equivalent or greater resistance than 8d common nails spaced a maximum of 6" in the field (max 24" truss/rafter spacing) or has a mean ultimate uplift resistance of at least 182 psf.

☒ B. Clips

- ☒ Metal connectors that do not wrap over the top of the truss/rafter, OR
- ☐ Metal connectors with a minimum of (1) strap that wraps over the top of the truss/rafter and does not meet the nail position requirements of C or D, but is secured with a minimum of (3) nails, OR
- ☐ Purpose-made metal connector(s) or structural fastener(s) with a substantiated wind allowable uplift capacity of 386 lbs. or greater installed per the manufacturer's installation specifications (requires site-specific documentation).
