# Wind Mitigation Inspection Report

| <b>Name:</b> | Sun Ketch 2 Condo Assoc Inc Bldg 9 | | | | | | | | | |
| <b>Address:</b> | 12324-12344 Sun Vista Ct W | | | | | | | | | |

# Uniform Mitigation Verification Inspection Form

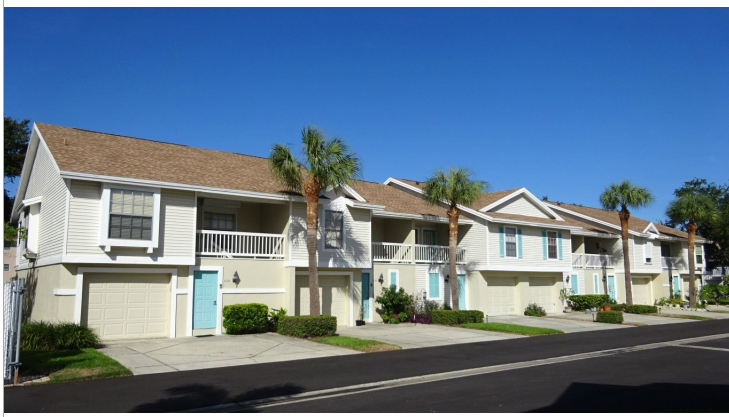
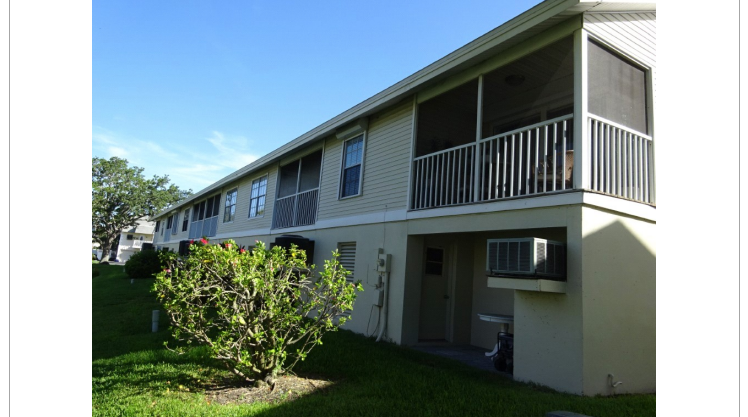
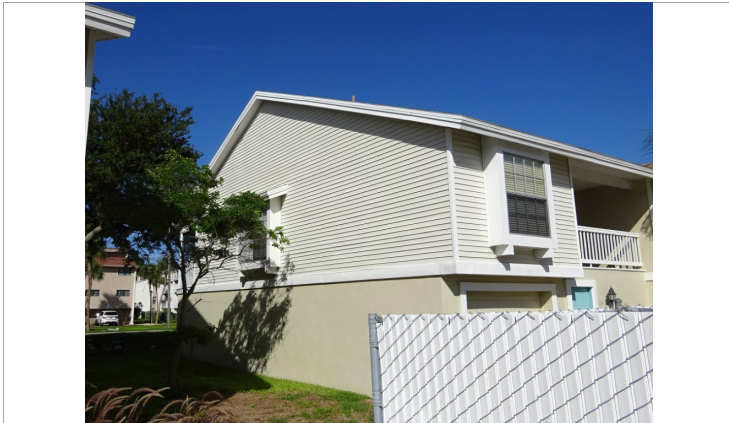
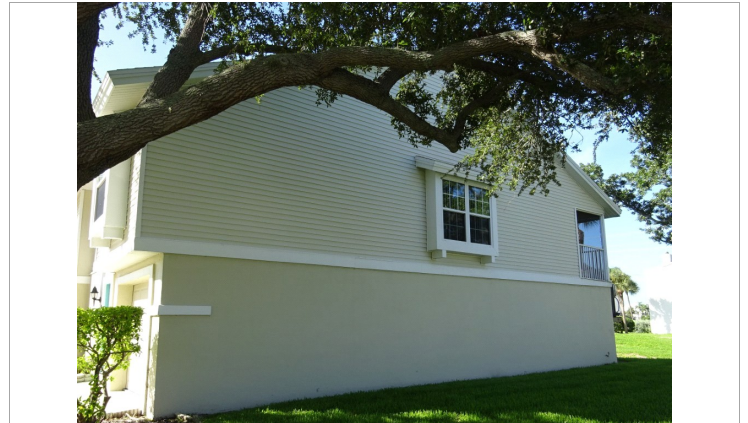
## Elevation and Roof Geometry

☒ C. Other Roof: Any roof that does not qualify as either (A) or (B) above.

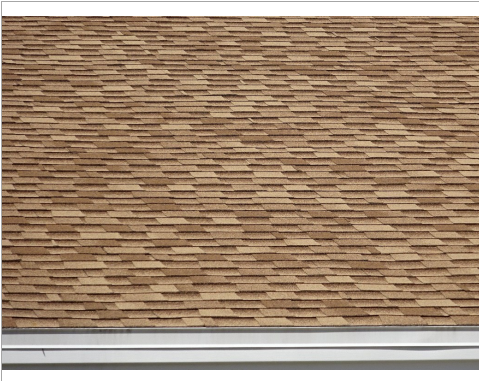
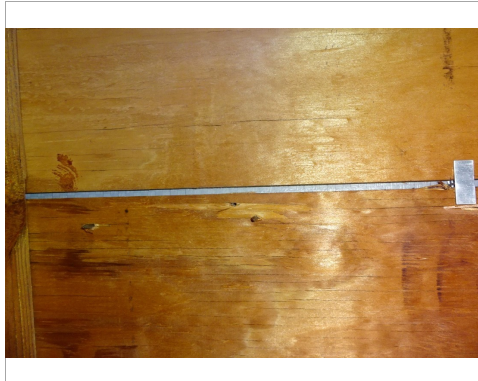
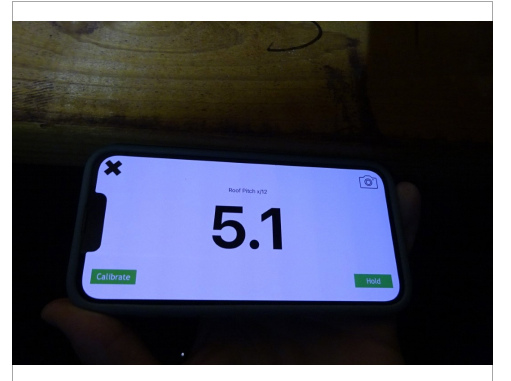
## Roof Covering Types, Roof Slope and Secondary Water Resistance

Permit Date: Nov 9, 2020

☐ Greater than or equal to ( ≥ 6:12) ☒ Less than (< 6:12).

| 4.1 Roof Covering Type: | Permit Application Date | FBC or MDC Product Approval # | Year of Original Installation or Replacement | No Information Provided for Compliance |
|---|---|---|---|---|
| <input checked="" type="checkbox"/> Asphalt/Fiberglass Shingle | <u>Nov 9, 2020</u> | <u>BLDC-001028-2020</u> | _____ | <input type="checkbox"/> |

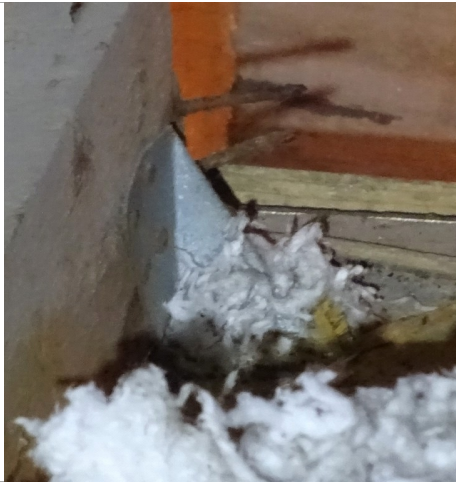
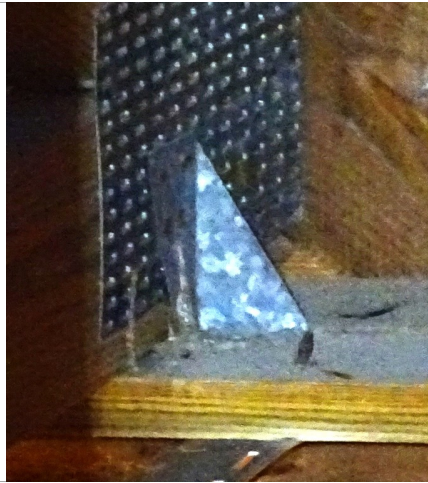
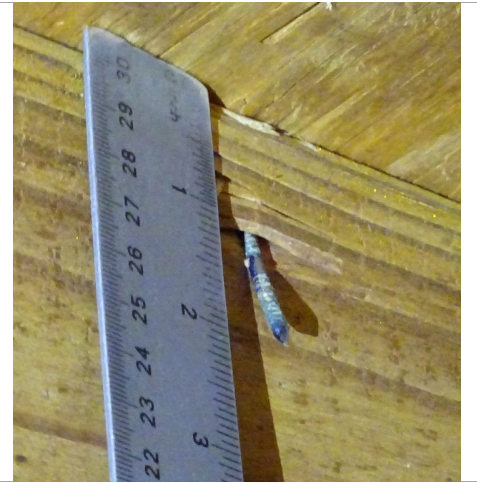
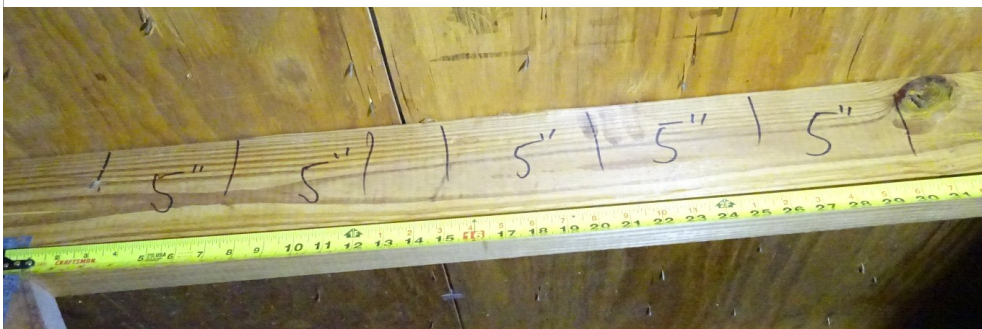
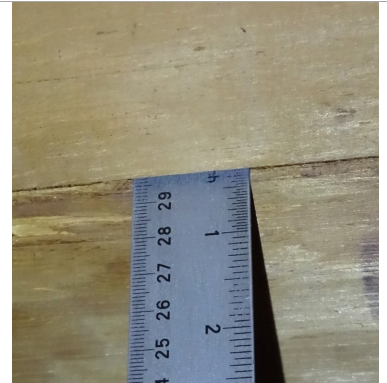
## Roof Deck Attachment and Roof to Wall Attachment

- ☒ C. Plywood/OSB roof sheathing with a minimum thickness of 7/16" attached to the roof truss/rafter (spaced a maximum of 24" o.c.) by 8d common nails spaced a maximum of 6" in the field. OR Dimensional lumber/Tongue Groove decking with a minimum of 2 nails per board (or 1 nail per board if each board is equal to or less than 6" in width). OR Any system of screws, nails, adhesives, other deck fastening system or truss/rafter spacing that is shown to have an equivalent or greater resistance than 8d common nails spaced a maximum of 6" in the field (max 24" truss/rafter spacing) or has a mean ultimate uplift resistance of at least 182 psf.

- ☒ 1. Metal connectors secured to truss/rafter with a minimum of three (3) nails, and attached to the side and/or bottom of the wall framing top plate, or embedded into the bond beam, with less than 1/2" gap from the blocking or truss/rafter, and blocked no more than 1 1/2" from the truss/rafter, and free of visible severe corrosion, OR
- ☐ 2. Metal connectors consisting of a single strap that wraps over the truss/rafter, are secured to the side of the wall and/or bottom of the top plate with a minimum of three nails on each side and free of visible severe corrosion, OR
- ☐ 3. Purpose-made metal connector(s) or structural fastener(s) installed per the manufacturer's installation specifications to meet the substantiated wind allowable capacity detailed below.

☒ B. Clips

- ☒ Metal connectors that do not wrap over the top of the truss/rafter, OR
- ☐ Metal connectors with a minimum of (1) strap that wraps over the top of the truss/rafter and does not meet the nail position requirements of C or D, but is secured with a minimum of (3) nails, OR
- ☐ Purpose-made metal connector(s) or structural fastener(s) with a substantiated wind allowable uplift capacity of 386 lbs. or greater installed per the manufacturer's installation specifications (requires site-specific documentation).
